JAPAN P&I NEWS

No.734-15/6/8

Argentina – Groundings in the River Parana

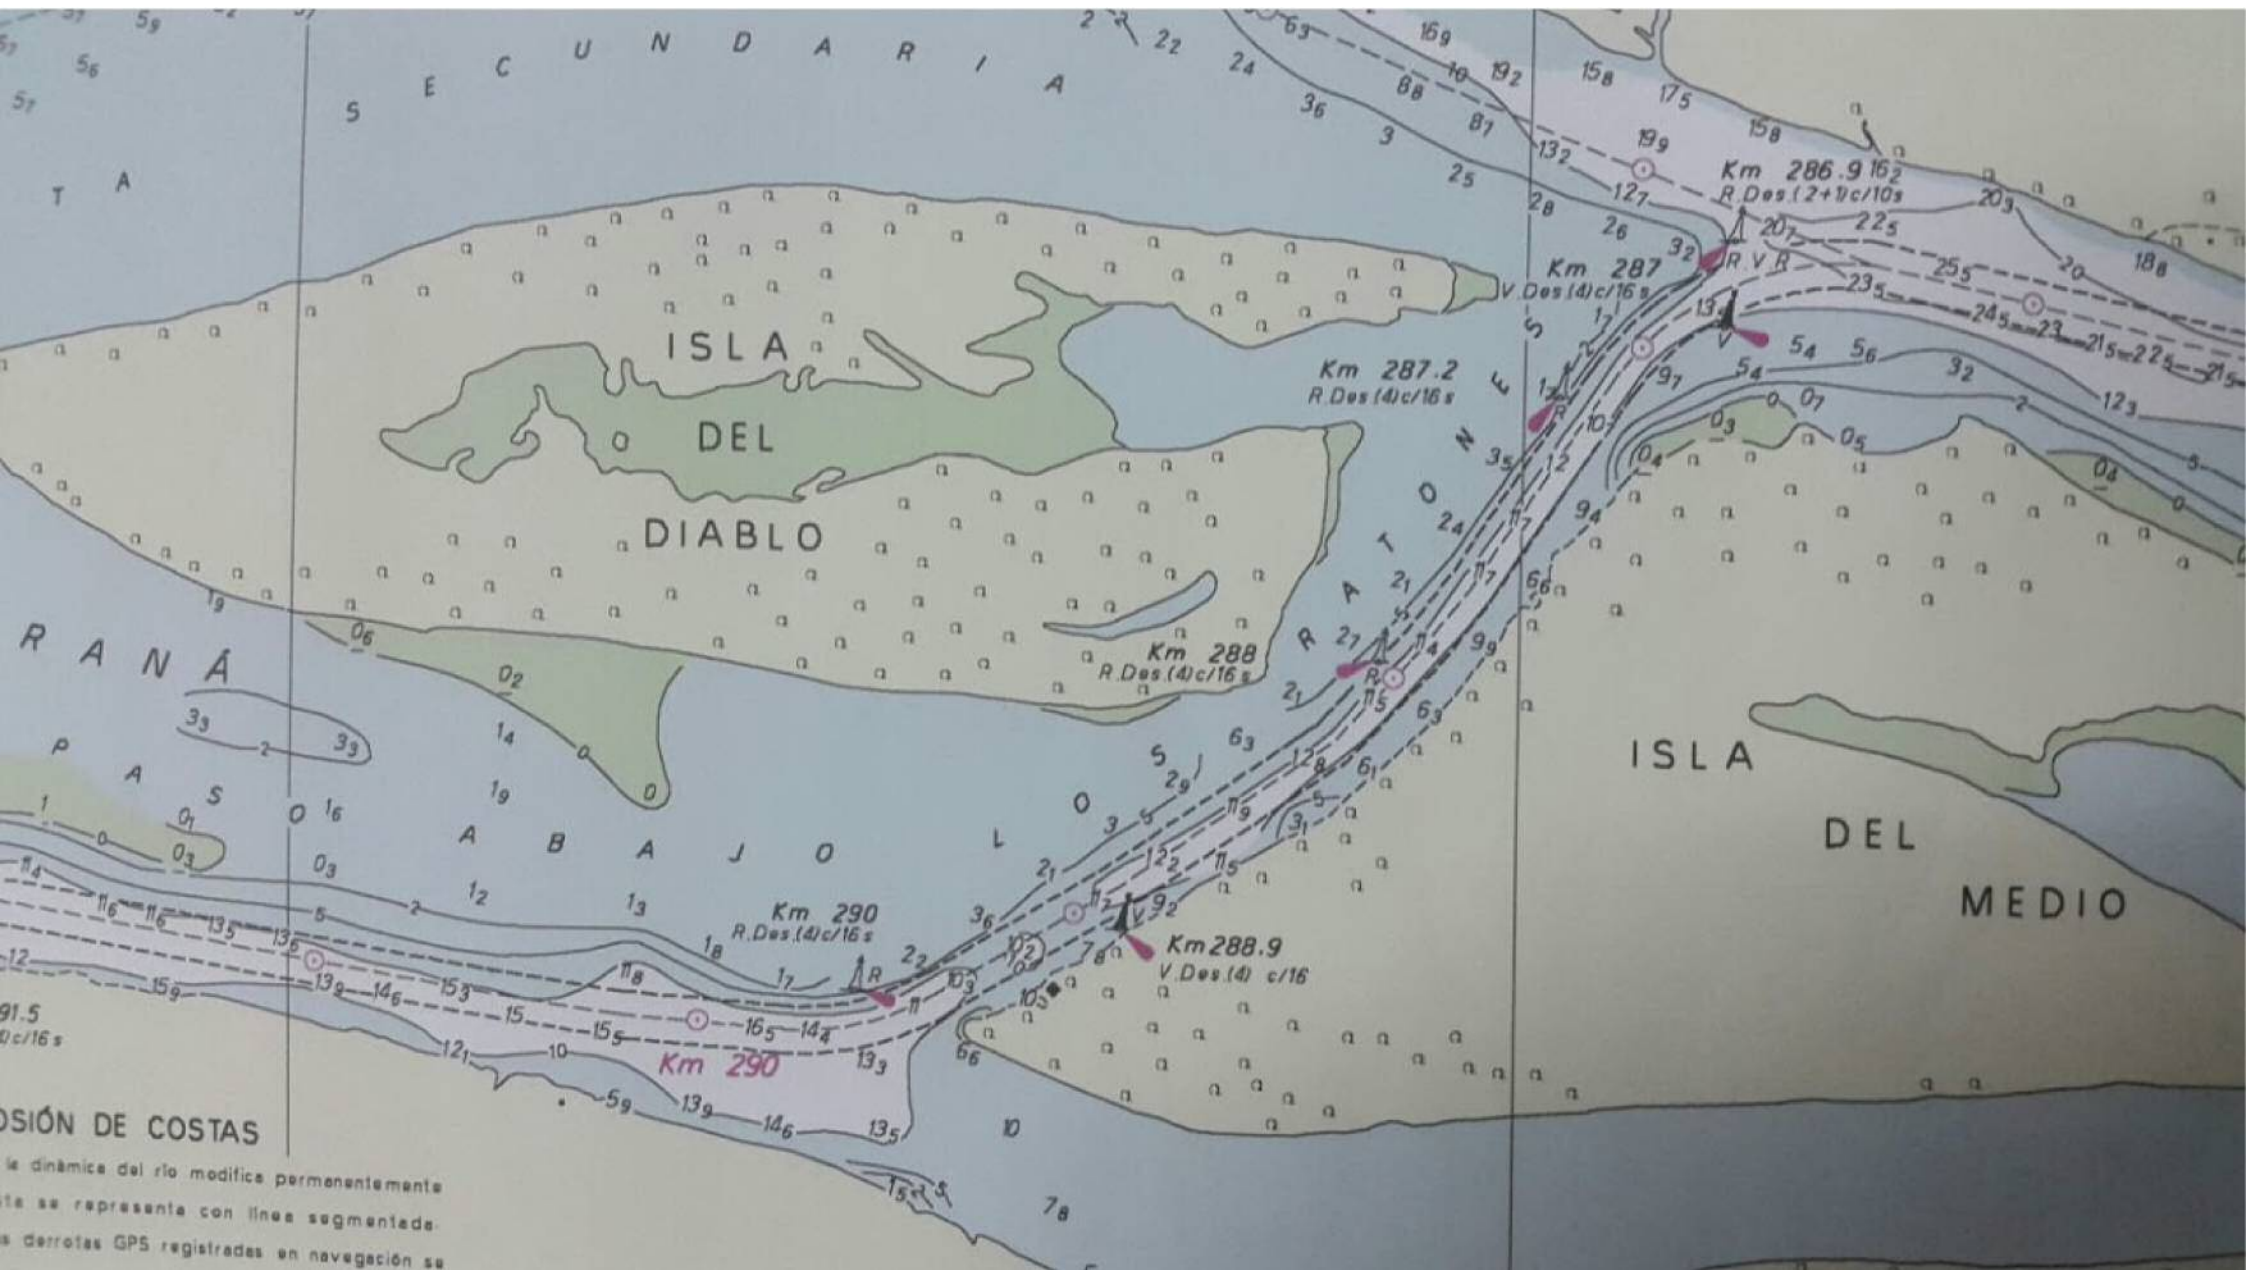
Attachment: Chart of the relevant area

In recent weeks, four vessels have grounded in the River Parana in the area between km 280 and km 290. The chart of the area shows that a vessel has to go through very sharp bends in the leg known as “Paso Abajo Los Ratones”, where the river current flows downstream at about 2.5 knots, though this may vary depending on the water level of the river. A combination of factors could cause a loss of control of the vessel and consequent grounding.

The authorities have indicated that vessels navigating through the Paso Abajo Los Ratones must remain within the dredged channel. Although the pilot carrying out the handling of the vessel is responsible for navigation, responsibility for monitoring the conduct of the pilot, and ensuring the ultimate safety of the vessel, remains with the Master.

Our correspondents therefore recommend that a proper navigation plan should be discussed between the Master and Pilot before navigating the stated section of the river. By doing this the Master will know beforehand the difficulties the vessel is likely to meet on the river and the Pilot can become familiar with the characteristics of the vessel. In addition, the Master must ensure the ship always maintains the 2 foot under keel clearance for safe passage taking into account the permissible sailing draft as announced by the Coast Guard on a daily basis.
