Prevention of accident damage to cargo loaded on Bulk Carriers

Case 1) Seawater damage

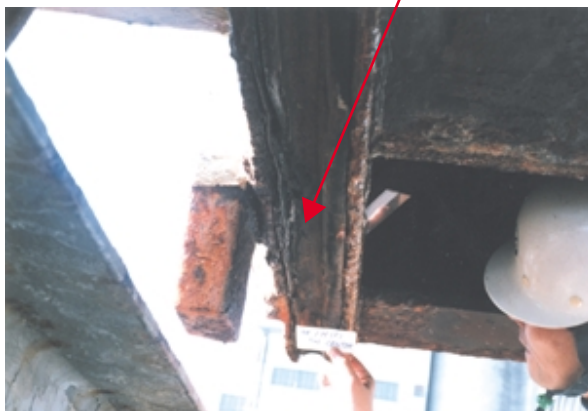
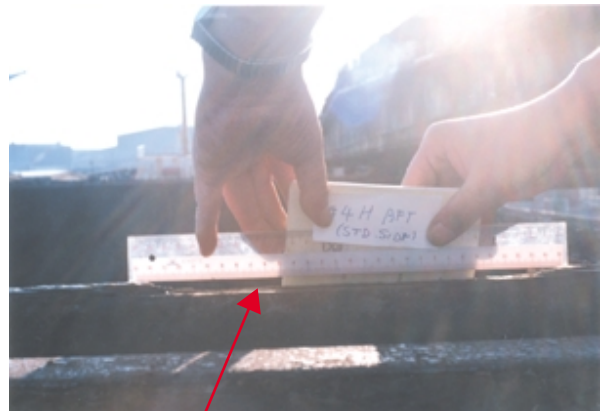
- Rubber gaskets become stiffened, lose elasticity, permanent grooves are deepened, and as a result, the strength of the contact between rubber gasket and compression bar becomes weak or they are not contacted.
- Rubber gaskets are partly missing and/or broken

Rubber gasket

Generally, rubber gaskets have a life expectancy of 4 - 5 years.

Though elasticity is inevitably lost with the lapse of years and permanent deformation (such as permanent groove) will start, if the compression margin when the compression bar is fitted into the gasket is more than 3mm on tightening with the securing devices, it is said that sufficient watertightness remains. Therefore, when the compression margin becomes less than 3mm, the gasket should be changed immediately, and also if the gasket is found to be partly broken or missing, it must be repaired by the proper method.

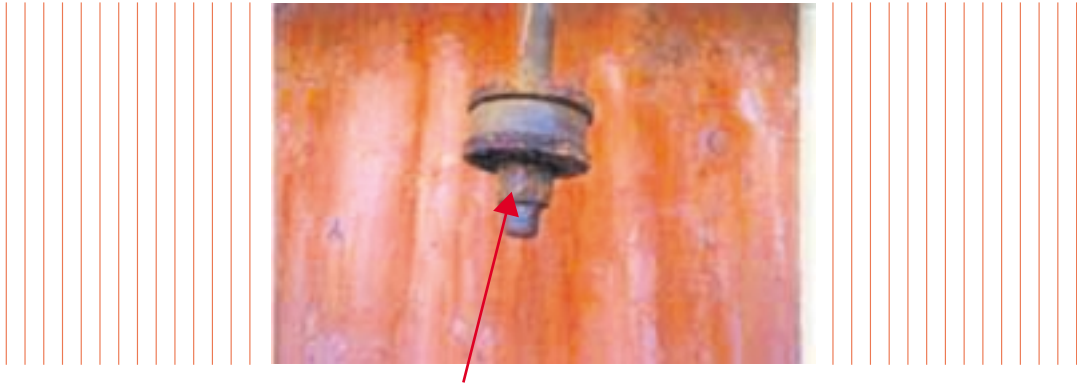
- Adjusting nuts of quick acting cleats rust and stick to the bolts, and there are no marks of the cleats having recently been adjusted. The cleat may be broken, bent or missing

The adjusting nut frozen to the bolt

When steel washers become worn-down or rubber washers become stiffened and/or elasticity is lost, and of course, when the cleat itself is lost or bent, they should be replaced or renewed immediately. Moreover, bolts and adjusting nuts should be greased properly in order to prevent rusting.

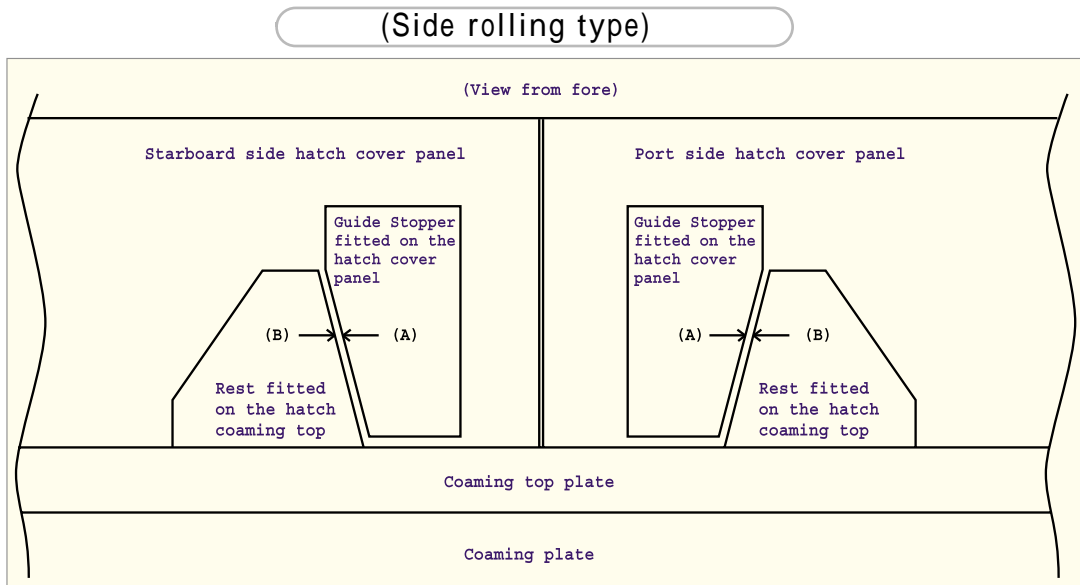
- Rubber washers of quick acting cleats can become deteriorated and/or stiffened.
- Drain pipes on the four corner of the hatch coaming top are broken and/or plugged with some debris, and the Non-return valves are also broken.
- The contact faces of the Rests on the hatch coaming top and Guide stoppers on the side of the hatch cover panel can become heavily worn-down

These days, most vessels are fitted with rests on the coaming top, and guide stoppers on the side/ end plates of the hatch cover panel as securing devices, as shown in the above sketch, and they work as follows :-

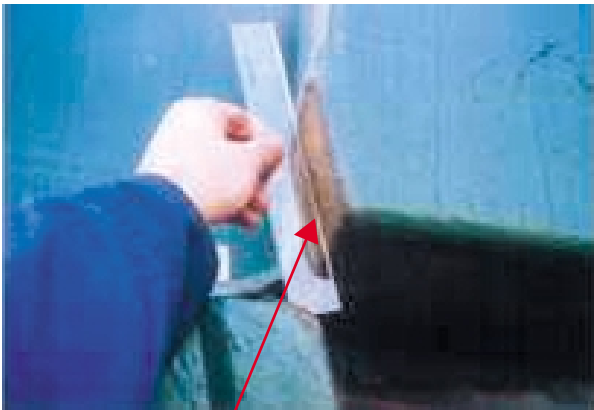
On hatch covers of side rolling type, the panels of both sides are held against each other strongly, and on folding type covers (two panels each fore and aft ; Jack Knife Type), the fore and after pairs are held against each other strongly, by a function of the slant (contacting) faces of the guide stopper and rest and the weight of the hatch cover panels. Therefore, if the contact faces of the guide stopper (A) and rest (B) are heavily worn-down, the strength of the contact between the panels becomes weak, and a gap(s) is created, allowing entry of sea water into the hold.

Showing heavy wear down at the contact face of the guide stopper

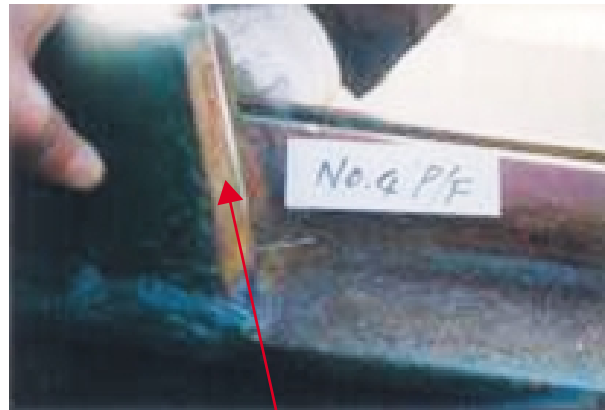
Showing heavy wear down at the contact face of the rest

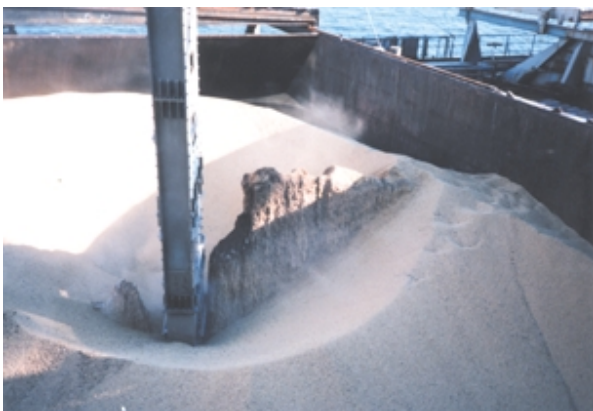
When seawater enters a vessel's hold laden with grain, as a consequence of such defects, remarkable trace showing seawater invasion are found on the inner side of the hatch coaming plate, and strip-shaped wet damaged cargo are found on the top surface just under the joins of the hatch cover panels, and lumps of wet damaged cargo are found at the corners of the hatch coaming. The damaged cargo may form pillars that reach the tanktop plate, and it may spread over the whole area on the tanktop plate in some cases.

Showing damaged cargo in the top surface just under the join of the hatch cover panels (Side rolling type)

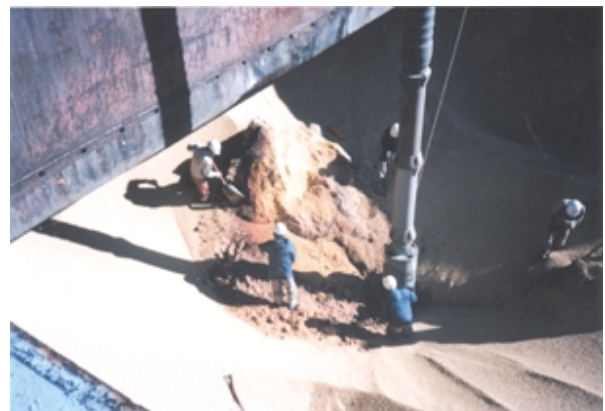
Showing the damaged cargo in the middle layer in the hold
