JAPAN P&I CLUB

P&I Loss Prevention Bulletin

Coastal vessels

Prevention of damage to harbour facilities and related cases

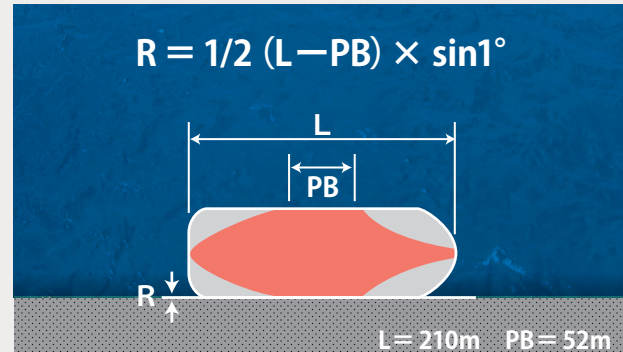
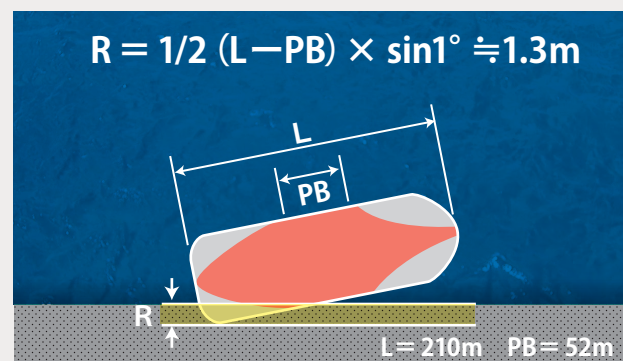
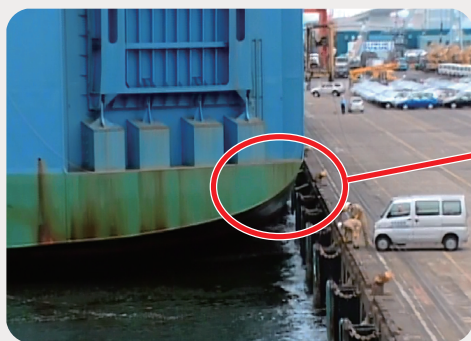
Also, the ship's hull construction is, as shown in Fig. 49, the Parallel Body (PB: the part contacting to quay) and it is short. And, if the mooring lines at fore and aft station were not rolled up evenly, the fore and aft parts may run aground on the quay (Over Hung) if the PB part loses balance during docking at this point. Consequently, it can cause damage to the edge of the quay, mooring bit, car stopper etc. According to the ship's hull construction shown below in Fig. 49-2, we can see that Over Hung (R) is approximately 1 m 38 cm. This was caused by shifting towards the quay by only one degree.

In the event that this part is over hung on the quay, this causes damage to the quay edge, car stopper, bit and hull.

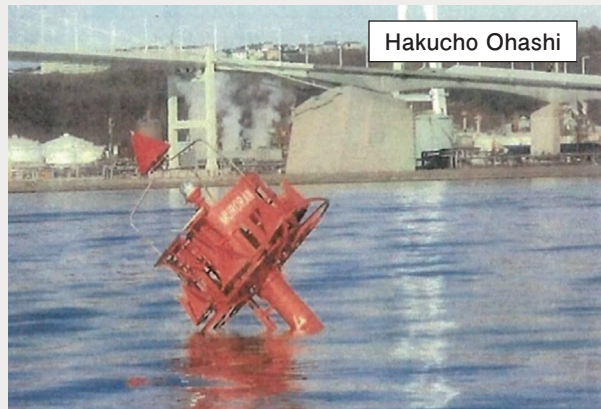
Photograph 67 Damaged state of No.2 light beacon

Bending loss on her port side bow and no flooding.

Label of No.2 light beacon: visible distance four nautical miles, red flash once every three seconds. Light height was 8.2 meters
