Case study

§ 5 - 1 Case Quay contact

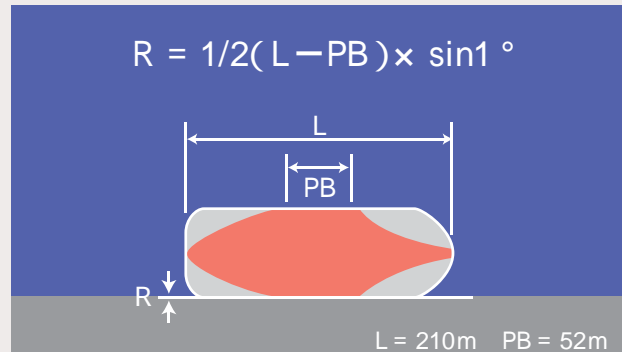
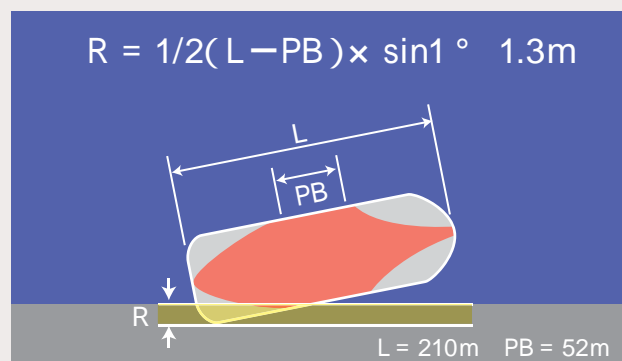
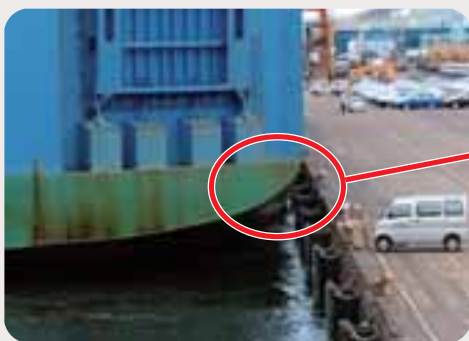
Also, the ship's hull construction is, as shown in Fig. 49, the Parallel Body (PB: the part contacting to quay) and it is short. And, if the mooring lines at fore and aft station were not rolled up evenly, the fore and aft parts may run aground on the quay (Over Hung) if the PB part loses balance during docking at this point. Consequently, it can cause damage to the edge of the quay, mooring bit, car stopper etc. According to the ship's hull construction shown below in Fig. 49-2, we can see that Over Hung (R) is approximately 1 m 38 cm. This was caused by shifting towards the quay by only one degree.

In the event that this part is over hung on the quay, this causes damage to the quay edge, car stopper, bit and hull.

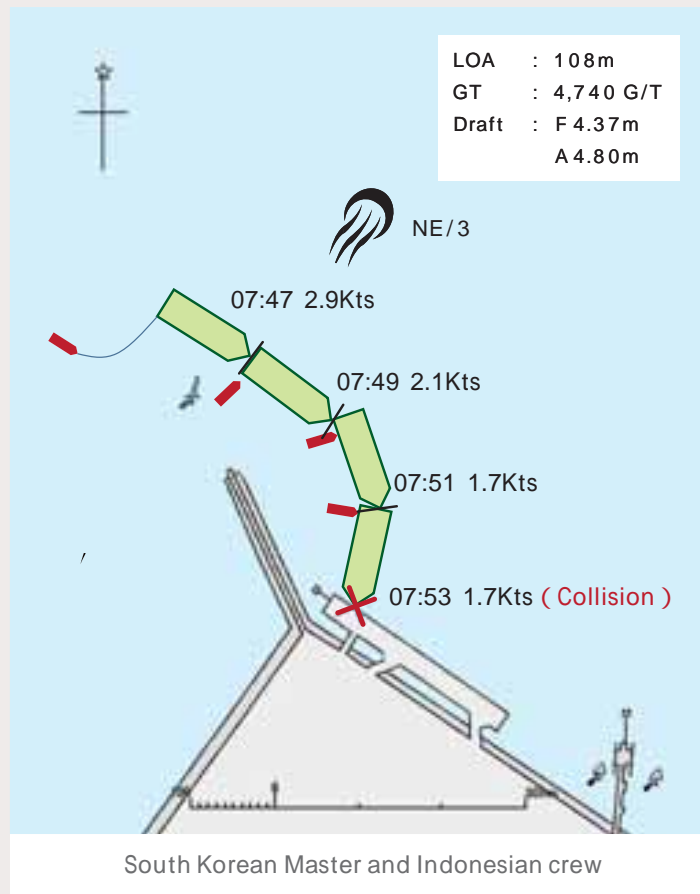
Fig. 60

Table 61 shows the chain of events leading up to the accident. The pilot let the tug boat report the distance from the bow to the quay, but did not explain this to the captain. On the other hand, the chief officer who was allocated at the bow had a duty to report the distance between the bow and the quay to the Master, but the Master did not relay this to the pilot, and he continued to entrust navigation entirely to the pilot.

The Master, now feeling anxious, ordered astern with engine only one minute before the accident was to occur and the vessel, unable to take corrective action, collided into the quay at 1.7 kts.

Main text of judgement:	Operation suspension as pilot for a month
Cause:	The pilot did not sufficiently confirm the approaching state between the bow and quay and delayed in carrying out speed reduction arrangement. In addition, he did not adequately confirm the speed, despite the fact that it was easy for the tug boat to push stronger into the half-loaded vessel which led to the situation of increasing Head way. Also, he over relied on the approaching condition reported by the tug boat.

As described above, BTM collapse including the pilot can be considered a root cause. For this reason, both the Master and the pilot should have fully recognised the importance of BTM, but again: Human beings are sometimes careless, Human beings sometimes forget and Human beings are sometimes lazy apply.

There should have been no problem with the ship maneuvering skills of the pilot and the Master. However, in light of the Human characteristics mentioned above that can be the root cause, forgetfulness may suggest that re-training of BTM in order to remember be one of the effective preventive measures taken.
