§ 5 - 3 Case Fair way buoy damage

Case Fair way buoy damage

Capt. Takuzo Okada
Master Mariner
General Manager
Loss Prevention and Ship Inspection Dept.
The Japan Ship Owners Mutual Protection & Indemnity Association

JAPAN P & I CLUB
日本船主責任相互保険組合

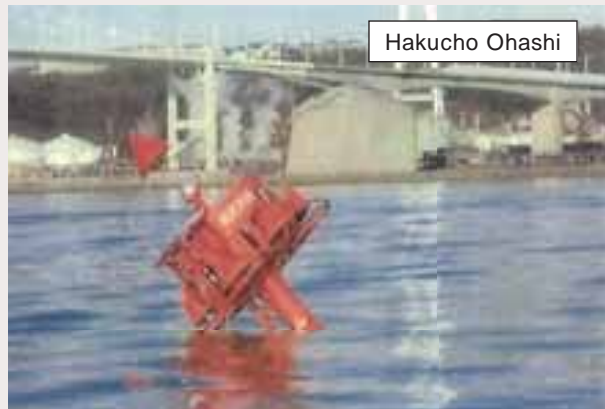
Photograph 67 Damaged state of No.2 light beacon

No2. light beacon:

Dent with a crack at the floating part and bending damage to protective fence.

Label of No.2 light beacon: visible distance four nautical miles, red flash once every three seconds. Light height was 8.2 meters

While solely watchkeeping at the bridge, concentration on maneuvering is a requirement. In the event that it is necessary to adjust the remote control device, including the engine, take measures that allow the staff members of the engine department to come up to the bridge.
