P&I ロス・プリベンション・ガイド P&I Loss Prevention Bulletin

編集:日本船主責任相互保険組合 損害調査部 総括グループ The Japan Ship Owners' Mutual Protection & Indemnity Association
Claims Administration Group, Claims Department

繰り返すケミカルタンカー火災、爆発事故 Prevention of fire / explosion on chemical tankers Repeated accidents on board chemical tankers

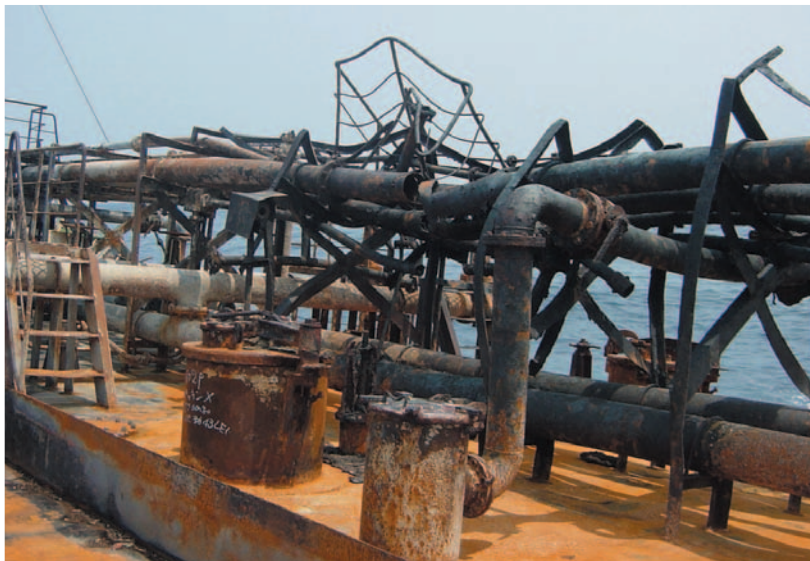
写真1 火炎に曝された右舷側タンク、配管類（ガスケットは効果が無くなっている）
Photo No.1 Deadly burned starboard side tanks and pipes
(the gasket has become useless)

- a) Diesel oil was leaking from the diesel oil tank, part of which was damaged at the time of collision,
- b) Vapor of crude benzene was leaking on deck from the manhole whose gasket was damaged due to high temperature during the fire,
- c) Piping / vents / masts and other deck structures were heavily damaged by the heat.

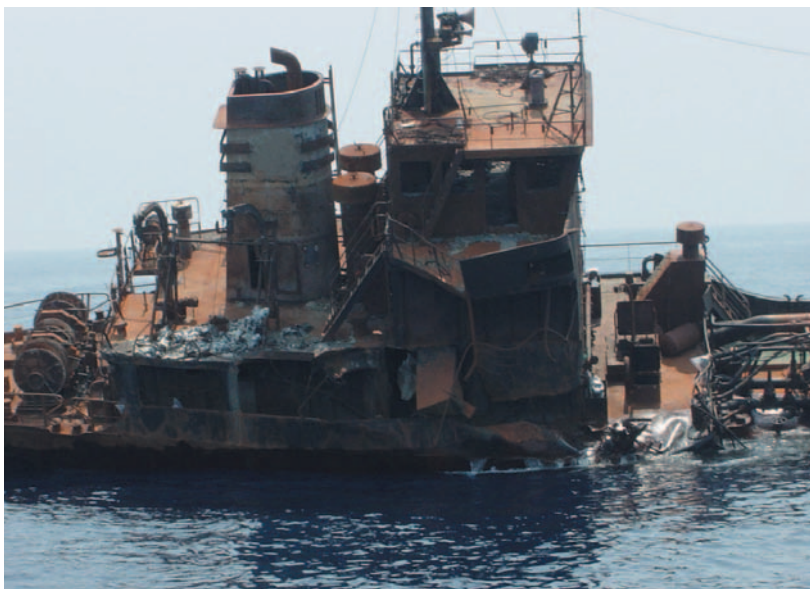
写真2 鎮火後右舷に大きく傾斜、火炎にさらされた居住区

Photo No.2 Burned-out crew's quarter listing to the right after fire extinguishment

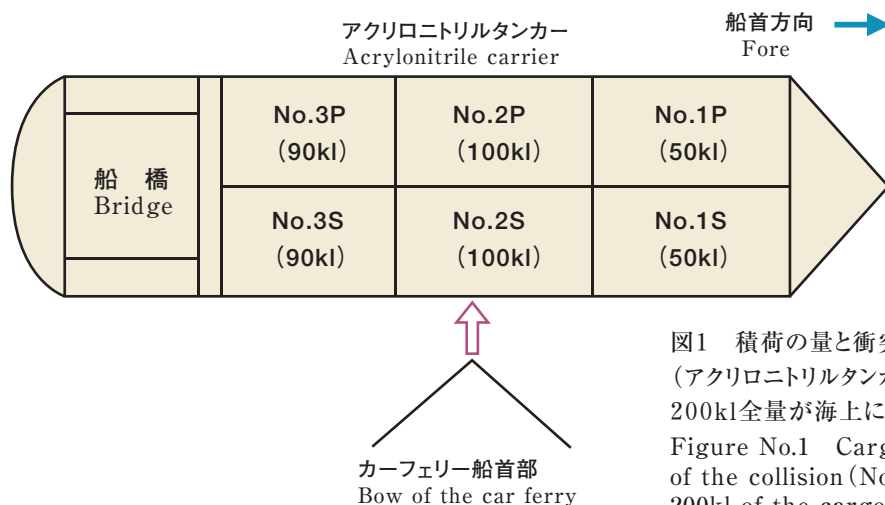
図1 積荷の量と衝突の状態

（アクリロニトリルタンカーのNo.2タンク P,S は破壊され積荷200kl全量が海上に流出した。）

Figure No.1 Cargo quantity of each tank and situation of the collision (Nos.2 PS tanks were destroyed and 200kl of the cargo fully spilled into the sea)

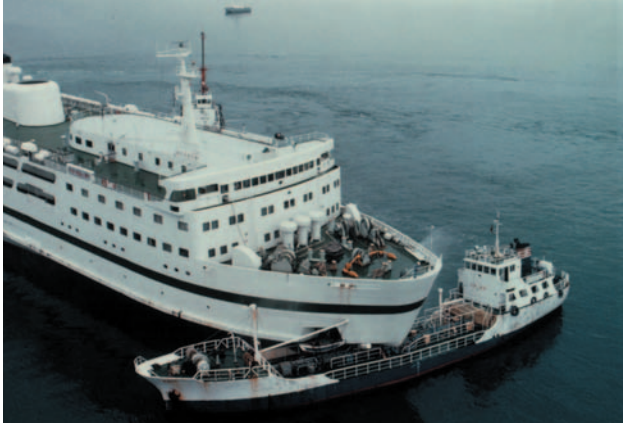
写真3 フェリーとアクリロニトリルタンカー衝突事故
Photo No.3 Collision between the car ferry and coastal tanker carrying acrylonitrile

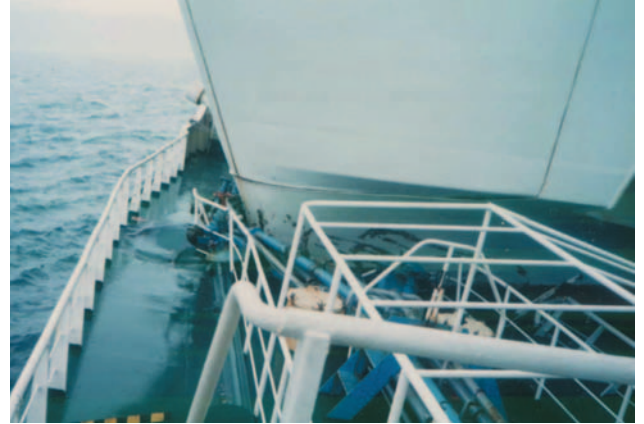
写真4 フェリーの船首部分がアクリロニトリルタンカーの真横に突き刺さっている
Photo No.4 The bow of the car ferry denting the side of the Acrylonitrile carrier

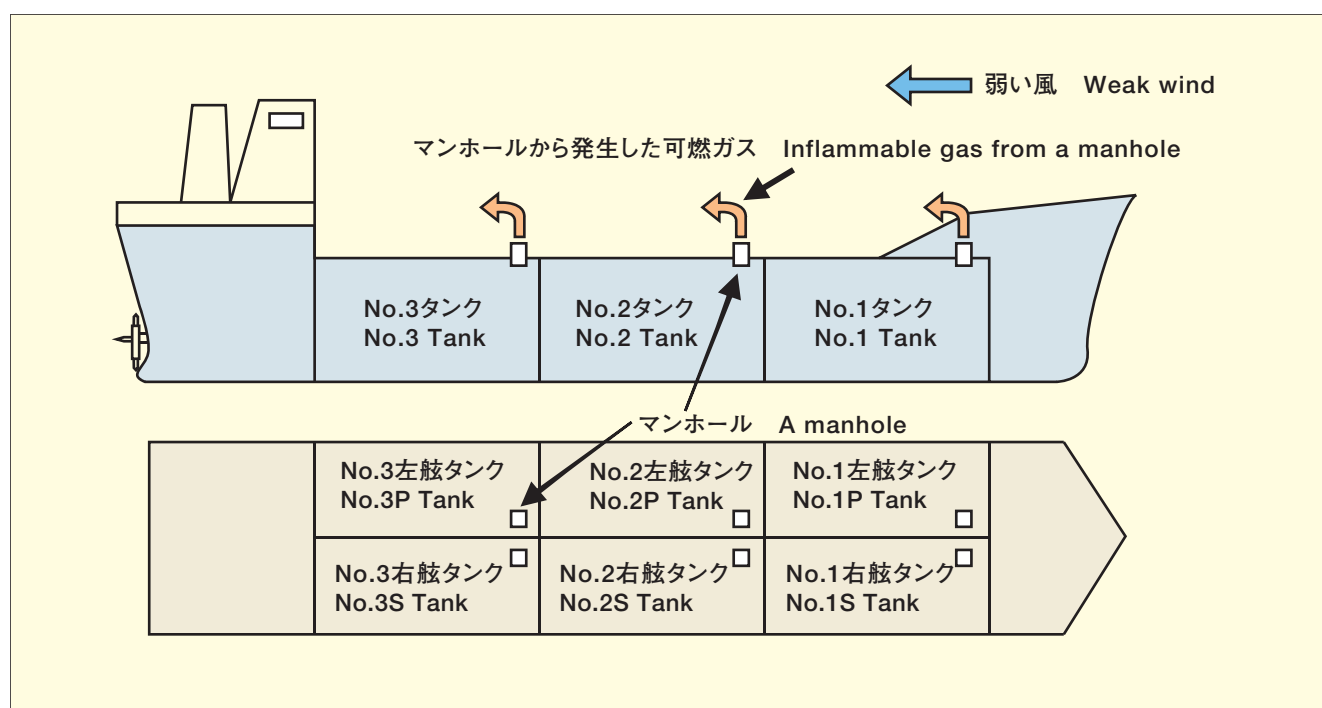
図2 スロップオイルタンカーの貨物タンクとマンホールの配置図

電気溶接機を始動して配管修理準備作業が始まった。しばらくして、No.3左舷タンクで大爆発が生じ、No.2左舷タンク、右舷タンクそしてNo.3右舷タンクも次々に爆発、その後火災となった。タンク爆発により本船はNo.2、No.3両舷タンク及びそれらの上部構造物が破壊され、周囲に飛散、大きく破損した。また本船の脇に止めてあった修理業者のトラック、そして周辺の建物などにも被害が発生した。事故原因の調査の結果、爆発の原因は、開放されたマンホールから気化した可燃性ガスが船首方向からの弱い風で居住区前側のNo.3タンク付近に滞留し、その滞留ガスに、修理の準備作業に起因する何らかの着火源（溶接棒と船体との接触による電流テストなど）により引火、可燃性蒸気発生源である各タンクに火が入り次々に爆発したものと結論された。

berth for repairs with all the manholes and ullage holes open. Without measurement of flammable vapor concentration around the working place, they prepared for the repairs of the piping. After arrival of a truck carrying repair equipment including a gas welding machine, they started to use an electric welder. Soon after that, a big explosion occurred to No.3P tank, followed by explosions at No.2P tank, No.2S tank and No.3S tank leading to a big fire on board where the No.2 and No.3 wing tanks and the upper structures were totally destroyed. Further, the repairer's truck parked beside the ship and some buildings in the vicinity were also damaged. After investigations, it was concluded that a certain amount of inflammable vapor which came from the open manhole, drifted by a breeze from the bow and stayed around No.3 tank near the crew quarters. It was ignited by some source of fire (including a current test by contact of welding rod and hull), spreading the fire into the other tanks.

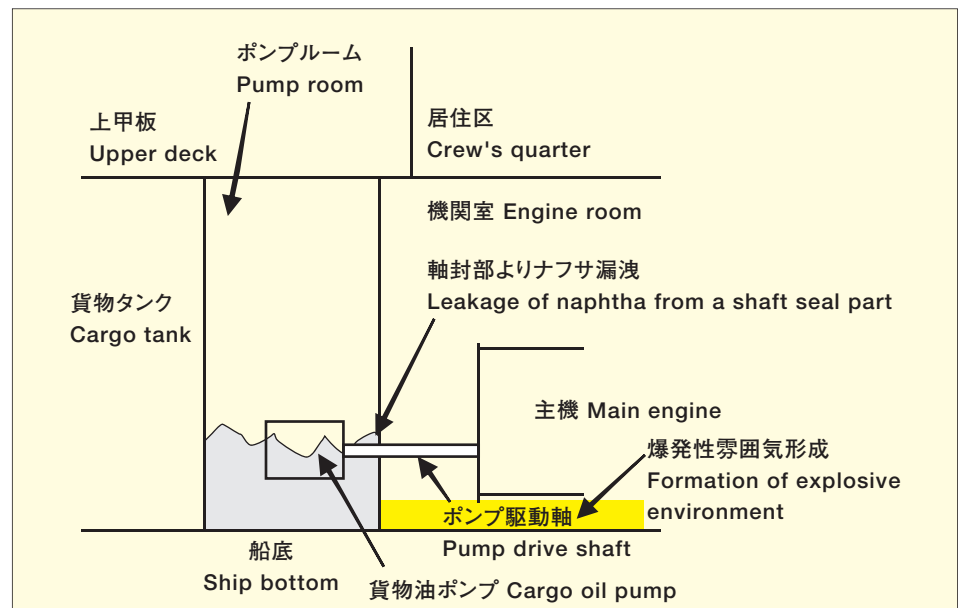
図3 ナフサタンカー ポンプルーム

事故は荷役開始前の準備作業にミスがあり、ポンプルーム内にあるバルブ類の閉鎖が不完全であったために起きた。荷役が開始されタンクに積み込まれ始めたナフサは船尾トリムであったこともあり配管を通じてポンプルーム方向に流れ、バルブ類が完全に閉鎖されていなかったため、ポンプルーム内に流れ込んだ。ポンプルームとエンジンルームには貫通シャフトがあるが、この部分は水密ではなく気密であり、貫通部付近までナフサが溜まった時点でナフサがエンジンルーム内に漏れだし、気化して爆発の原因となった。エンジンルーム内では色々な修理作業を行っていたことからそれらが着火源となり爆発したものである。

came down toward the pump room through pipes, as the vessel happened to be by the stern. The cargo which entered the pump room due to insufficient closure of valves stayed in the vicinity of a pump shaft. Naphtha then leaked into the engine room from the seal of pump shaft (The seal is airtight but not watertight). The leaked naphtha was vaporized soon in the engine room and caused an explosion by catching some fire source used for repair work in the engine room.

爆発事故を起こすような濃度について考えると、ベンゼンやナフサは爆発下限が1%前後であり、これは10,000ppmという高濃度となる。このような濃度に人間がもし曝されるとすれば、瞬時に意識を失い死に至るであろう。例に挙げたベンゼンタンカー、ナフサタンカーいずれの事故においても、爆発が生じるまでポンプルームやエンジンルーム内では人が普通に作業を行っていた。このことは、これら事故において爆発性雰囲気がポンプルームあるいはエンジンルームの空間全体的ではなく低層部にのみ形成されていたことを示している。(図3及び図4参照)

The lower level of explosion limit of benzene or naphtha is known to be around 1% which is as high as 10,000ppm. If humans are exposed to such high concentration of vapor, they will immediately lose their consciousness and die. In the accidents described above, the crew continued to work in the pump room or engine room until the explosion occurred. These facts indicate that the explosive atmosphere did not occupy the entire rooms but was formed only in the lower part of the space. (See the fig.Nos.3 and 4)

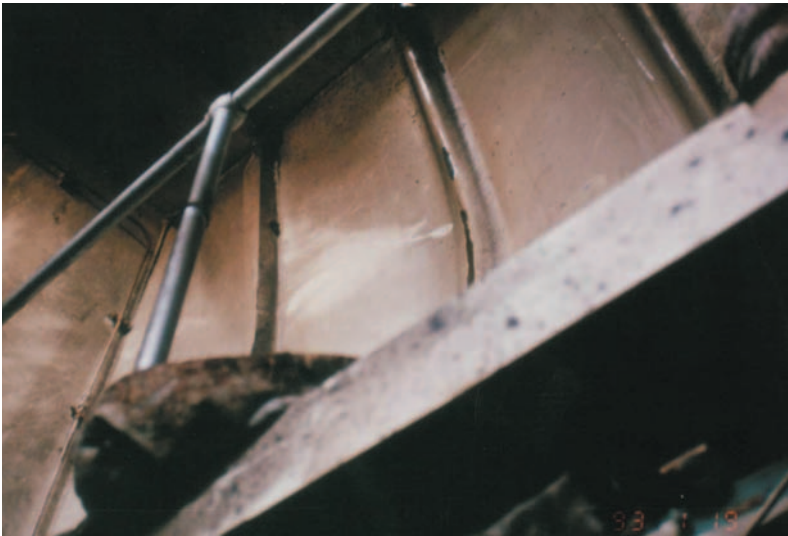
写真5 爆発により丸みを帯びたエンジンルーム内部の壁(ナフサタンカー)
Photo No.5 Ballooned inner wall of the engine room due to the explosion (Naphtha carrier)

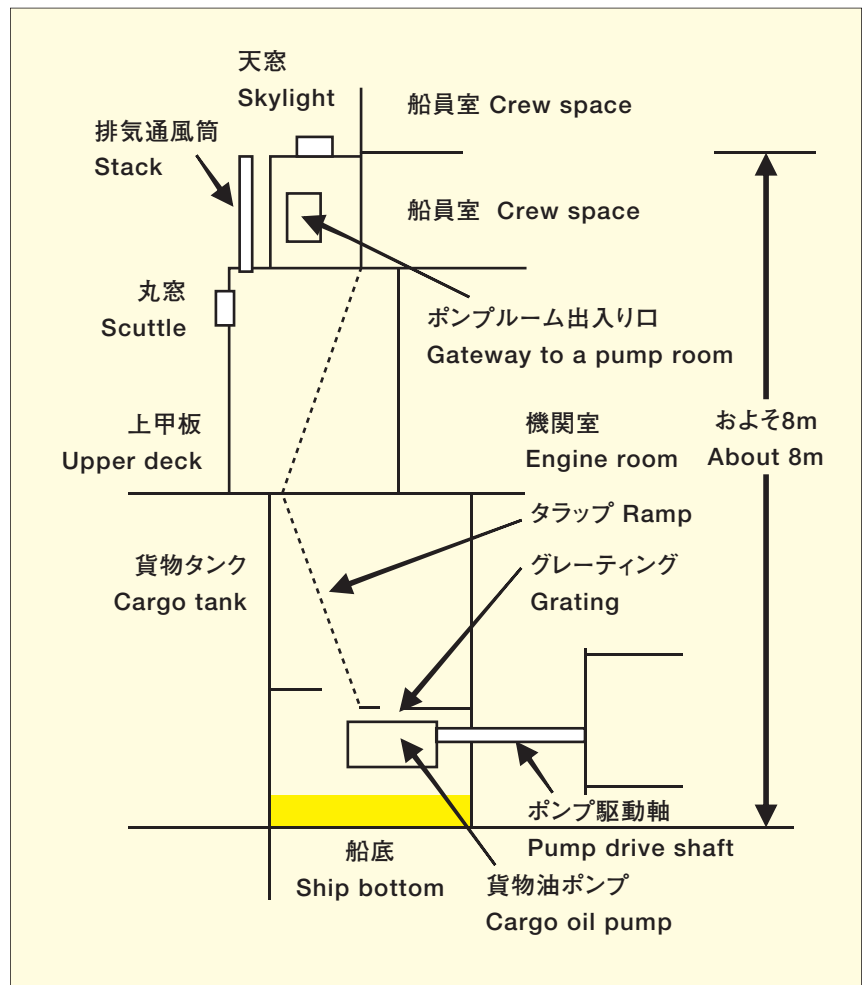
事故の原因としては、濾過器や配管の清掃中にそれら内部に溜まっていた少量のベンゼンがポンプルーム底部に漏洩し、徐々に気化してポンプルーム低層部に爆発性雰囲気形成、乗組員の何らかの作業に起因する着火源により爆発が生じたものと考えられる。ポンプルーム底部に溜った蒸気は本船に装備された換気装置で連続排気されていたが、ガス吸引口がポンプルーム底部から1m程度上部にあり、ベンゼンのような重い蒸気の吸引に適しておらず、結果として低層に爆発性雰囲気が形成されてしまった。着火源について専門家の調査が行われたが、特定することは出来なかった。しかし人の活動自体が着火源を作することを十分認識しておく必要がある。

図4 ベンゼンタンカー ポンプルーム
グレーティングより下層（黄色部分）に
爆発性雰囲気を形成した。
Figure No.4 Pump room of the
Benzene carrier
Explosive environment was
formed under the grating
(yellow part)

The pump room was equipped with a mechanical ventilation system, but a ventilating opening was located about 1 m above the bottom, and thus unfitted for sucking such a heavy gas as benzene. As a result, an explosive atmosphere was created at the lower layer. In spite of the investigation held by the experts, the fire source was failed to be identified. It is important to note that any human actions can be associated with sources of fire.

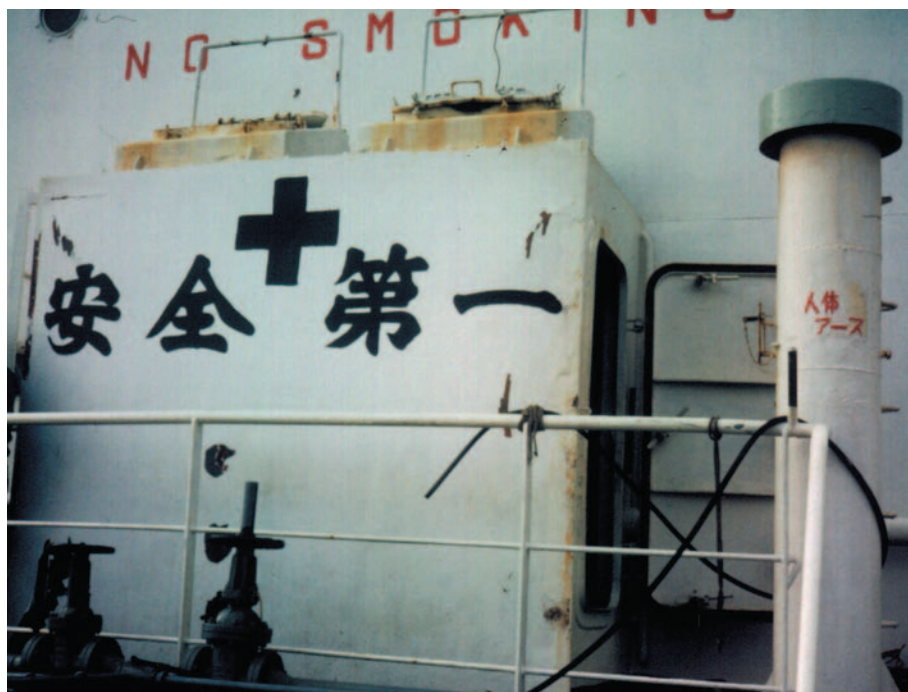
写真6 爆風によりポンプルームの入り口正面が丸みを帯びている(ベンゼンタンカー)

Photo No.6 Curved iron casing of the pump room because of blast
(Benzene carrier)

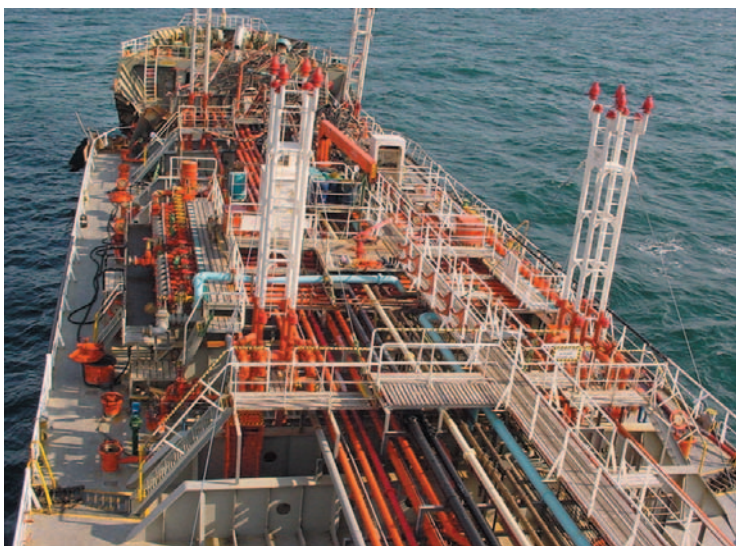
写真7 ブリッジから船首方向を見る
No.1左舷ウイングタンクが大きく破壊されている
Photo No.7 Heavily damaged No.1P wing tank, viewed from the bridge

爆発は、水洗の終了した空のNo.2センターカーゴタンク及びスロップタンクに最終段階の洗浄行程としてスチームを導入して間もなくNo.2センターカーゴタンクで起き、エチルアルコールを積載していた隣接のNo.1センターカーゴタンクも爆発、積荷のエチルアルコールは火災となり、さらにこれらの爆発はNo.1とNo.2センターカーゴタンクの両サイドに位置する空のNo.1ウイングカーゴタンクP,Sをも大きく破壊していた。No.2センターカーゴタンクに隣接しているNo.3センターカーゴタンク船側のタンク上甲板継ぎ目には溶接の剥離による小さな開口がいくつか生じ、甲板上からNo.3センターカーゴタンク内のエチルアルコールが目視できるような状態となっていた。爆発事故後のNo.1センターカーゴタンク積荷のエチルアルコール火災は、乗組員の手により約1時間で鎮火された。爆発によるタンク破壊により、No.1及びNo.2センターカーゴタンク、並びにこれらタンクの両サイドに位置するNo.1ウイングカーゴタンクP,Sのタンク内部は海水が自由に出入りする状態となったが、これらタンクの下部に位置するNo.1ウオーターバラストタンクP,Sは破壊を免れたため本船はかろうじて強度を維持し、折れることなく沈没を免れた。

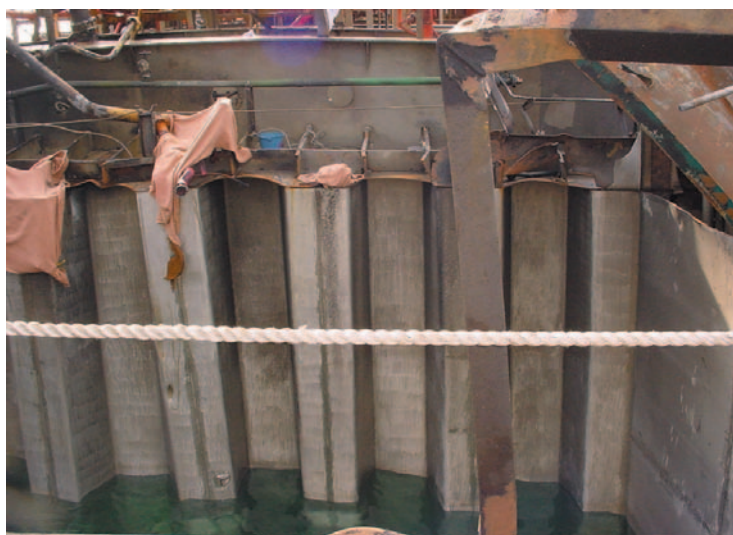
写真8 爆発して上甲板が吹き飛んだNo.2センタータンク（艀から艀を見る）
濡れ毛布でNo.3センタータンクの艀側破孔部を覆っている

Photo No.8 Upper deck of No.2 centre tank was blown off in explosion, viewed from the fore
Wet blankets cover the damaged parts of No.3 centre tank
