## Prevention of accident damage to cargo loaded on Bulk Carriers

### Case 2) Heat Damage caused by heat transfer from the Fuel Oil Tanks

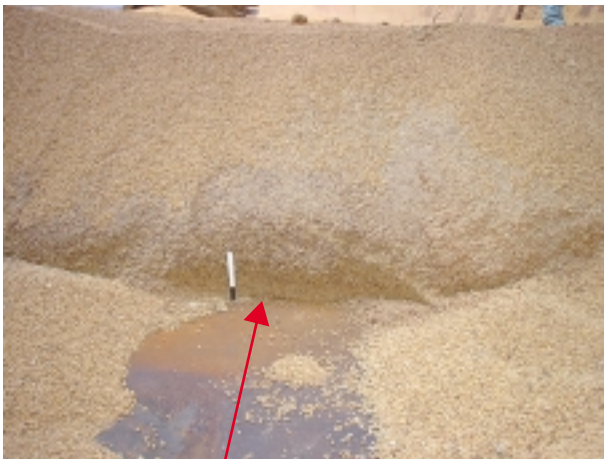
When the fuel oil in those tanks is over heated, the plating above the tanks may become warm, and as a result, the cargo may become discoloured, caked and mouldy, and sometimes the cargo may be carbonised. Although the type and the extent of the damage will vary in proportion to the moisture content of the cargo and the degree of heating of the fuel oil, typically the cargo may be damaged up to a height of some 2 to 3 meters above the tanktop, and the temperature of the beans may rise to some 80°C. Moreover, in rare cases, the whole cargo in a hold may have to be treated as damaged. From experience, the degree of damage to cargo in No.7 hold is often worse than in No. 5 and 6 holds, and this is usually due to the fuel oil heating lines for the oil in the tanks under the No. 5 and 6 holds or in the deep tank located at forward of No.1 hold, passing through the tank under No.7 hold, and so, the duration of heating of the tank under No. 7 hold is longer than for the other tanks. (Damaged conditions and pattern are shown in the photos below)

Showing heavily caked and discoloured cargo of 1m thick

Of course, in order to prevent heat damage to the cargo by heat transfer from the tanks, the fuel oil in the tanks should not be over heated or heated longer than necessary.

**b** Usually, the heating lines in the double bottom tanks are installed at a height of about 10cm from the tank bottom. From past experience, when the heating lines are exposed above the surface of the oil or are at the same level, the amount of heat transferred to the tanktop plates is greater than when the tanks are full or have a lot of oil in them.

Therefore, sufficient oil should be left in each tank when shifting consumption to the next tank. In this connection, it is also important to take into consideration the order of consumption. Experience shows that heat damage has frequently occurred to the cargo in the after hold, because of oil consumption starting from the after tank to the fore. It is recommended that the order of consumption of the oil should be from the bow to the stern.

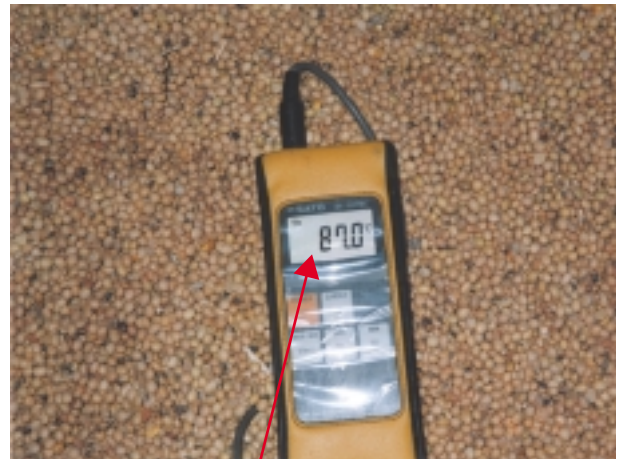
Soybeans are especially sensitive to heat, and if the temperature of the beans reaches about 40°C the beans will become withered and lose their ability to sprout, and oxidisation is increased.

Showing beans heated to 87.0°C

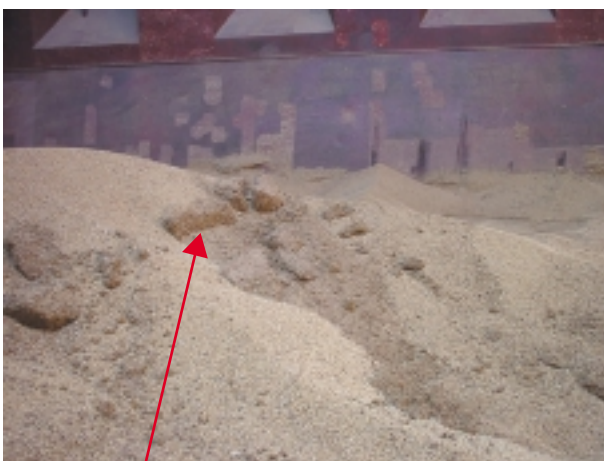
Heavily discolored and caked cargo

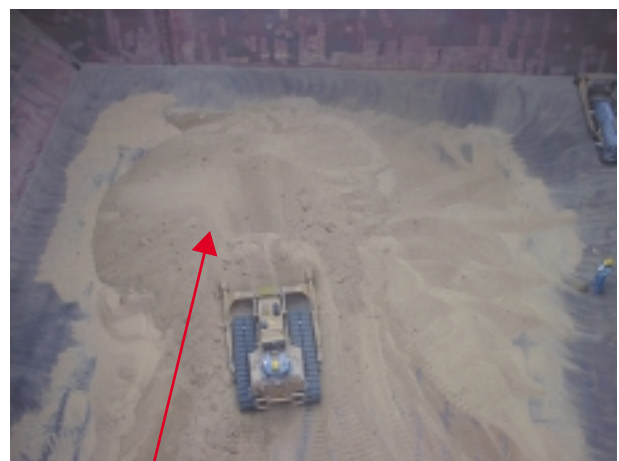
Showing gathering of the damaged cargo

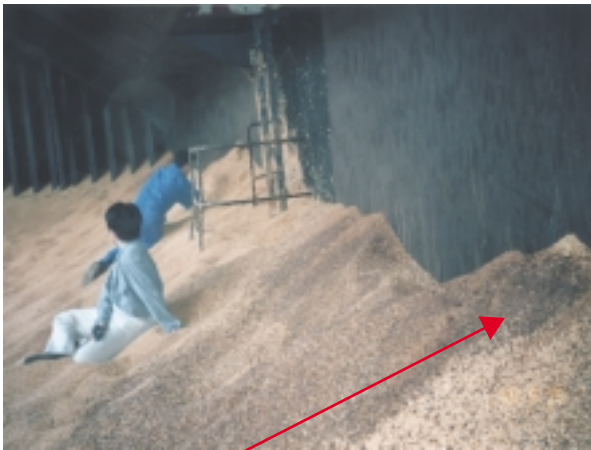
Not all vessels are equipped with a Deep Tank, but some have a Deep Tank between the Chain Locker and No.1 hold. When the fuel oil in this tank is overheated, the cargo in the fore part of No.1 hold adjacent to the aft bulkhead of the deep tank may be damaged similarly to the cargo on the double bottom tanks, described previously. The damage may extend some 1 to 2 meters from the forward bulkhead of No.1 hold, and may reach the level of the tanktop. (same depth as the deep tank)

Damaged cargo along the fore bulkhead in No.1 hold cargo

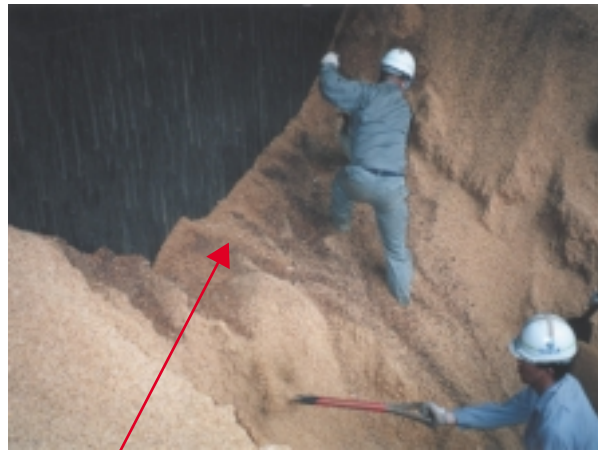
Showing heavily caked and discoloured

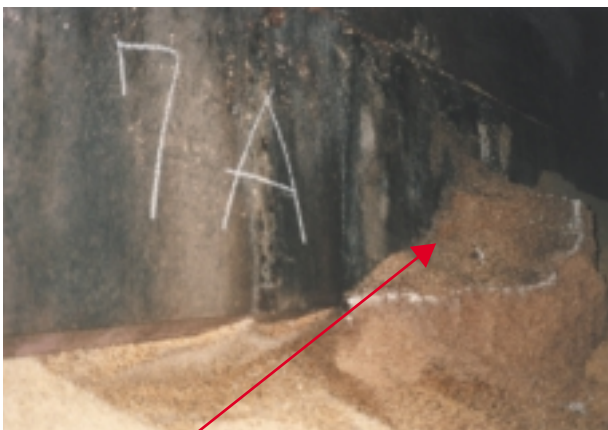
A few vessels have the Fuel Oil Settling and Service Tanks along the sides in the middle of the engine room or at the aft end, but in most vessels, they are located some 30cm away from the forward bulkhead near the vessel's centerline. These tanks are joined to the forward bulkhead by the bottom plates of the tanks and by brackets, etc., at the top of the tanks. Therefore, if the fuel oil in these tanks is heated too much (Generally, it is heated to 80°C for the settling tank, and 90°C for the Service tank), the cargo along the aft bulkhead in the hold adjacent to these tanks may sustain heat damage in the same manner as the cargo along the forward bulkhead of No. 1 hold.

Showing heavily caked and discoloured cargo along bulkhead plates between the engine room and the aftermost hold

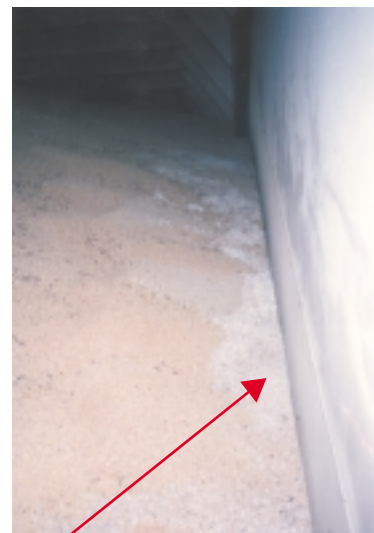
Mouldy cargo in the top surface along the aft bulkhead of the aftermost hold
