Case Studies

4-1. Crew Claims

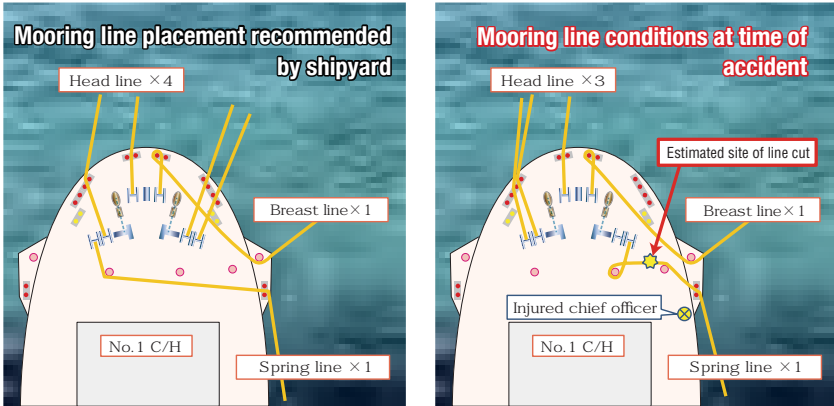
Figure 1. Mooring Line Placement Recommended by Shipyard and Mooring Line Conditions at Time of Accident

The rope shift work was using one fore spring line to move the vessel back. There was a 2.9 knot current in the opposite direction of the movement of the vessel. This increased load on the rope is believed to be the cause of the spring line breakage.

- The bow spring line was not connected as indicated in the shipyard's guidelines, but it is not clear if this resulted in abnormal tension being placed on the spring line (see Figure 1 below).

- Although it was not an issue in this particular case, mooring line inspections should be performed at appropriate intervals. Rope manufacturers do not have standards for when ropes should be replaced, but break testing on 75mm diameter double-braided hawsers used for six years found that the break load was reduced to 65% of that of new ropes. Ropes replacement, like inspection, should be performed at appropriate intervals.
- When performing ship rope shift work, provide detailed explanations of the procedures, etc. to all deck crew, and if any situations arise which differ from planned procedures, work must be immediately halted and the situation re-assessed.
- Situations in which rope shift loads are placed on a single mooring line should always be avoided. It is also important to consider using tugboat support when necessary.
- Inform crew of snap back danger zone

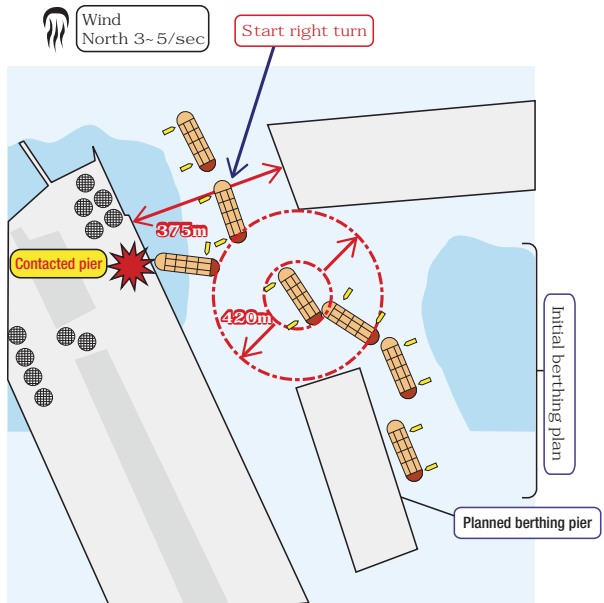
The vessel (woodchip carrier / 38,844G/T) planned to dock at a port in Indonesia to discharge cargo. A pilot boarded when the vessel was anchored and navigated outside the port through a 375m wide channel at D. Slow Ahead (approx. 4 knots) with a 2,000HP tugboat at the vessel's starboard bow, and another at its starboard stern. However, there were two other vessels berthed on the port side pier of the channel, so the effective channel width was approximately 350m or less. A barge was preparing to leave port, facing the port side of the vessel, so the pilot hailed the barge via VHF and requested that it stand by until the vessel had completed its turn round work in the area it planned to turn in (a roughly 420m diameter turn area, approximately twice the length of the vessel). However, there was no response from the barge, which continued on its course to leave the port. The pilot was therefore forced to start its starboard turn, driven by the tugboats, near the exit of the channel, but the vessel lost control when starting rotational maneuvers without slowing, and the bow struck the starboard berth, damaging the fender and its support. When the accident occurred there was a 3 to 5m/sec northerly wind and almost no current, so external force was deemed to have almost no impact on vessel handling.

- The pilot was so concerned with the departing barge that he changed the initial turning maneuver plan and began turning within the channel.
- The pilot should have stopped the vessel before turning.

Generally speaking, even when a vessel is stopped, the diameter of the turning basin, the area needed for tugboats to turn the vessel, must be twice the length of the vessel (in this case, 400m). The vessel should have avoided the departing barge and then stopped and performed its turn within the 420m turning basin, according to its original maneuvering plan.

- When a pilot boards where a vessel is anchored before anchor up, it is possible to take time to discuss berthing maneuver plans in depth, so it is important to recognize the importance of BRM and engage in in-depth discussions. It is especially important to closely confirm how much tugboat horsepower will be required.
- It is important not to leave handling entirely to the pilot, but create detailed berthing preparation plans, including calculating how much space and what speeds will be required before entering the port, instead of relying purely on past experience and gut instinct. In particular, it is important to stop the vessel entirely before beginning turning work when turning in confined areas such as narrow channels. (For details see Loss Prevention Bulletins Vol. 31/32: Preventing Damage to Harbor Facilities and Ship Handling in Harbors.)
