JAPAN P&I CLUB

Vol.38 March 2017

P&I Loss Prevention Bulletin

Thinking Prevention of Engine Trouble

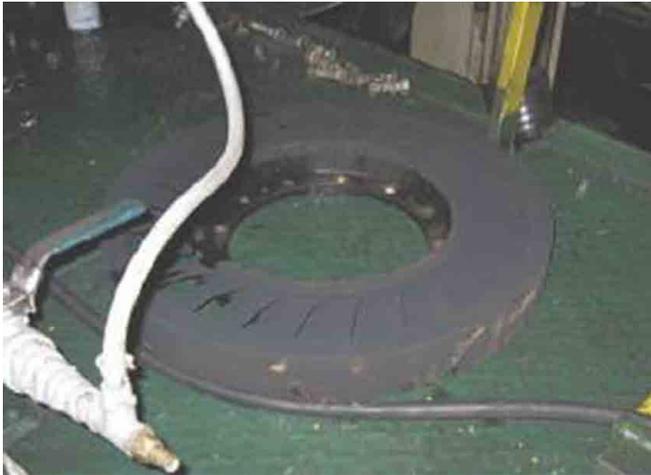
Figure 17 Damaged turbine blade / reference*7

- Turbine blade: damaged (Figure 17)
- Journal bearing: burnout
- Labyrinth: damaged
- Nozzle ring: deformed (Figure 18)
- Thrust bearing: peeled off white metal (Figure 19)

As we mentioned the mechanism of explosion and over-run, described in above (4)- ② , a fire occurred in the scavenging air box and the fuel burned incompletely in the combustion chamber. As a result of this, unburnt fuel accumulated in the exhaust manifold and exploded.

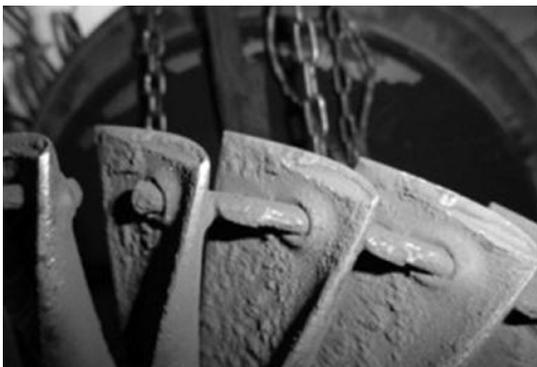
Figure 20 Carbon adhering excessively on turbine blade / reference *7

Here is an example of damage due to vibration & abnormal noise. During the ship navigation, vibration & abnormal noise occurred in the turbo charger, and the performance of the main engine declined.

Judging from circumstance, it was impossible for the ship to self-propell. The detailed investigation was conducted after the ship was towed into the port. It was found that there was significant adhesion of carbon on the turbine blade and the nozzle ring, (Figure 20 and 21).

As for the causes of damage, the causes were related to dirty deposit due to incomplete combustion in diesel main engine and a lack of regular cleaning.

- ① To clean stained items and to replace damaged components such as bearings and sealing and etc. (Figure 22 and 23), and
- ② To make a maintenance work of the diesel main engine (air cooler, piston ring replacement and others).

As for the preventive measures, as mentioned above, the measures were “to conduct proper inspection and maintenance” only based on referring to good engineering practices on a day-to-day basis.

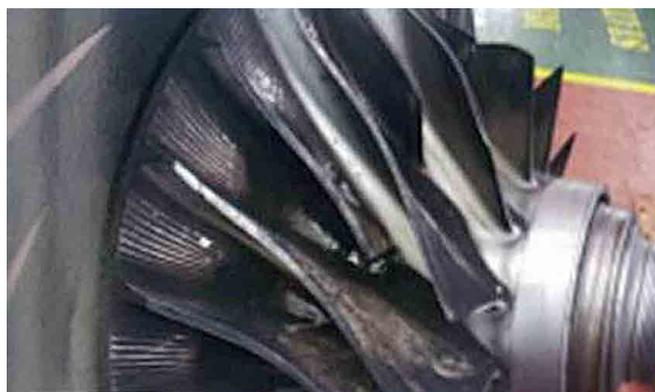
Figure 24 Scratches on compressor wheel, lubricating oil shortage damage leading to speed reduction in fiscal year 2014, reference*4

During ship navigation, abnormal noise & vibrations occurred in turbo charger of the diesel main engine. After the turbo charger was overhauled for the investigation, it is confirmed that there were the burnout bearing and the contact scratches on between compressor wheel and casing. The damaged parts were replaced and renewed.

As for the cause, the root cause was to postpone the periodic inspection of L.O. pump because of the tight work and navigation schedule on board. As the result of this, the lubrication of bearings became the inadequate, and the burnout (heat damage) of the bearings occurred. It is assumed that the resulting imbalance of the shaft led to the compressor wheel and casing contacting each other.

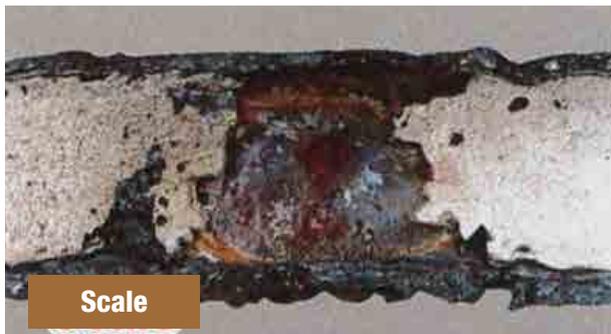
Figure 38 Broken hole due to scales / reference *12

In the case of a lack of management of boiler water, it can be considered that thermal conductivity partly declined due to the accumulation of scale in tubes, the tubes over-heated due to the influence, and material strength declined significantly. As a result of this, the tube was breached and the leak of water occurred. From Figures 38 and 39, it shows about the concern holes in water tubes.

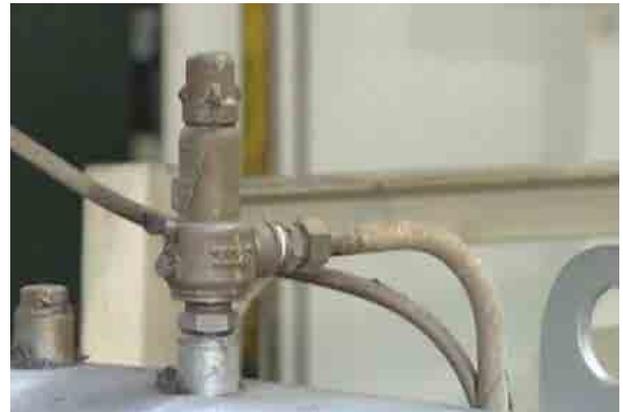
Figure 96 Leaking safety valve of fuel oil heater

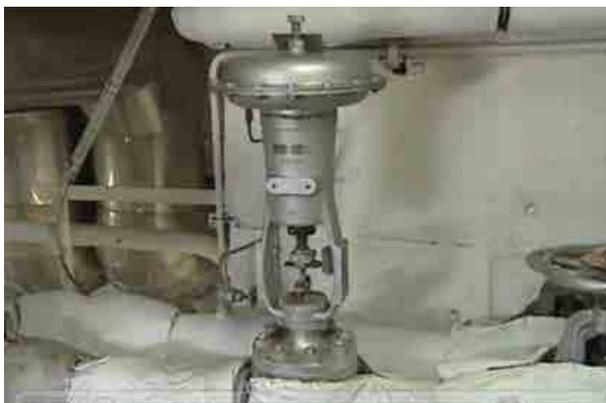
Figure 97 Damage of diaphragm on control valve

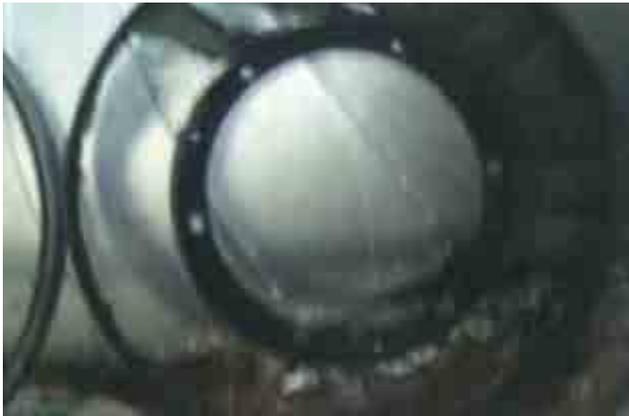
a) Broken nozzle ring.
Damage requiring towing
in fiscal year 2014 / reference *4

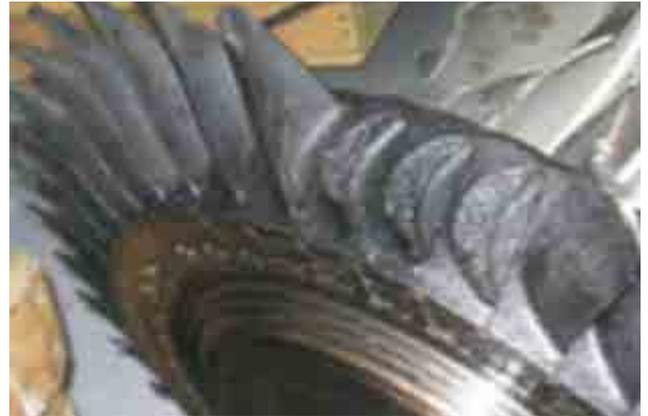
b) Broken turbine blade
Damage leading to speed reduction
in fiscal year 2014 / reference *4

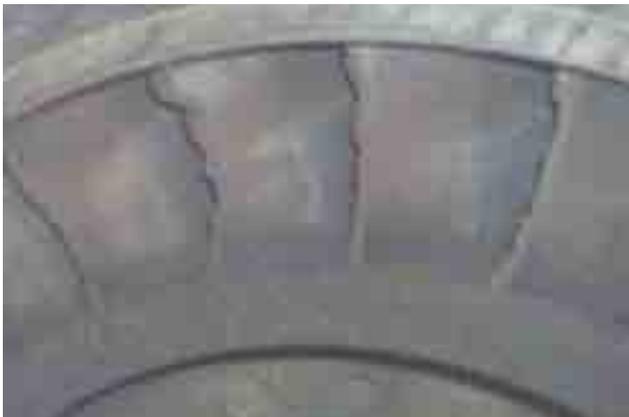
c) Damaged nozzle ring (Over run)
Damage leading to speed reduction
in fiscal year 2014 / reference *4

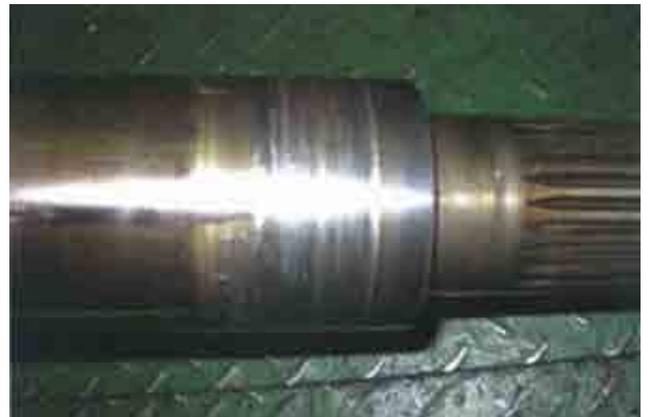
d) Scratch on turbocharger rotor shaft
Damage leading to speed reduction
in fiscal year 2014 / reference *4

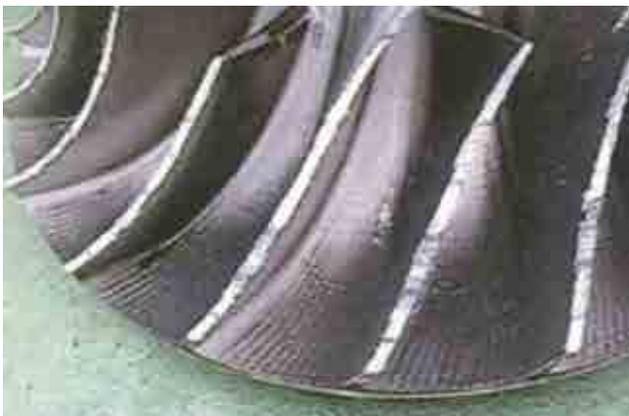
e) Scratch of impeller due to contact with casing
Damage leading to speed reduction
in fiscal year 2013 / reference *8

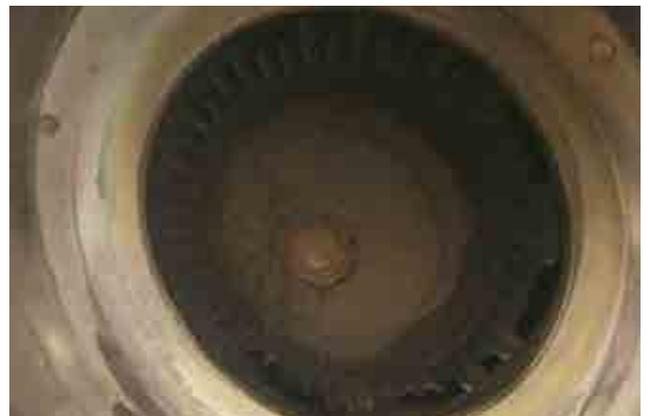
f) Broken turbine blade
Damage leading to speed reduction
in fiscal year 2013/ reference *8

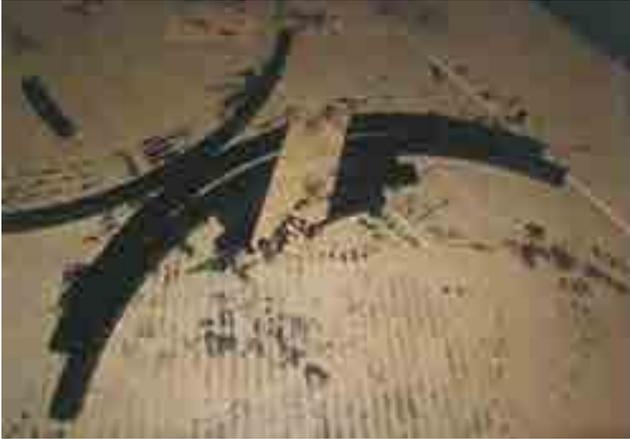
a) Broken piston ring
Damage requiring towing
in fiscal year 2014 / reference*4

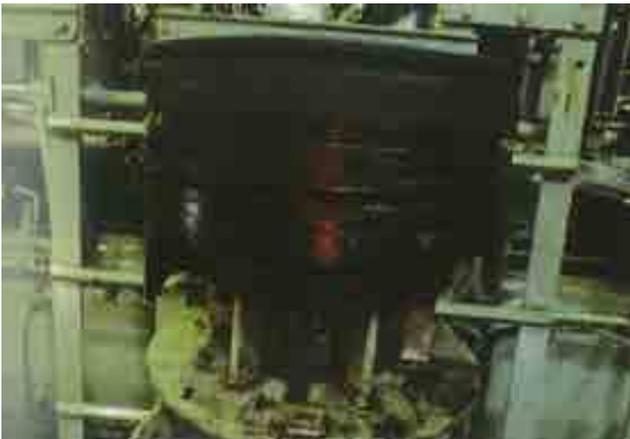
c) Damaged piston (Blow-by)
Damage requiring towing
in fiscal year 2013 / reference*8

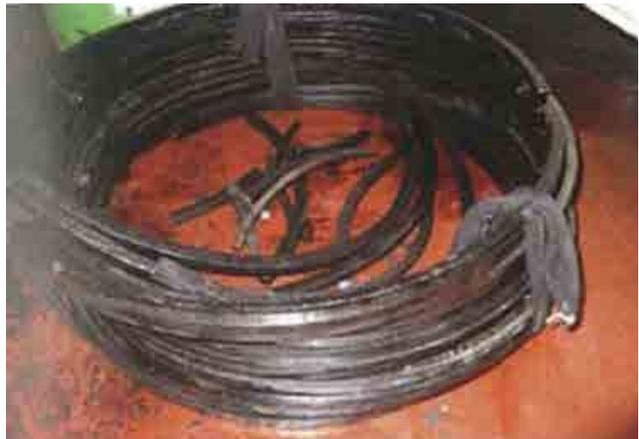
d) Broken piston ring
Damage requiring towing
in fiscal year 2013 / reference*8

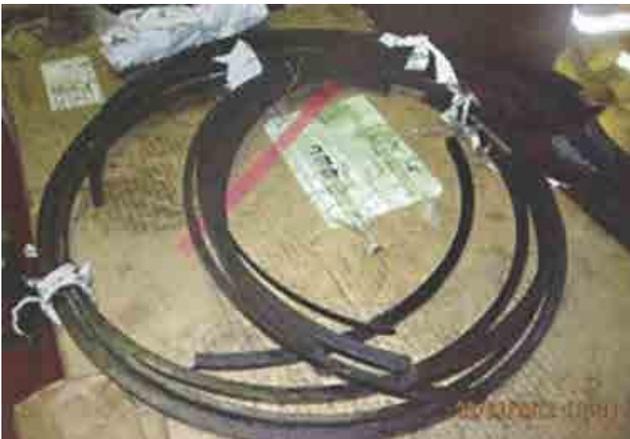
e) Broken piston ring
Damage leading to speed reduction
in fiscal year 2012 / reference*9

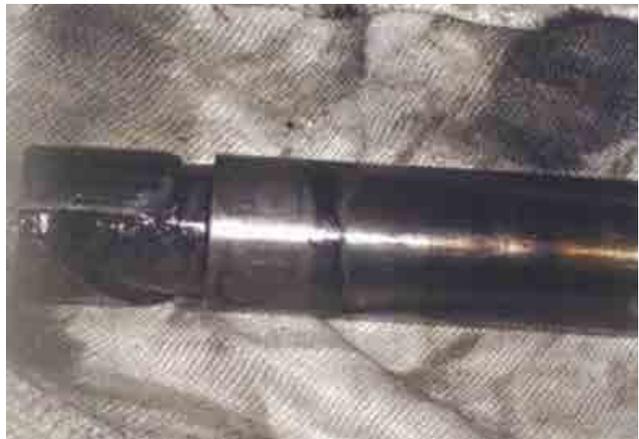
f) Wornout plunger
Damage leading to speed reduction
in fiscal year 2012 / reference*9

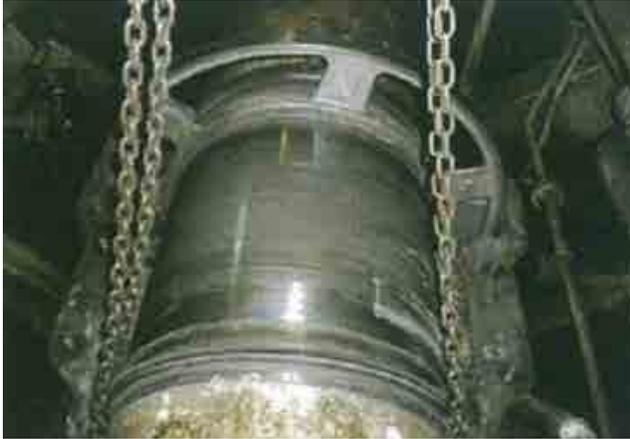
a) Burn-out Intermediate shaft bearing (Over-heated)
Damage requiring towing
in fiscal year 2013 / reference*8

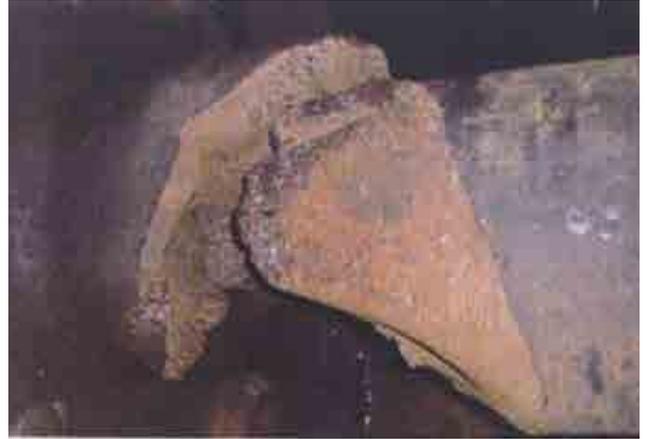
b) Broken intermediate shaft
Damage requiring towing
in fiscal year 2012 / reference*9

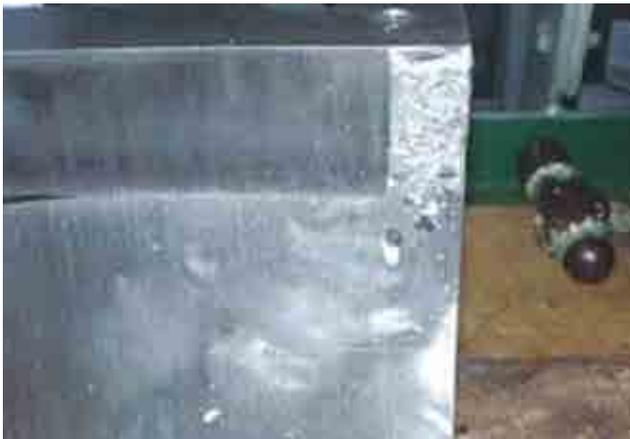
c) Burn-out Intermediate shaft bearing metal(Over heated)
Damage leading to speed reduction
in fiscal year 2012 / reference*9

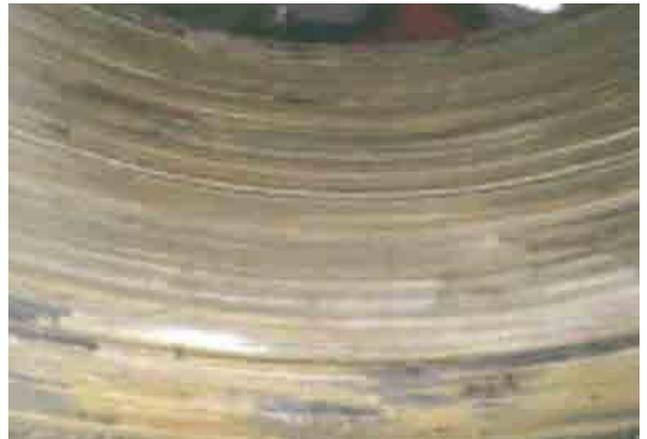
d) Burned-out intermediate shaft bearing metal (Over heated)
Damage leading to speed reduction
in fiscal year 2011 / reference*10

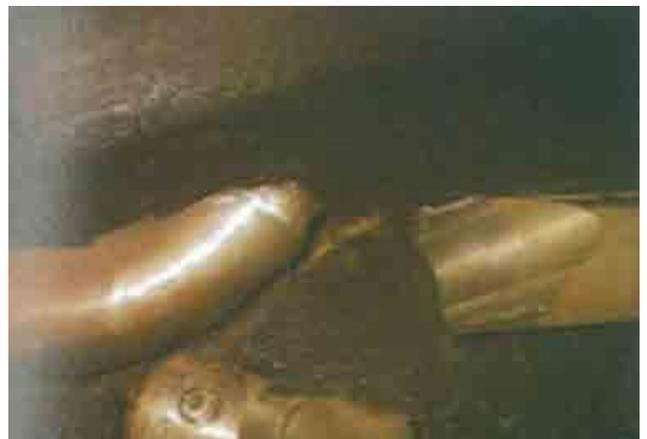
f) Bent and damaged guy rod of CPP
Damage leading to speed reduction
in fiscal year 2011 / reference* 10
