Chapter 1 | Occurrence Status of Engine Trouble and Trends of Accident Causes

1.5 Details of Damaged Parts (Class NK)

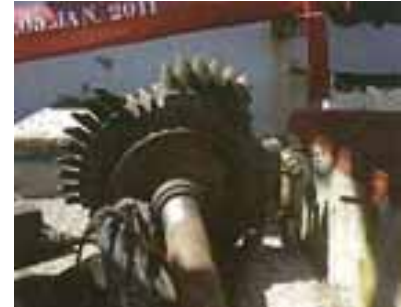
Figure 12 Damaged turbine blade, T/C explosion damage led to speed reduction in fiscal year 2011 / reference*10

The picture on the right shows the case when an explosion causes damage which leads to a speed reduction. The turbine blade on the driving side in turbo charger was damaged.

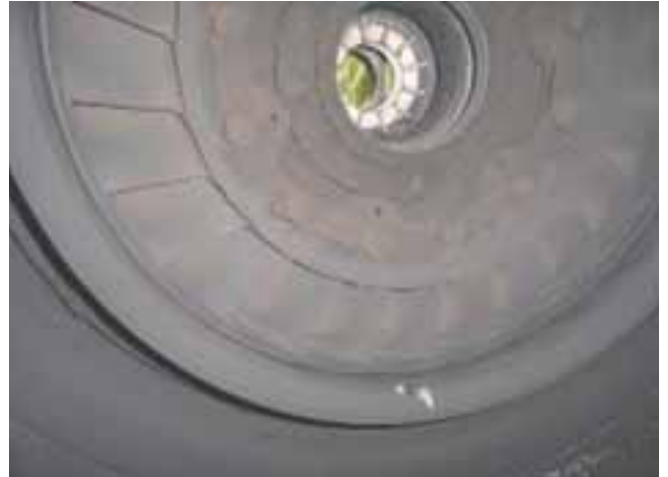
- Turbine blade: damaged (Figure 17)
- Journal bearing: burnout
- Labyrinth: damaged
- Nozzle ring: deformed (Figure 18)
- Thrust bearing: peeled off white metal (Figure 19)

Figure 18 Excessively deformed nozzle ring / reference*7

As for the preventive measures, the problems of “Retention of oil in the manifold or scavenging air box” or “Blow-by occurrences” in (4) - , may be prevented by, for example, removing unburnt fuel or lubricating oil and ensuring proper maintenance. That is to say, it is important that the basic actions of inspection, maintenance and cleaning are carried out rigorously and routinely.

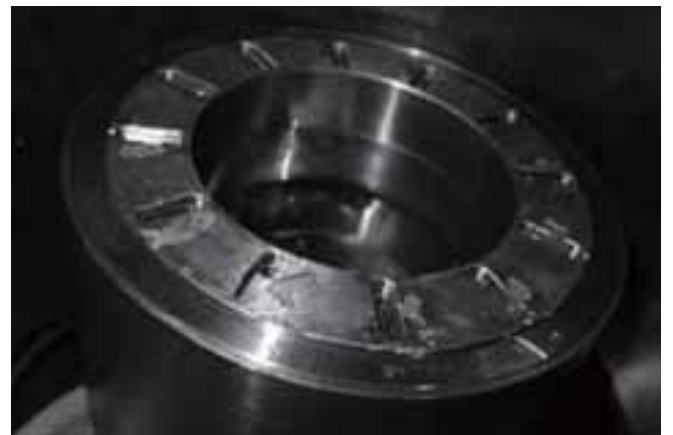
Figure 19 Thrust bearing with metal peeled o / reference*7

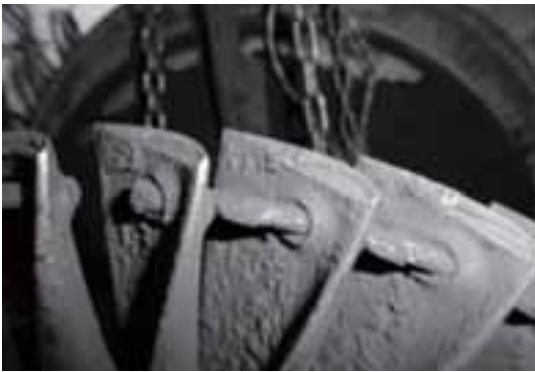
Judging from circumstance, it was impossible for the ship to self-propell. The detailed investigation was conducted after the ship was towed into the port. It was found that there was significant adhesion of carbon on the turbine blade and the nozzle ring, (Figure 20 and 21).

As for the causes of damage, the causes were related to dirty deposit due to incomplete combustion in diesel main engine and a lack of regular cleaning.

Figure 20 Carbon adhering excessively on turbine blade / reference *7

As for the preventive measures, as mentioned above, the measures were “to conduct proper inspection and maintenance” only based on referring to good engineering practices on a day-to-day basis.

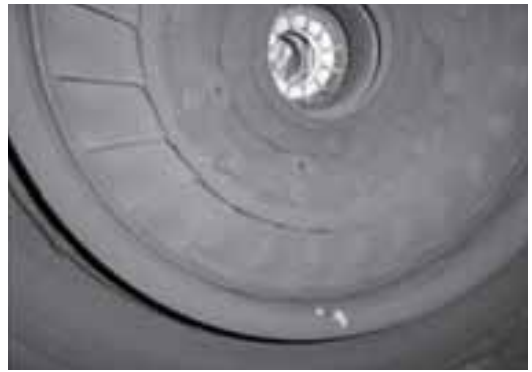
Figure 21 Carbon adhering excessively on nozzle ring / reference*7

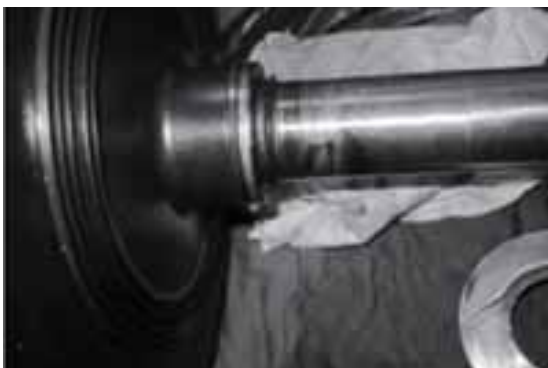
Figure 22 Scratches in rotor shaft / reference*7

To clean stained items and to replace damaged components such as bearings and sealing and etc. (Figure 22 and 23), and

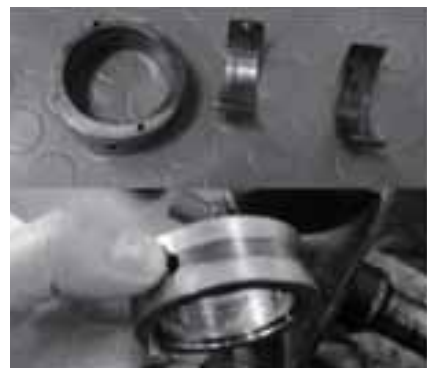
Figure 23 Slipping out of lub. oil hole on bearing / reference*7

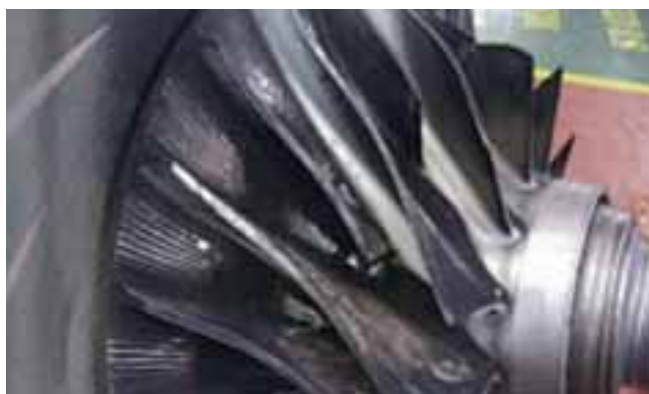
During ship navigation, abnormal noise & vibrations occurred in turbo charger of the diesel main engine. After the turbo charger was overhauled for the investigation, it is confirmed that there were the burnout bearing and the contact scratches on between compressor wheel and casing. The damaged parts were replaced and renewed.

As for the cause, the root cause was to postpone the periodic inspection of L.O. pump because of the tight work and navigation schedule on board. As the result of this, the lubrication of bearings became the inadequate, and the burnout (heat damage) of the bearings occurred. It is assumed that the resulting imbalance of the shaft led to the compressor wheel and casing contacting each other.

Figure 24 Scratches on compressor wheel, lubricating oil shortage damage leading to speed reduction in fiscal year 2014, reference*4

As for the preventive measures, the cause of this damage was lack of time for scheduled maintenance, and so the measures are to establish and implement maintenance plans on the basis of the manufacturers' instruction manual.

Moreover, if the ship side try to manage the maintenance work within keeping the normal ship operational schedule strictly, it is difficult and limited for crew to accomplish the required maintenance items. Therefore, we recommend the ship management department and the ship operations department to conduct the close meetings together, and coordinate and ensure the necessary schedule for proper maintenance work.

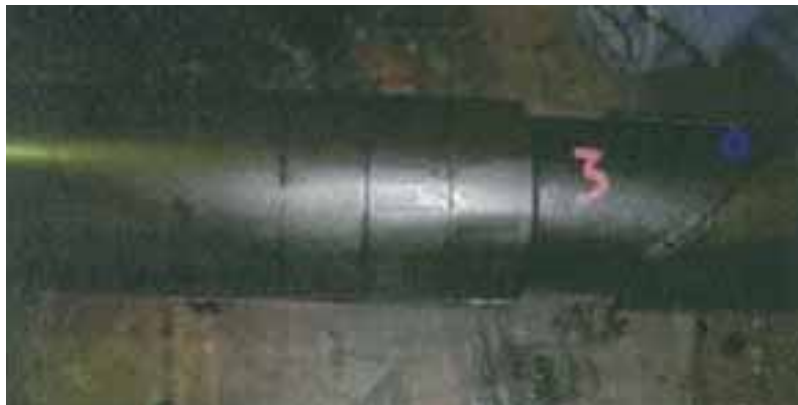
We will introduce the case of using low quality fuel leading to damage requiring the towing. During the ship navigation, a number of abnormalities occurred and eventually the main engine failed to start. The ship was required with towing to the nearest port.

Figure 25 Wornout plunger, low grade fuel damage requiring towing in fiscal year 2011 / reference*10

As a result of emergency repairs to the main engine, the fuel injection pump and fuel injection valve were opened up, and renewed as necessary., and 300 Mt of new fuel was bunkered and the ship operation restarted. After arriving at the repairing site, the excessive wornout was found on No. 1, 2 & 4 of the piston crown and piston ring, and so these were replaced with a reconditioned one.

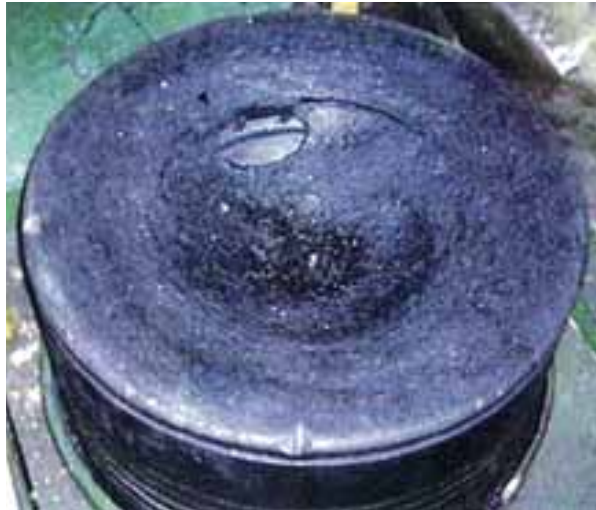
During the ship navigation, the temperature of lubricating oil in the main engine became high, and the main engine stopped automatically. A broken hole was found at the top of No.6 piston crown, and this piston crown was replaced with a spare one.

Figure 26 Hole in piston crown, damage from poor maintenance and repair mistake , requiring towing in fiscal year 2009 / reference*11

As for the cause of damage, in this case of the main engine, there are double defects that one is the incorrect scheduled maintenance and the other is an incorrect procedure during the repairing of damage and restoring work.

The oil dirty lubricating oil from the main engine was transferred to a waste oil tank. In addition the sump tank, oil pan and all filters inlet side were all cleaned. 10,000 litres of new lubricating oil was supplied.

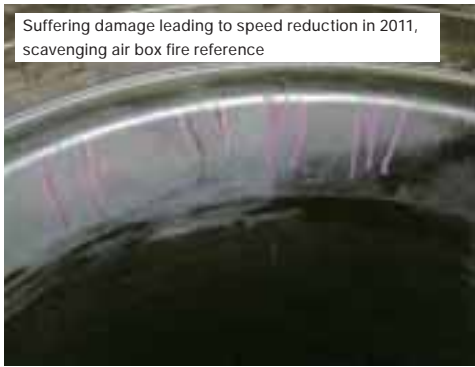
Figure 27 Liner with crack, fire in scavenging air box ,leading to speed reduction in fiscal year 2011 / reference*10

Treatment : No.1 piston crown was renewed

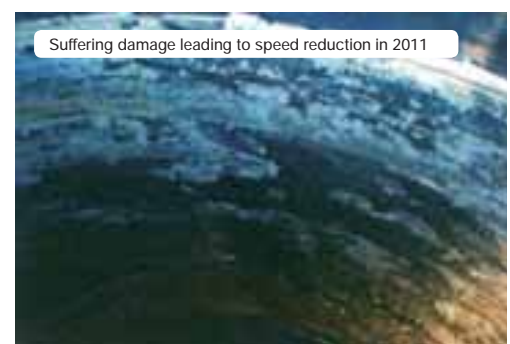
Figure 28 Burnout intermediate shaft bearing metal, damage leading to speed reduction in fiscal year 2011 / reference*10

- ① To monitor rigorously the operating parameters around the bearing, such as the temperature of the bearing and the quantity, flow volume, leakage of lubricating oil and the operating status of cooling systems,
- ② To predict early malfunctions of cooling systems,
- ③ Then, to conduct an adjustment of quantity of cooling water and proper maintenance and so on.
