# Chapter 2 | Trend of Claims Caused by Engine Trouble In Ships Entered With Our Club

## 2.1 Trend in Our Club

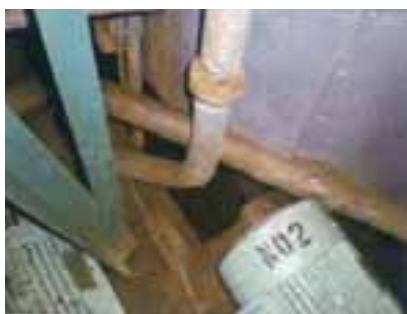
The crew stopped operating the boiler when water was found leaking in the lower boiler casing in the engine room.

Figure34 Lower boiler casing  
(Water leakage trace from upper part)

For their damage prevention, it is important for crew “to manage and treat the boiler water (water quality check/chemical treatment/discharge of boiler water (blow-off))” and “to inspect from inside of combustion chamber”.

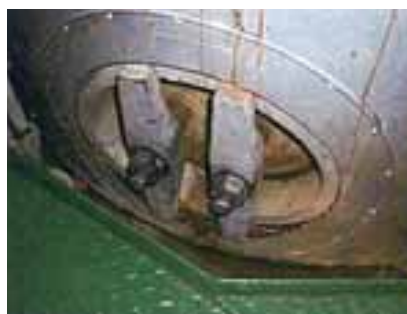
Figure35 Lower drum/manhole  
(Water leakage trace from upper part)

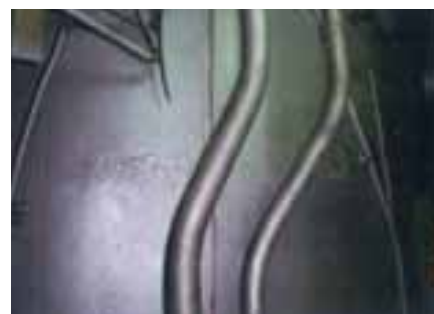
Figure36 Upper boiler casing  
(Paint swelling)

It can be considered that the deformation and swelling of the upper drum of the boiler was caused by overheating when the water level in the drum decreased. Safety features such as alarms, fuel shut off, etc., should come into play, based on the automatic detection device of the drum water level transmitter when the water level decreased. However, above mentioned problems will occur if the defects of the water level transmitter are not rectified.

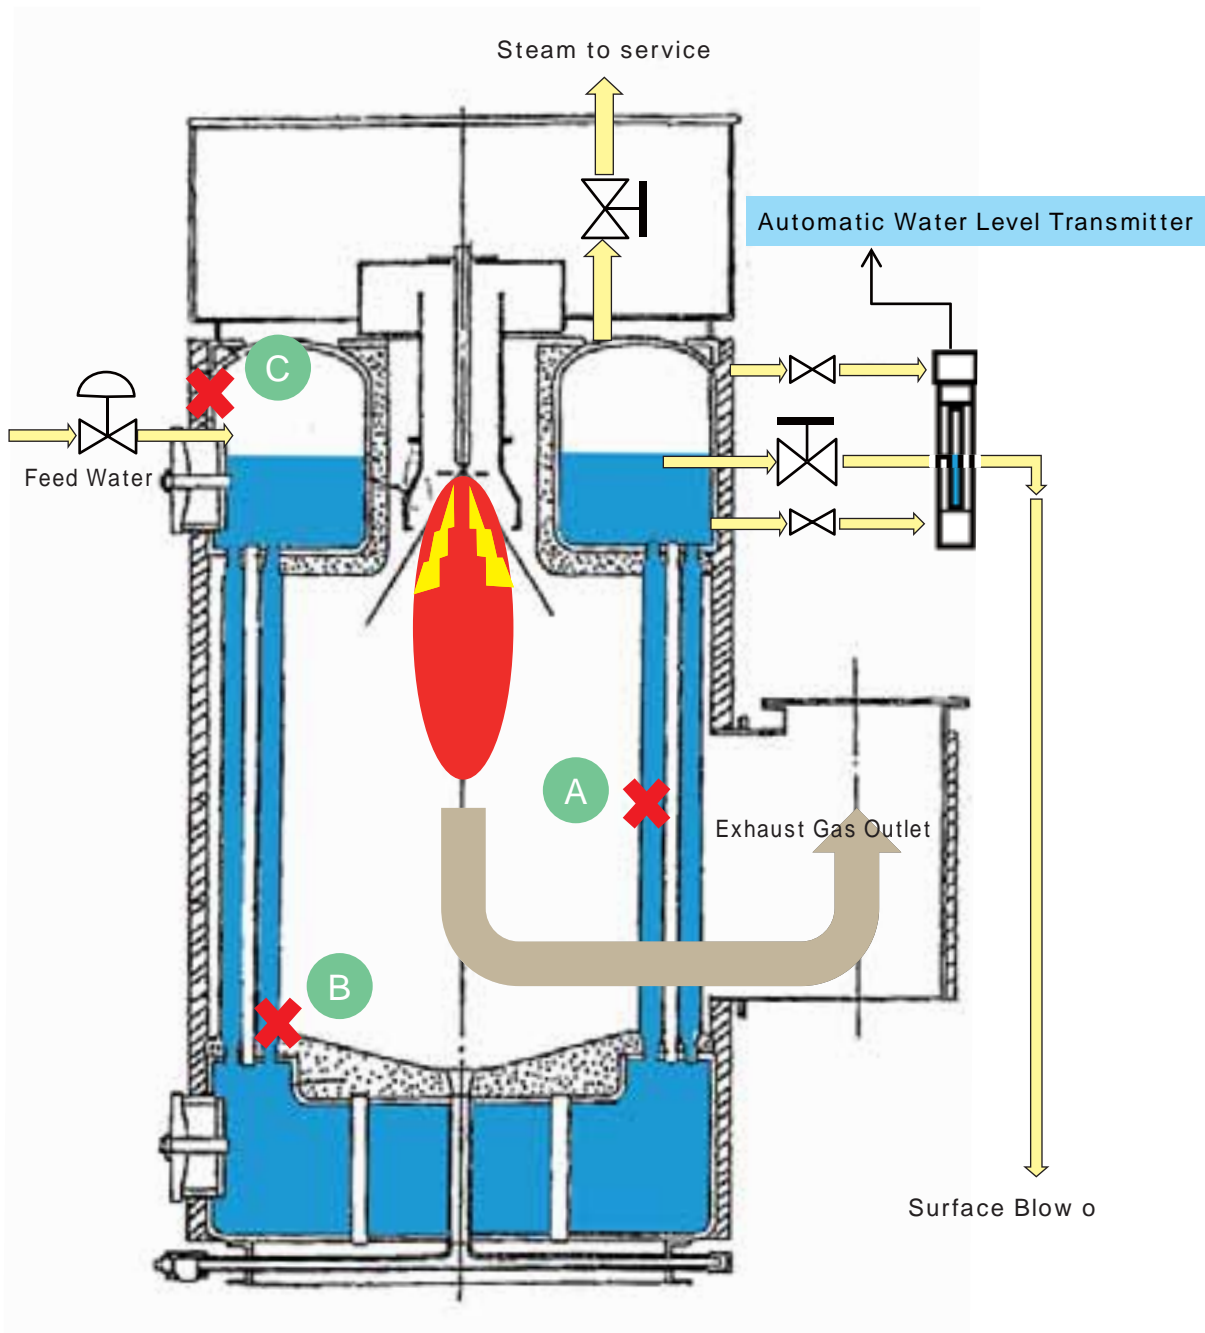
Figure 37 Cross section view of boiler

The boiler installed on this ship is a once through boiler shown in Figure 37 “Cross section view of boiler”. Unfortunately there is no detailed information including the extent of the damaged part. Judging from the trouble situation, the main cause of water leakage might be a breakage of the water tube caused by corrosion from both boiler water and combustion gas side, and the second cause might be considered to be the deformation of a drum.

We set the damaged locations, shown in Figure 37, into three sections based on the assumed cause considered from trouble situation. We will check the important points in the order of A, B, and C.

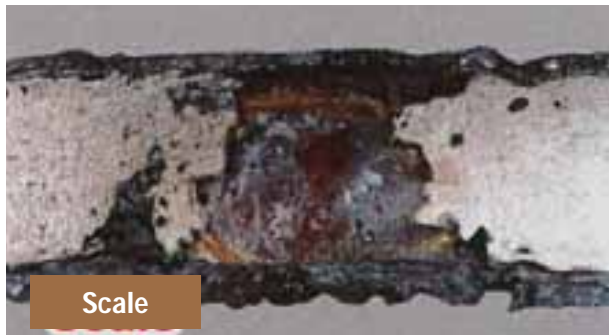
In the case of a lack of management of boiler water, it can be considered that thermal conductivity partly declined due to the accumulation of scale in tubes, the tubes over-heated due to the influence, and material strength declined significantly. As a result of this, the tube was breached and the leak of water occurred. From Figures 38 and 39, it shows about the concern holes in water tubes.

Figure 38 Broken hole due to scales / reference \*12

It is necessary for crew to maintain the result of chloride ion concentration and all sorts analysis within control limit value which are recommended by the boiler manufacturer for prevention of scale adhesion and corrosion and carry over.

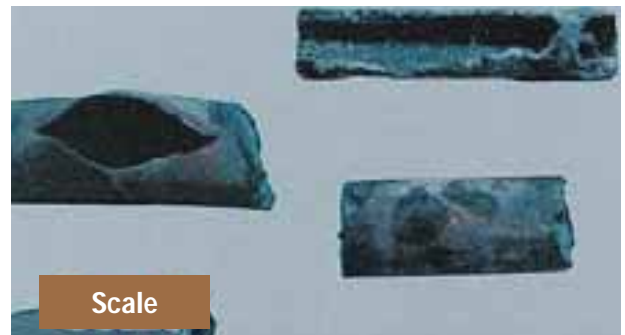
Figure 39 Broken hole due to scales / reference \*12

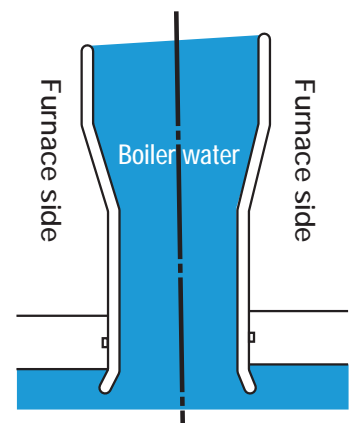
Figure40 Structure of expanding part

The boiler drum and water pipe are connected with the expansion of the tube at the end of the water tube (expanding). From Figure 40, it shows about the component drawing of the expanding junction. Leakage of water may occur due to the influence of loosening of the same junction, which led to flooding of the bottom of the combustion chamber (furnace).

In addition, the sulphuric acid is created due to the chemical reaction between the leaked water and the sulphur contained in the unburned soot residue accumulated on the side of combustion chamber, and led to sulphuric acid corrosion.

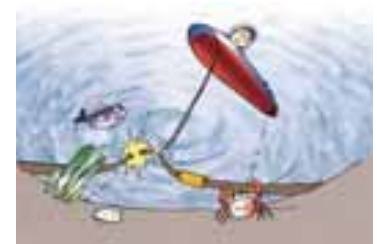
When heaving up the anchor after resolving the trouble of the diesel main engine, as shown in Figure 44 and 45, it was found that the anchor was tangled around the submarine cable (transmission line of electric power company). She anchored urgently instructed by the pilot, however, the location was prohibited area for anchoring as shown in Figure 46.

Figure 44 Image figure of submarine cable damage

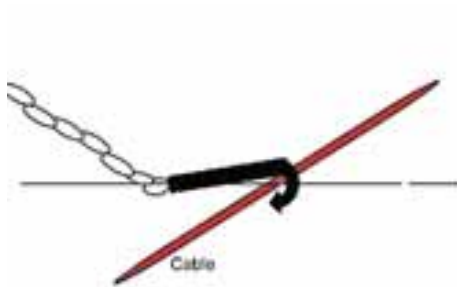
Figure45 Anchor's contacting condition to the cable

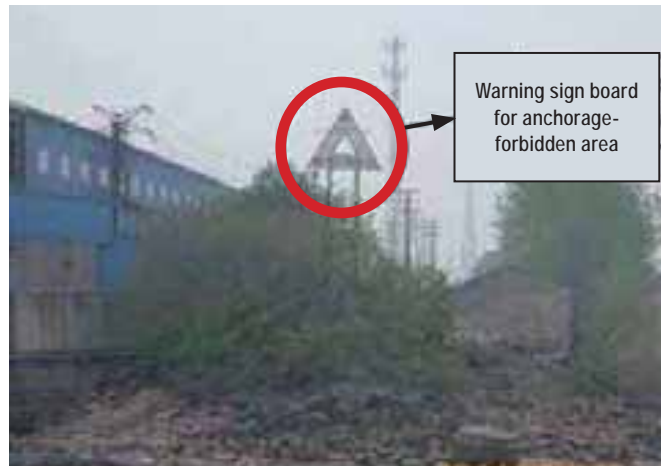
Figure 46 Warning sign board for anchorage-forbidden area

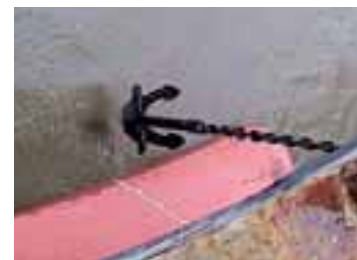
Figure49 Functional validation of anchor chain and anchors

Still, Maritime Safety Agency did not approve the departure with one side anchor only, and requested installation of new anchor and chains at the repair dock. The shipowner arranged the replacing the anchor and chains as shown in Figure 48 and 49.

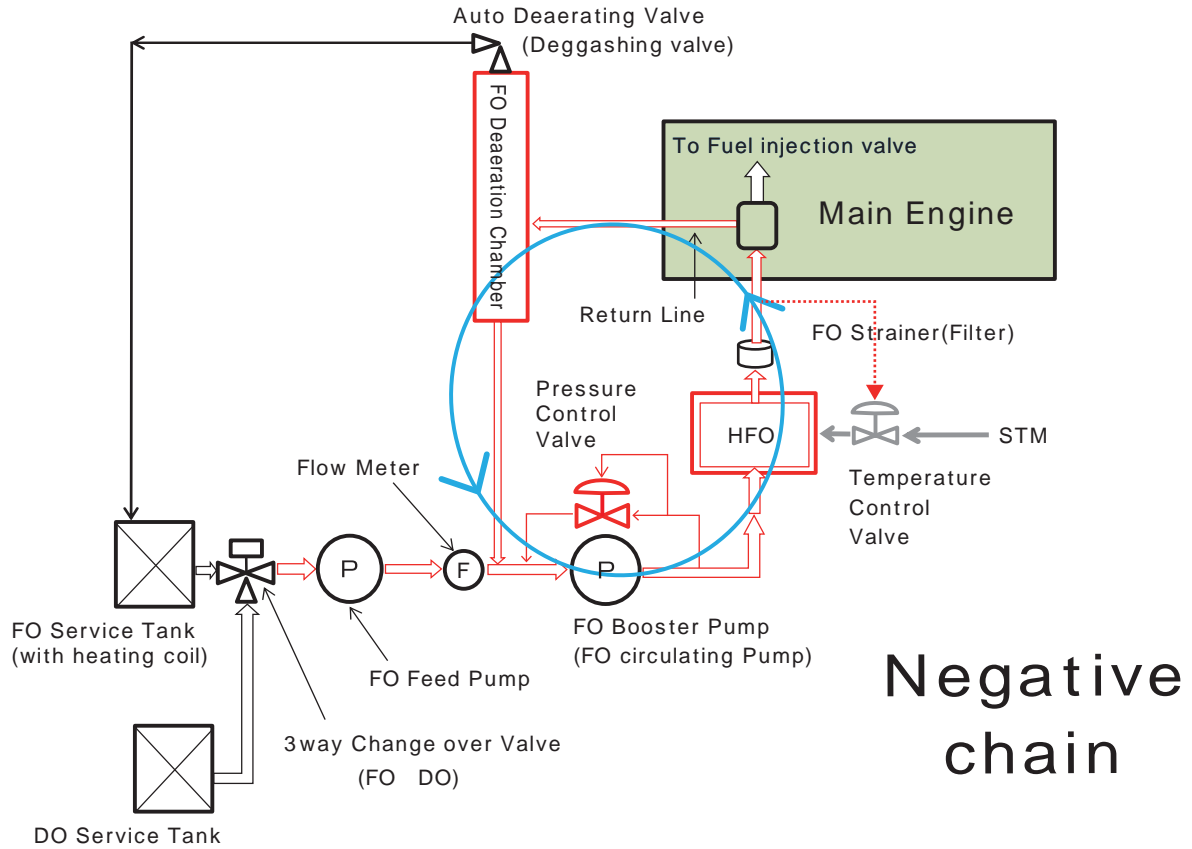
Figure 50 Outline of fuel oil supply system for Main Engine

Originally, fuel oil in the system must be adjusted properly depending on the condition, such as transition of consumption, temperature and viscosity of fuel oil. Its purpose is that it can maintain the manufacturer recommended fuel viscosity range at engine inlet.

In case that you conduct switching fuel oil from MDO to HFO, at the timing when the engineers can expect the status of continuous operation of the main engine, and please start heating it. Its purpose is that the fuel oil can maintain the manufacturer recommended fuel viscosity range at engine inlet.

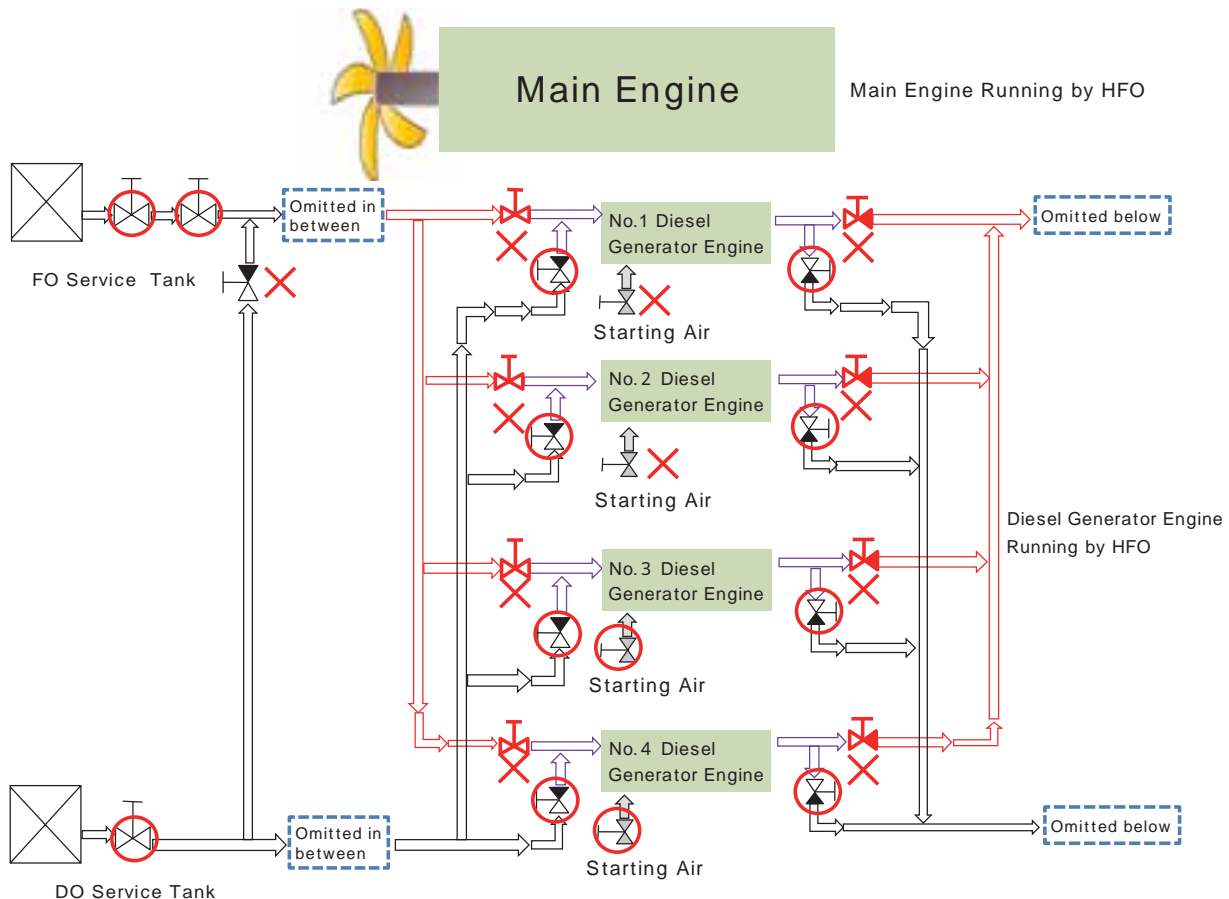
Figure 57 Outline of Fuel oil and Starting air system for Diesel Generator Engine

The engineer in charge (3/E) did not follow work instructions and operated with the starting air valve closed. However he followed work instructions from another ship, **[Breach of work instructions]**.

(Of course, the starting air valve should be closed for safety at engine maintenance work. However, if it is not opened in S/B, it cannot be started automatically.)

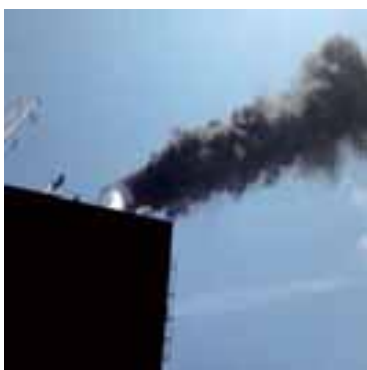
After the vessel arrived at the terminal, during unloading cargo operations, the black smoke with soot came out from funnel due to the boiler's defect. It had continued for 20 or 30 minutes (Figure 59). As a result, the soot scattered widely (Figure 60) and accumulated to the ocean, terminal, and some factories being located near the terminal (Figure 61, 62, and 63).

Figure 59 Black smoke

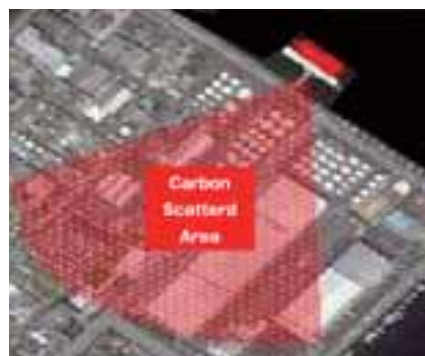
Figure 60 Scattering range of black smoke (550 m)

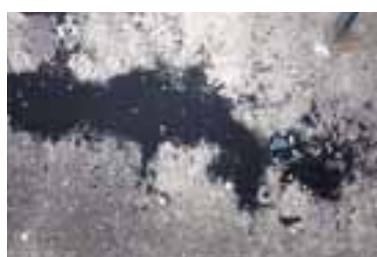
Figure 62 Soot on working passage of factory

The shipowners arranged clean-up work immediately and it took for 3 days to complete.

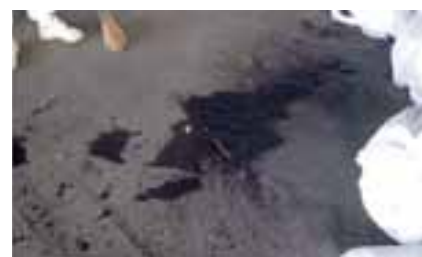
Figure 63 Soot on working passage inside factory

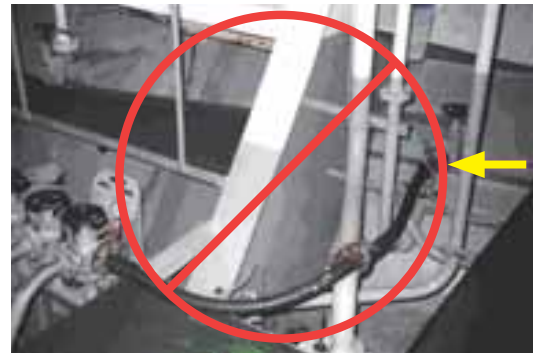
Figure 65 Magic Pipe / reference\*16

- 1 A lot of oil-water-mixed bilge was illegally discharged to the sea.
- 2 Misstatement on Oil Record Book
- 3 Engineers plotted together, and for example as shown in Figure 65 they illegally install special pipes made in the vessel on bilge overboard line; they illegally put it between bilge pump and overboard valve, by-passing bilge separator, and discharged the bilge overboard.
- 4 During USCG inspection, they removed and hide the illegal pipeline, and evaded the inspection.
