JAPAN P&I CLUB

Vol.40 September 2017

# P&I Loss Prevention Bulletin

## CASE STUDY

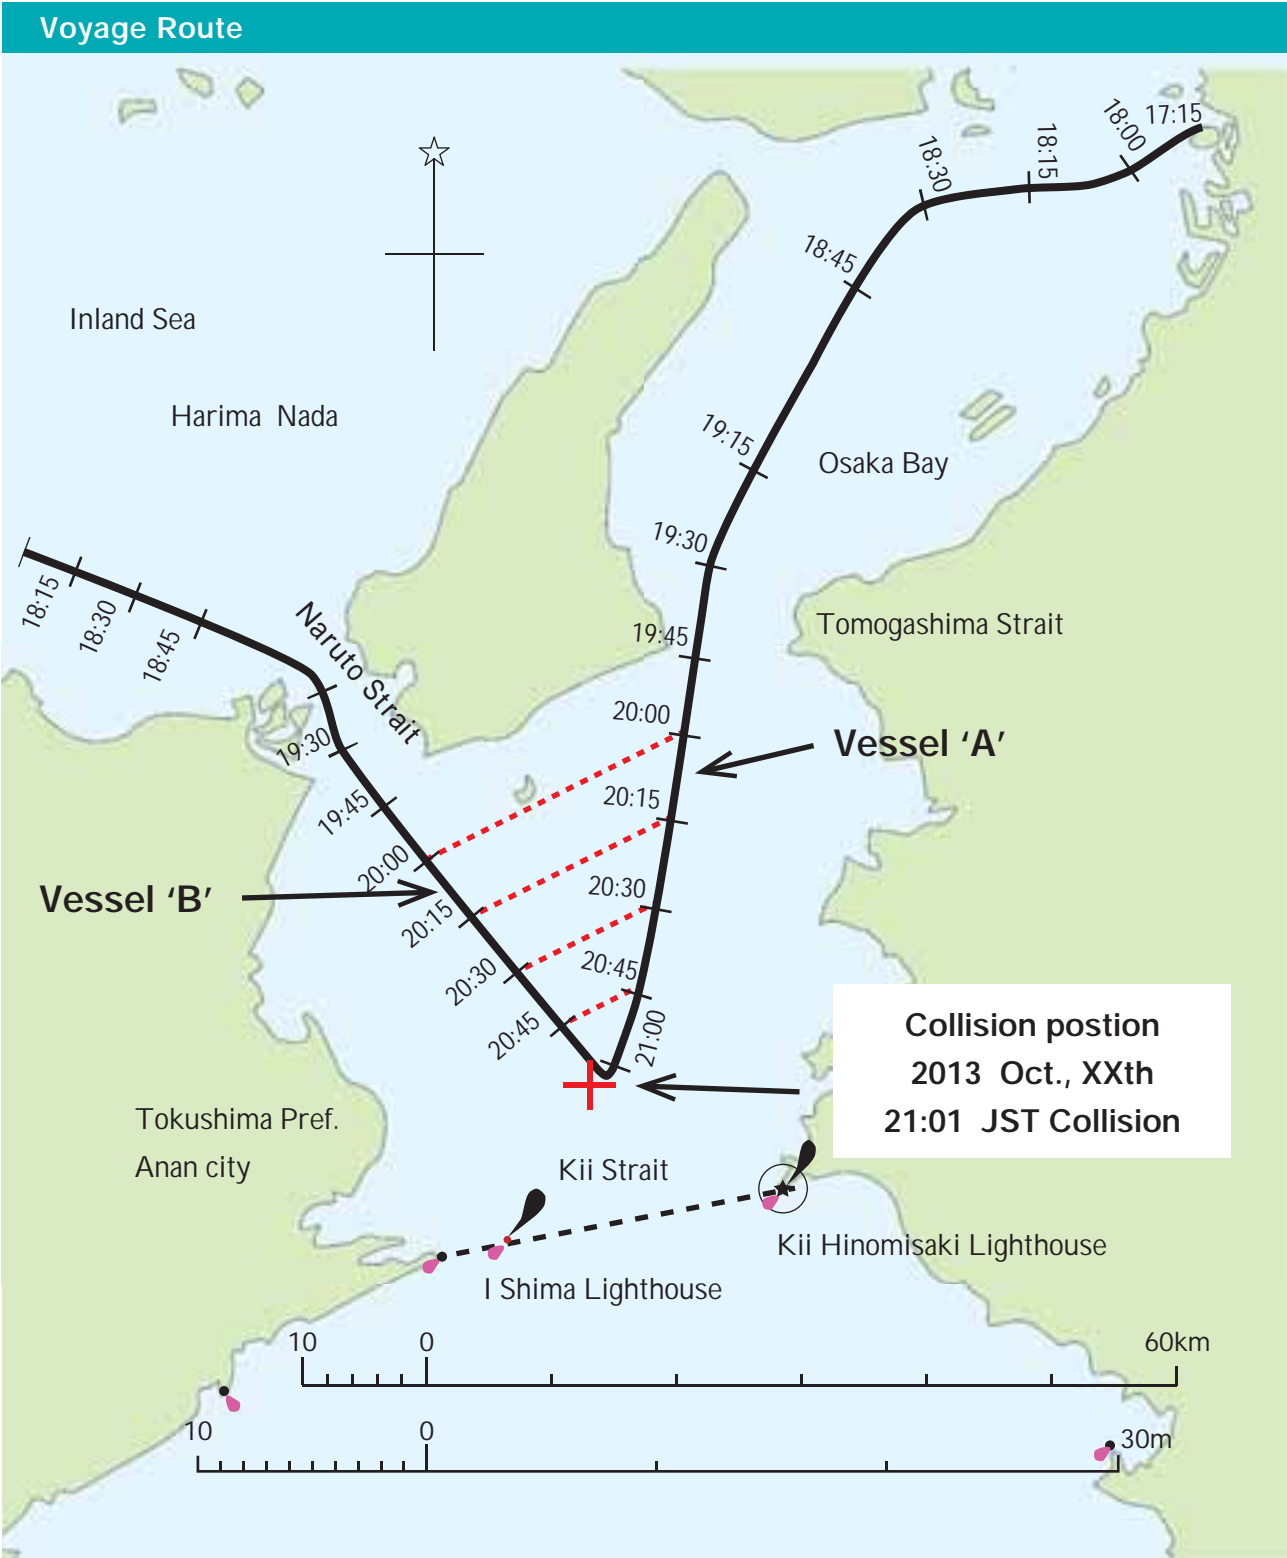
Fig. 17 Voyage Route

When both vessels approached cutting across each other's courses, the third officer of Vessel A noticed that there was a risk of collision with Vessel B due to the approach alarm sounded by the ARPA and informed that she (Vessel A) would pass the astern of Vessel B via VHF. However, he continued to navigate on the same course and speed, with the exception of altering course to starboard 6 degrees. Also, after the third officer of Vessel B noticed the Closest Point of Approach (CPA) which indicated zero on the ARPA, he altered course to starboard 5 degrees, but still sailed continuing on the same course and speed.

As a result, both vessels kept closing head-on to each other. Although it steered immediately to avoid collision immediately before the collision, the starboard side bow of Vessel A collided with the port side astern of Vessel B. Both vessels sustained damage to the hull, however, there were personal injuries. Please see Figs. 17, 18 and 19 and Table 20 for collision details and the actions that were taken by both Vessels.

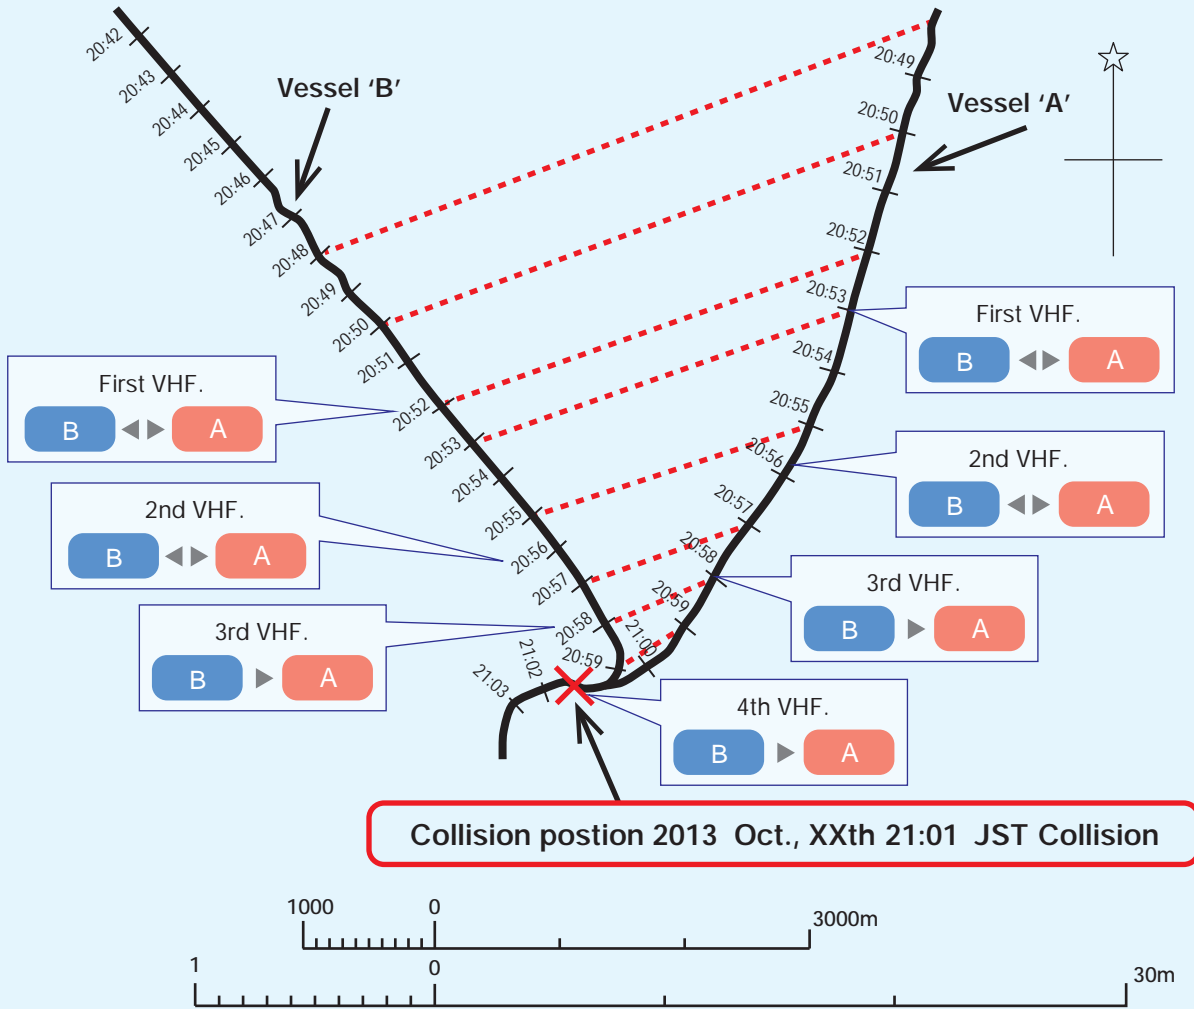
Fig. 18 Details of Voyage Route

20:25 (approximately)	Vessel B was observed at 7.5 nautical miles. 51 degrees with bearing of <245> off of its starboard bow. Supplemented at 5 nautical miles with ARPA. Verified with the screen that indicated a course of <135> and a speed of 13.0 kts. At the same time, Vessel B's white, white and red lights were visibly confirmed	— —

20:47 (approximately)	CPA alarm sounded at a distance of 3.0 nautical miles (the alarm setting was unknown).	—
20:50 (approximately)	Vessel B was observed at 52 degrees with a bearing of <248> on her starboard bow at 2.3 nautical miles via ARPA. Responded to a call from Vessel B via VHF and communicated that Vessel A would pass the stern of Vessel B. Altered course to starboard 6 degrees. Set the new course <196>.	Vessel A was captured on the monitor at 70 degrees on her port side at approximately 3.0 nautical miles via AIS (superimposed in ECDIS). Visibly confirmed as the CPA indicated it at 0.2 nautical miles. Recognized white, white and green lights of Vessel A. Contacted Vessel A via VHF and confirmed she was going to pass the stern of Vessel B. Vessel B believed Vessel A was heading toward the stern.

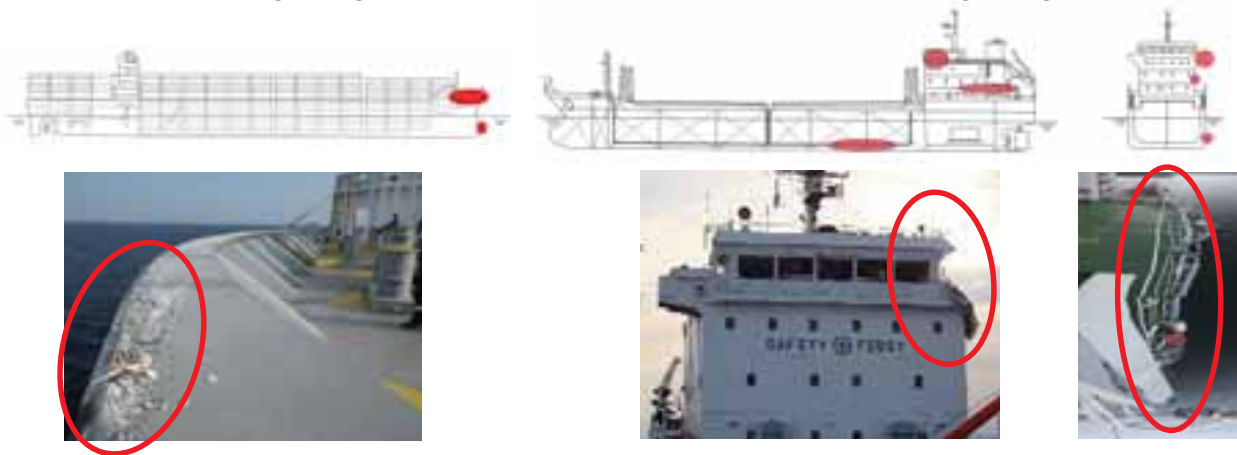
Fig. 21 Damage Diagram

Vessel "A" Damage Diagram

Vessel "B" Damage Diagram

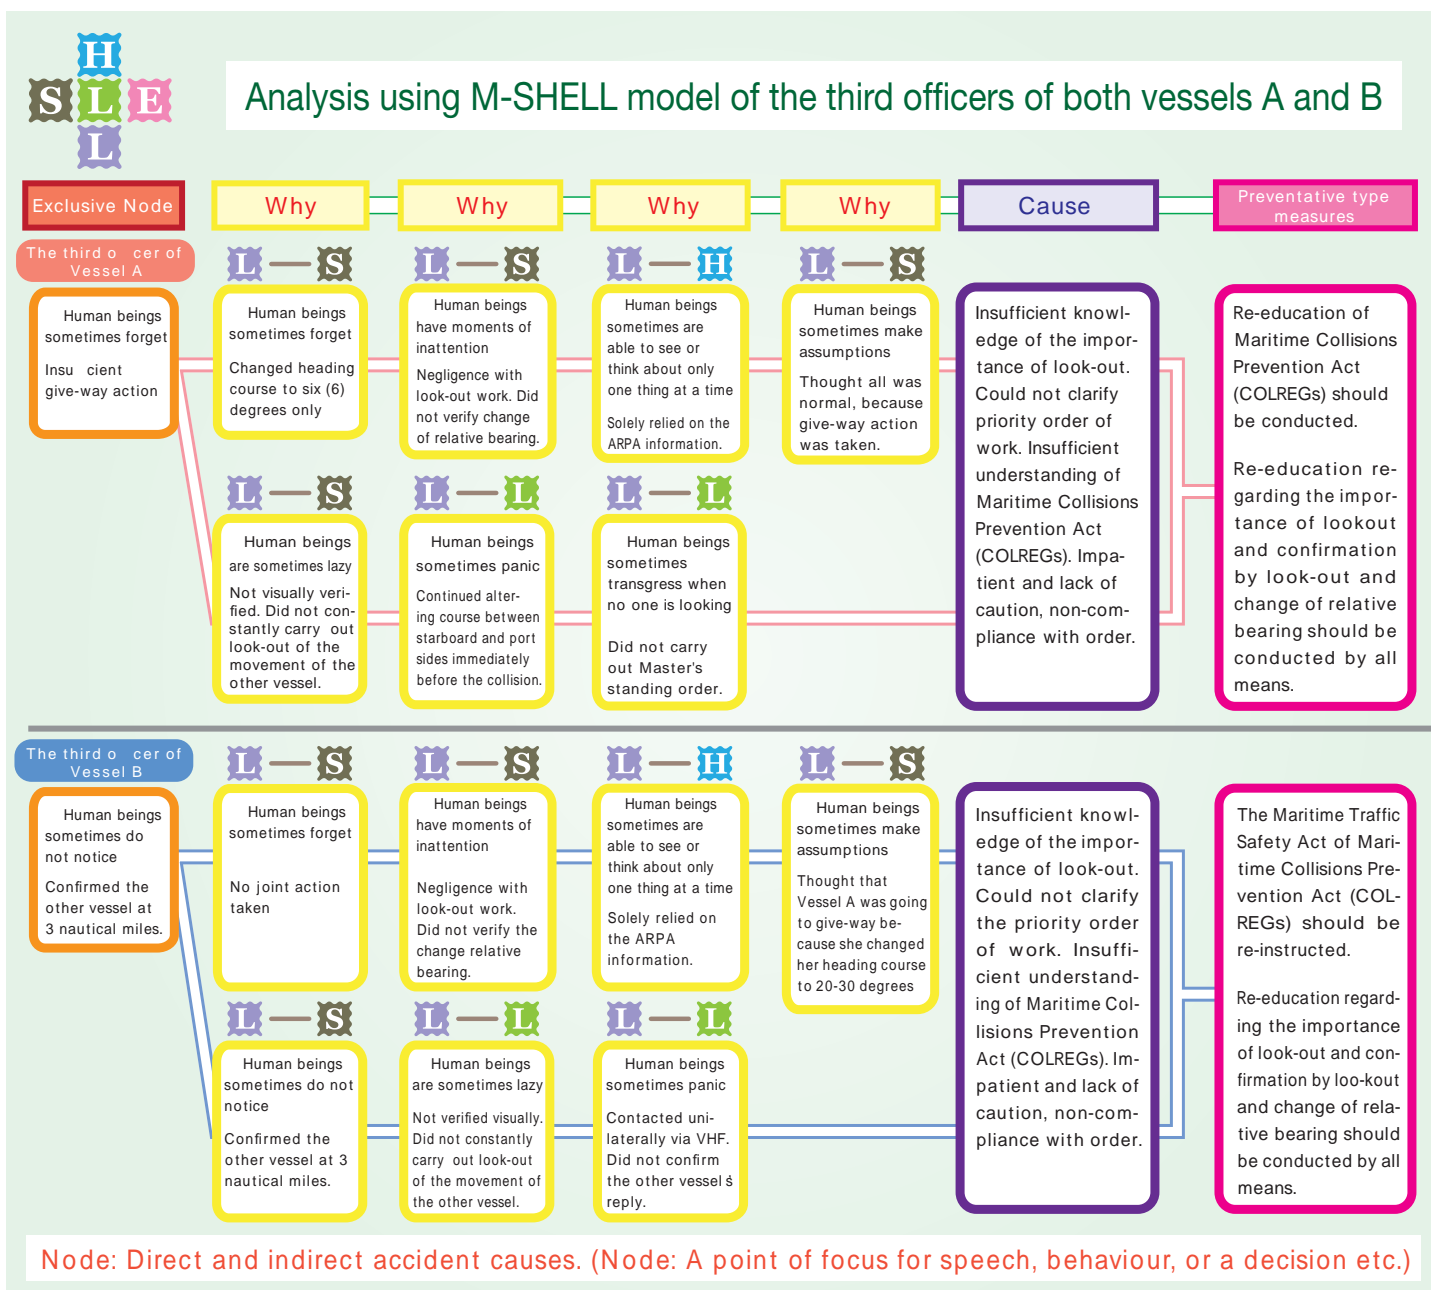
Fig. 24 Why-why? Model

To begin with, we consider the root cause to be 'Exclusive Node'. In spite of insufficient avoidance action (third officer communicated that Vessel A would pass the astern of Vessel B), however in reality, Vessel A altered course to starboard 6 degrees only (in general, Vessel A should alter her heading course to starboard 60 degrees).

On analysing as to why the third officer of Vessel A caused the accident, firstly we can say that there was a lack ability in recognizing the importance of look-out. Further, this was not only down to the fact that work was not prioritised appropriately, but that there was also an insufficient understanding of the Maritime Collisions Prevention Act (COLREGs). In addition, it is clear that there were other causes, such as impatience, a lack of caution and non compliance with the Master’s standing order.

On the other hand, when analysing the third officer of Vessel B similarly, we can conclude that the accident causes are the same for the third officer of Vessel A. We understand that the cause was not only down to the fact that there was a lack ability in recognizing the importance of look-out, but in addition, work was not prioritised appropriately. Moreover there was insufficient understanding regarding the Maritime Collisions Prevention Act (COLREGs). It is also clear that there were other causes, such as impatience, a lack of caution and non compliance with the Master’s standing order.

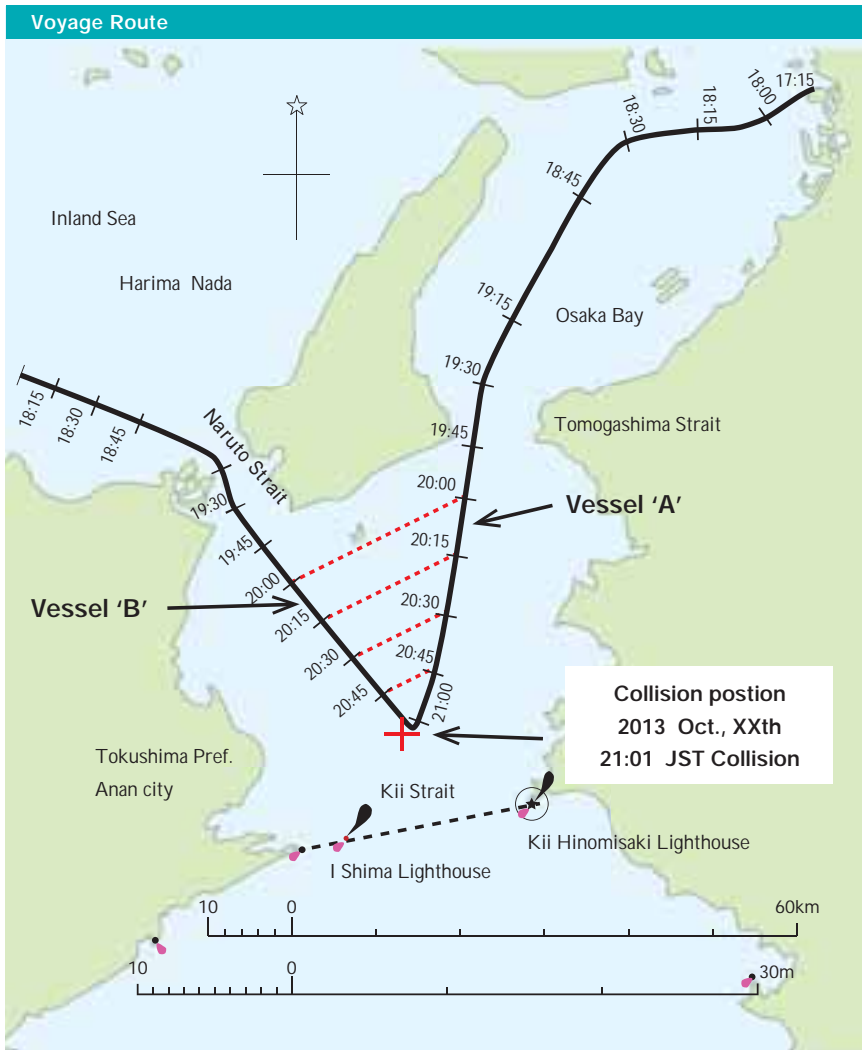
Fig.26 Voyage Route (same as Fig17)

As can be seen in Fig. 26, the traffic system of the Kii Suido (Strait) is a sea area which easily causes a crossing situation because it has a narrow angle for approaching ‘vessels between the Naruto Strait and Hinomisaki’ and ‘those navigating north to south between the Tomogashima Strait and the Kii Hinomisaki coast of I-shima Island’. Also, there are a large number of fishing vessels operating, along with a high volume of marine traffic. Although it depends on the individual circumstances, if the waters are congested and there is a narrow channel, the Master is expected to command by himself in a large ocean-going vessel. Why did both Masters of the vessels stay in each of their cabins? We are going to analyse the Masters of both vessels, according to the Human Characteristics.

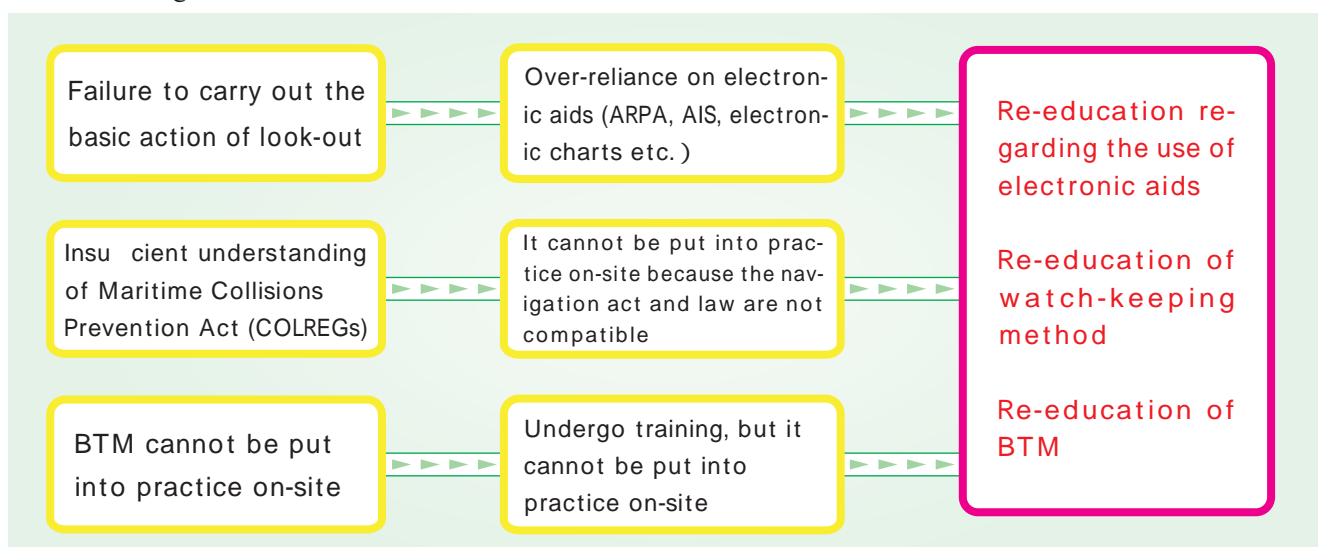
Fig. 27 Preventive Measures for the Third Officers of Vessels A and B

There were similarities in the specific behaviours of the Human Characteristics involved that led to the accident. If these specific behaviours can be eliminated, preventive measures can be formulated. These are summarized as illustrated in Fig. 27 below:

A failure to carry out the basic action of a look-out.
	A tendency to rely too heavily on ARPA, AIS, electronic charts and other electrical equipment.
	Although the Maritime Collisions Prevention Act (COLREGs) is understood, it could not be put into practice on-site.
	There was failure in implementing the BTM despite the presence of the A/B (able seaman) and a cadet on the bridge.
