§ 3 Traffic Systems of the Kii Suido (Strait) and Tokyo Bay

§ 4

§ 4-1 Feature of Trouble and Damages (Attachment See ' 4 Cycle Diesel Engine of vessel ')

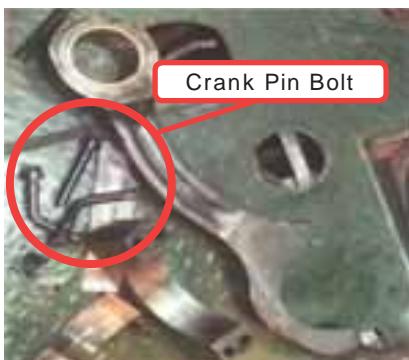
- (a) Two bolts were cut at the stud bolt end
- (b) The other two bolts sustained bending damage in the middle section

Reference Picture 34
Bending loss of connecting rod

In the event of piston draw-out work, based on the guideline for maintenance work and standard (instruction manual), maintenance of the crank pin bolt (replacement, dye penetration inspection, cleaning, tightening force and so on) is to be carried out appropriately.

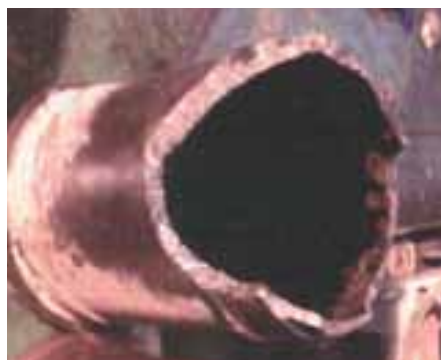
Broken damage of piston and cylinder liner (See Reference Pictures 35 and 36)

Reference Picture 35
Broken damaged cylinder liner

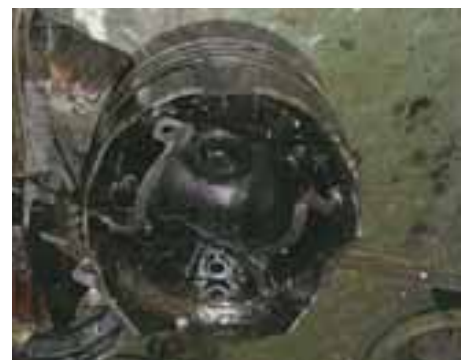
Reference Picture 36
Broken damaged piston

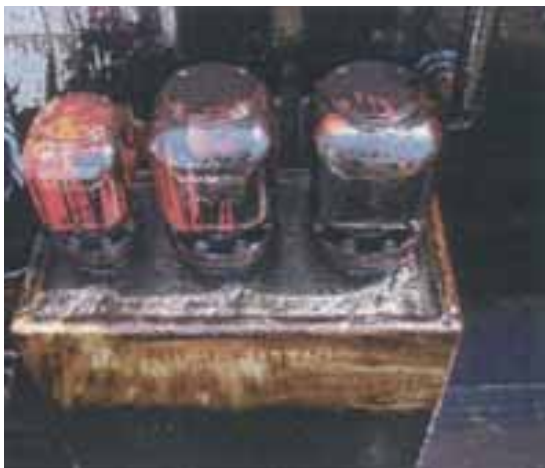
- FO overflows from the air vent (See Reference picture 39)
- The crew could not contain the fuel on the deck and approximately 100 liters spilt into the sea (See Reference Pictures 40 and 41).

Reference Picture 39
No.3 Fuel oil tank air vent (after overflow)

During tank overflow, the No.3 FO tank was filled with approximately 91KL of FO, which is equivalent to 96% of tank capacity. However, the oil transfer amount from the barge was as instructed.

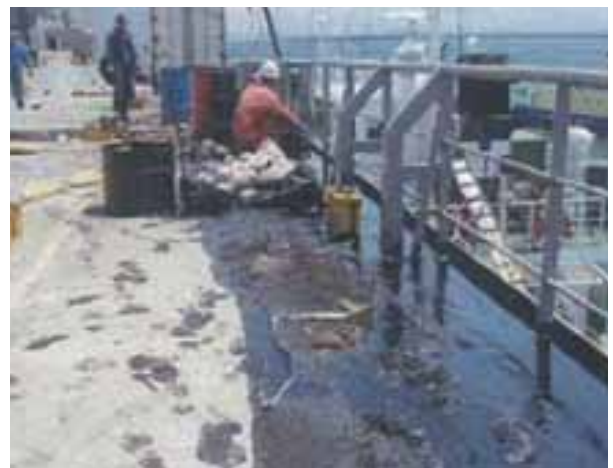
Reference Picture 40
Port side of upper deck

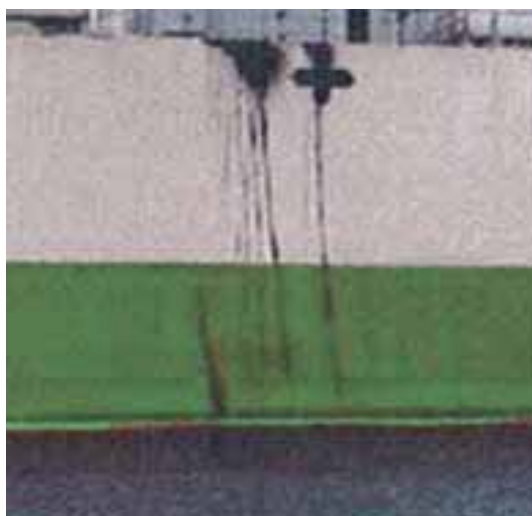
Reference Picture 41
State of oil spill overboarding

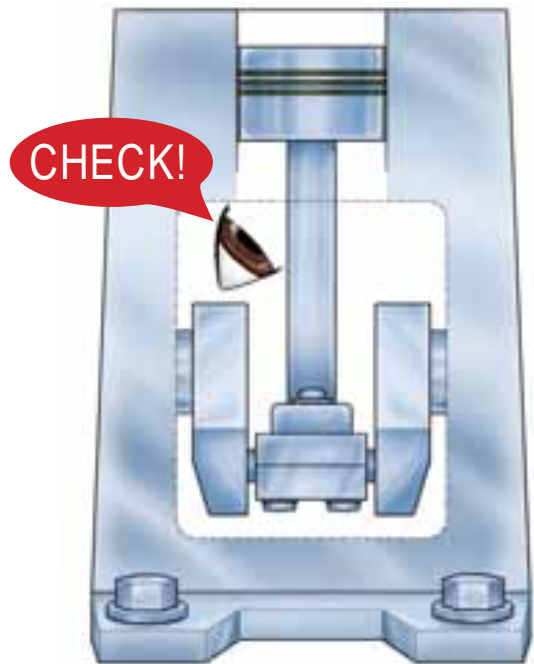
Fig. 42 Appearance of Crankcase

A crankcase is, as shown in Fig. 42, a box shape room which houses the crankshaft. As there is a door attached, it is possible to inspect the inside. However, this door is too small and it is not possible to observe the internal structure without using a hand mirror or adjusting the position of the crankshaft (See Fig. 42). There are three errors that occurred in the chain, when analysing as to why the abnormality was not detected at the time of inspecting the crankcase.

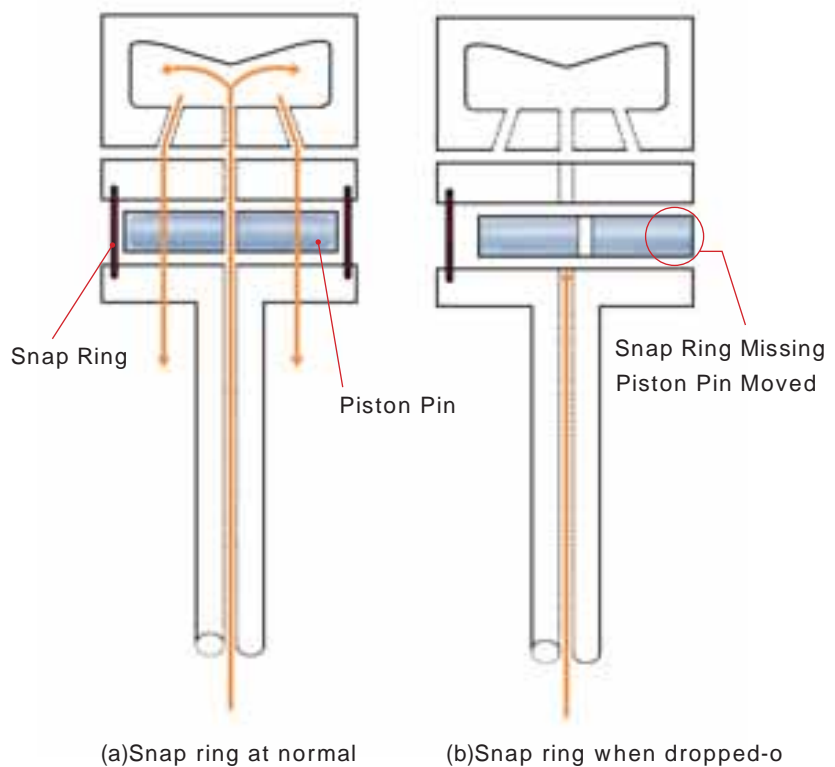
Fig. 43 Prevention of LO Flow which Aids Piston Pin Movement

The main reason for burnout was a lack of LO, but it was in fact caused by the dropping-off of a snap ring. A description of the mechanism that controls LO and how this causes the oil to not flow smoothly, as a result of a snap ring dropping off, is as follows. (See Fig. 43)

- (a) As described earlier, the piston pin (full floating type) is inserted into the piston pin boss. The snap ring is inserted into the gutter of both ends of the boss.
- (b) Therefore, if the ring gets separated, the pin will move toward the axial direction. Thus, the passage of LO gets blocked by the shifting of the positions between the oil hole of the connecting rod and the filling hole of the piston pin.
- (c) As a result, the filling oil to the upper part of the piston pin boss and piston cooling space will be stopped.
