§ 3 Dragging Anchor Cases

(From the Maritime Casualty Analysis Report [Vol. 6]: Typhoons and marine accidents issued by the Marine Accident Inquiry Agency [MAIA] in 2006)

3 - 1 The Aomori - Hakodate ferry “ Touya Maru ” accident

3 2 Cargo Vessel B Dragging anchor and grounding accident

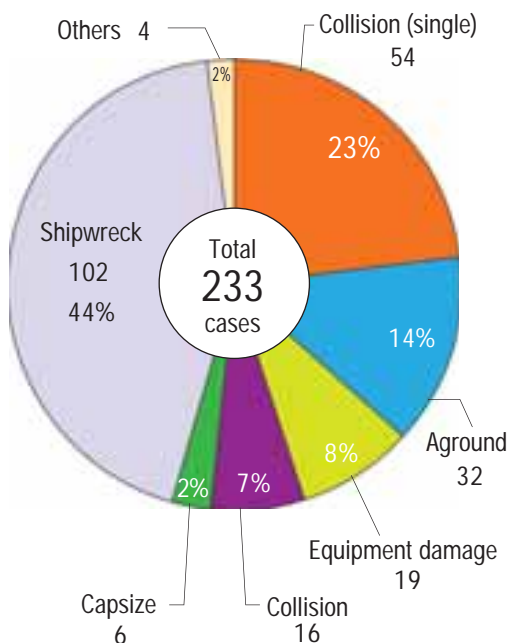
Fig. 29

Looking closely at 233 accidents due to the typhoons in 2004 “by type of case”, the main aspects of typhoon maritime accidents will follow. The ratio of those accidents will be shown in Fig 29.

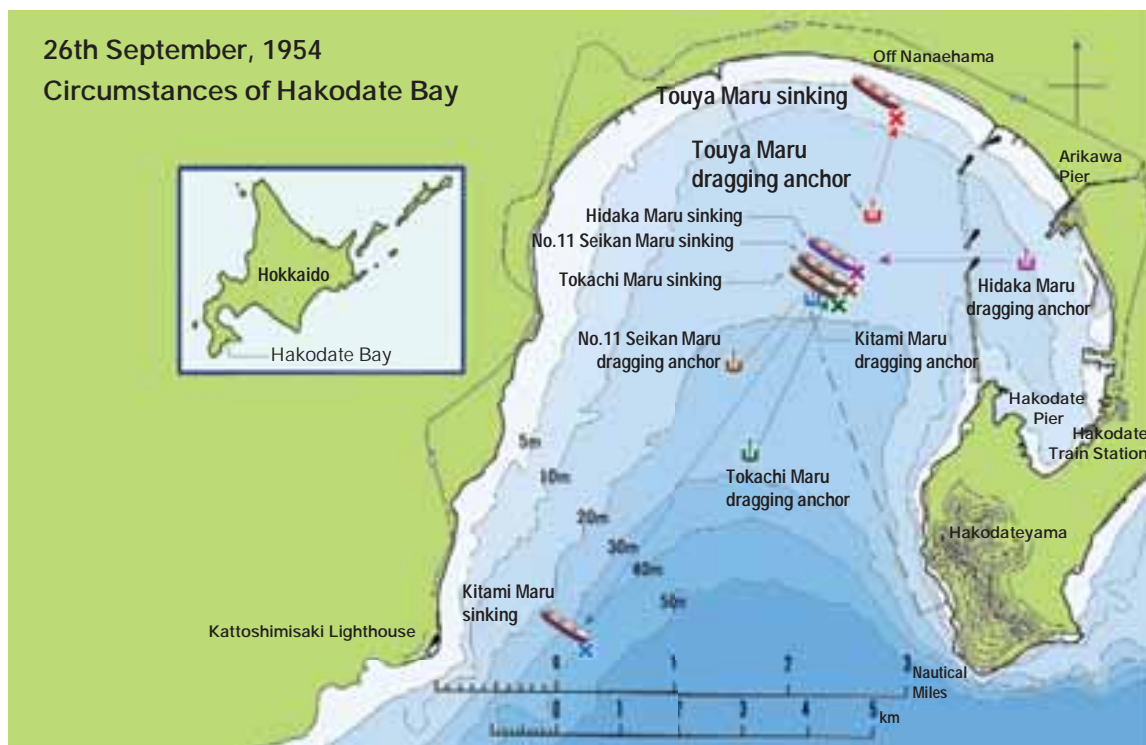
Fig. 30

The state of affairs at Hakodate Bay on the 26th of September in 1954 is shown in Fig. 30. Hakodate Bay has a land shape that makes it less influenced by wind and waves because it is shielded by high mountains, when there is a northwest wind.

“However, the bay mouth is open widely towards the direction of the ‘south-southwest’. Thus, because of the long fetch, in the event that a southerly wind blows continuously, high waves are thrust into the bay as time goes by”.

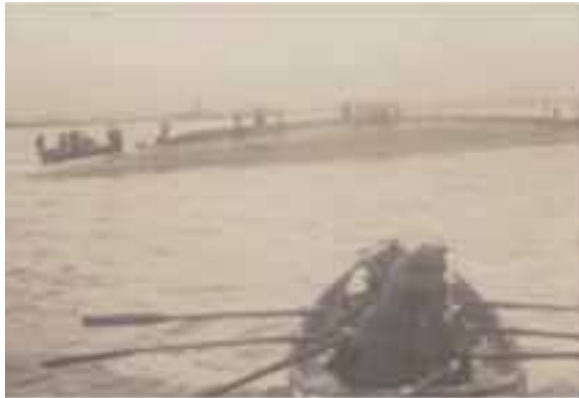
Photograph 35
"Capsized Touya Maru"

departed Hakodate Pier from within the Port of Hakodate bound for the Port of Aomori. She was to take refuge at the Hakodate Bay because outside the Port of Hakodate had already been seeing very stormy weather (at sea), however, she dragged anchor due to a gale and high waves. Touya Maru therefore grounded in the shallows of Nanaehama in Hakodate Bay. She then capsized and sank which caused a total number of 1,155 deceased or missing persons including passengers etc.

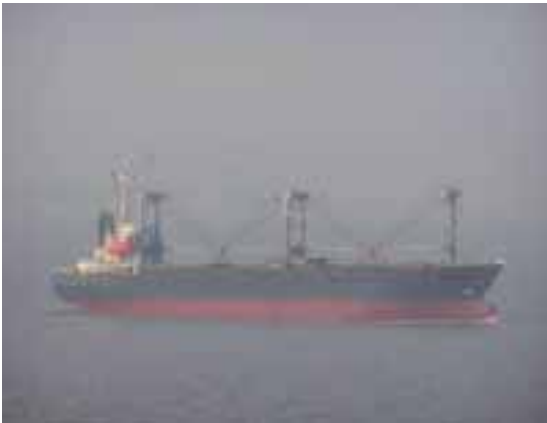
Photograph 45

the Japan Coast Guard and the Self-Defense Force. Photograph 45, Figs. 46 and 47 show the path of Vessel B and its anchor being dragged.

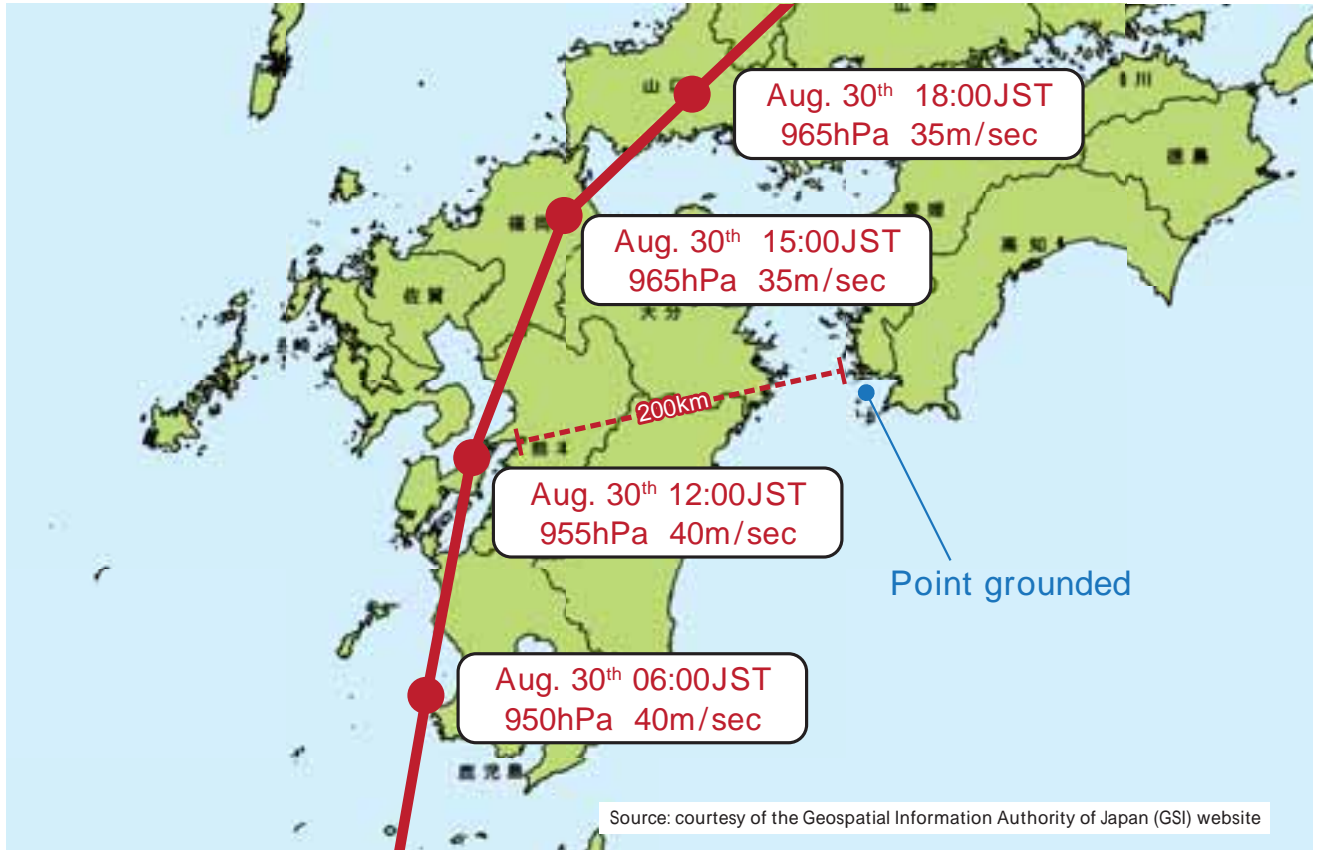
Fig. 48

Figs. 48 and 49 show the route of Typhoon No. 16 in 2004, which caused a case of dragging anchor.

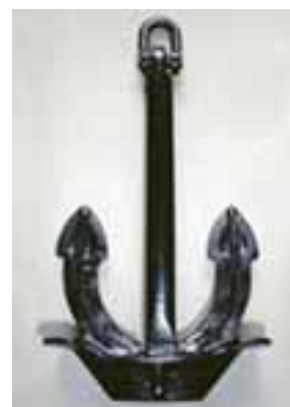
Photograph 52
JIS type anchor

The anchor and anchor cable outfitted on the ship were as follows:

Anchor:	JIS type Weight 3,300kgs
Anchor cable:	1 shackle was at 27.5m × 9 shackles per side 248m

When tentatively calculating the minimum required length for an anchor chain, in 92m of water, an anchor chain with 513m (19 shackles) of length is required (at times of rough seas: $4 \times d + 145m$). Sheltering from stormy weather in a location which exceeds 50m in water depth is thought of as unsuitable.
