# JAPAN P&I NEWS

No.996

30 November 2018

## **Incandescent reflector lamp setting fire to timber in Cargo Hold**

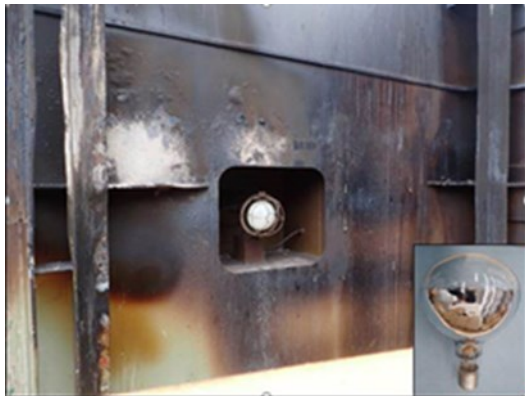
Figure 1

The face of the lamp was 40 mm away from the inside of the protective cage and the protective cage was set in 5 mm from the edge of the recess. The timber packs had been tightly stowed to minimise the risk of the cargo shifting at sea. The ends of the timber packs were loaded up against the side of the hold and across the light recesses and would have been about 45-50 mm from the face of the lamps.

Cargo hold light in recess (inset, the reflector lamp)

- Some lamp types generate a substantial amount of heat that can be a fire hazard. Ship owners and operators should consider using other types of lamp that do not generate high heat in locations where the risk of fire is present (see attachment)
- Safety procedures such as switching off cargo hold lights should be documented and include systems for checking that they have been carried

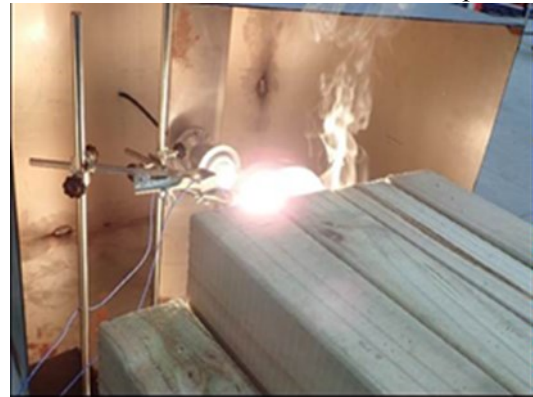
Figure 2

Lamp test set-up

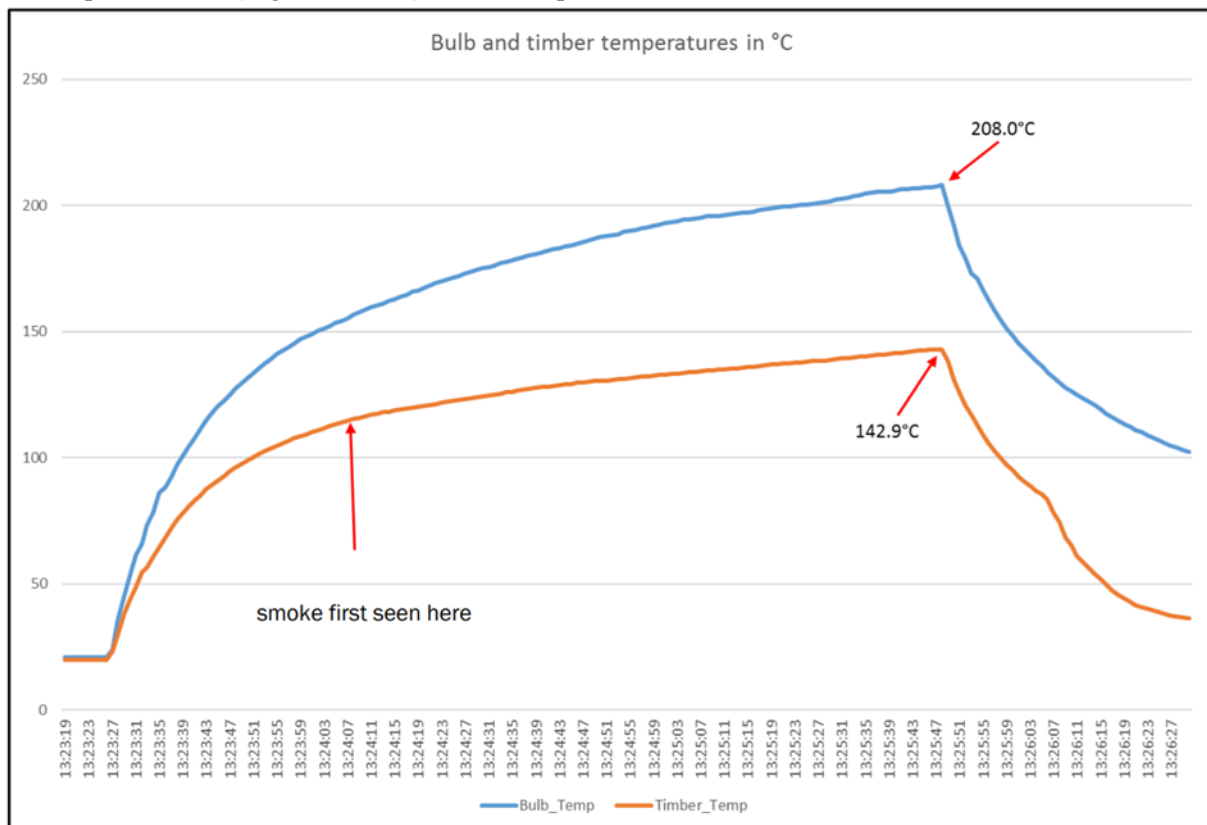
At 40 seconds after rising the surface temperature, the smoke was first seen. At that time the temperature of the lamp was 155°C (degrees Celsius) and the temperature at the surface of the timber was 114°C.

Figure 3 Graph showing temperatures recorded by test thermocouples
