§3 Case Study = Collision Accident =

Japan Transport Safety Board Report MA2019-6-02

The collision accident of the outgoing large size container which occurred off the port of Kobe on XX May, 2018 is to be analysed.

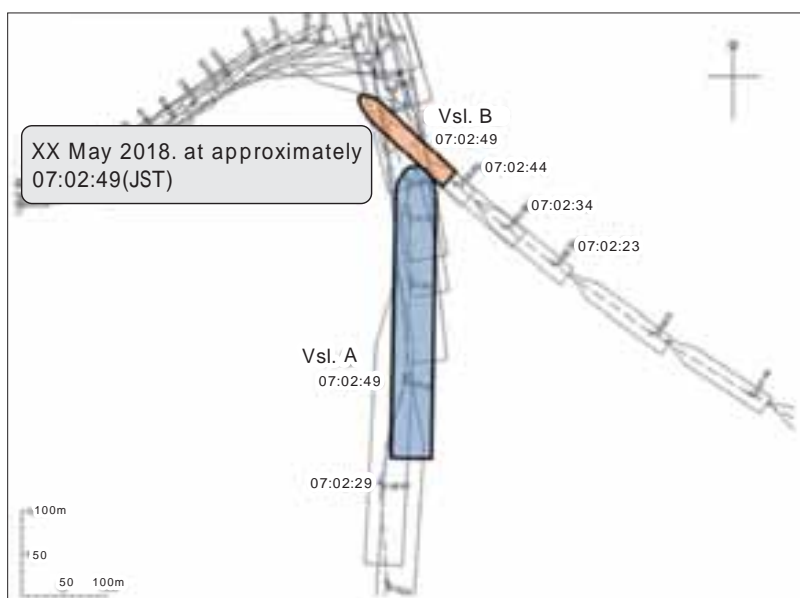
Fig. 23

Vessel B departed Osaka bound for Kobe RC-4 (Kobe Rokko Island) via Kobe Central Fairway. While navigating northwestward and westward, **at 13 knots of speed, S/B Full,** the starboard bow of Vessel A collided with the accommodation space near the astern port side of Vessel B. (See Figure 23)

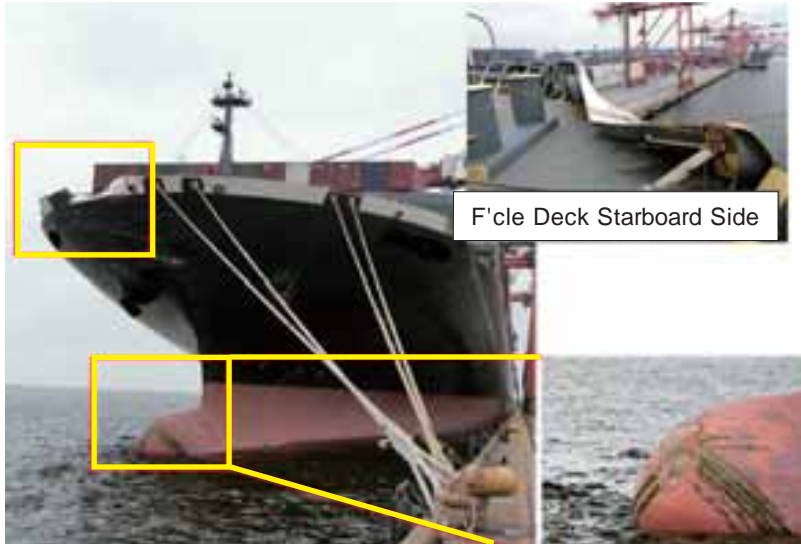
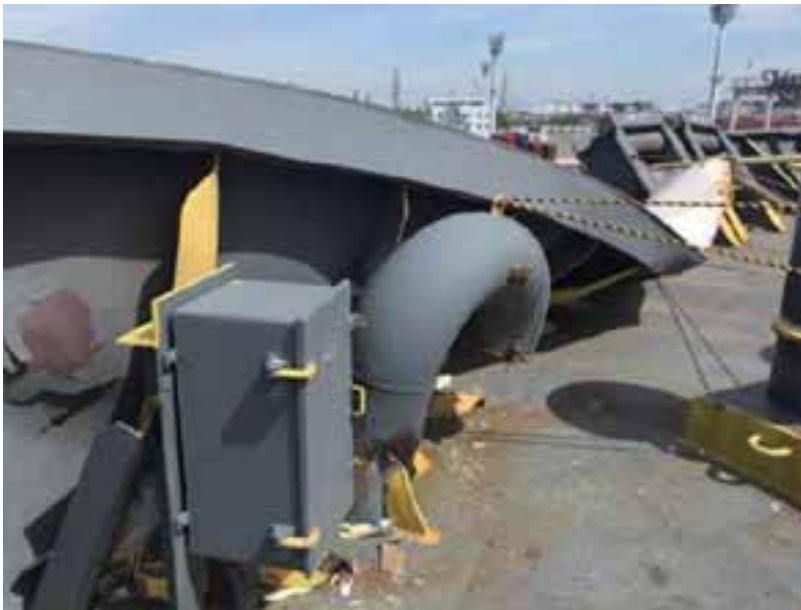
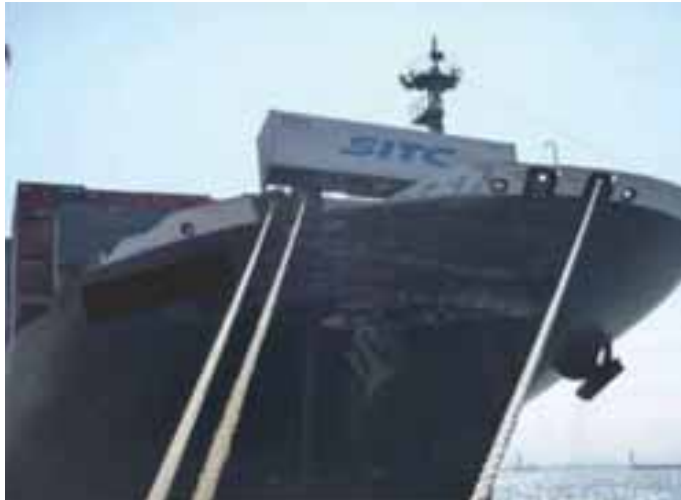
Photograph 26

Vessel A was damaged due to a bent and dented bulwark at the starboard bow with scratched shell plating and concave loss on the bulbous bow. (Photograph 26)

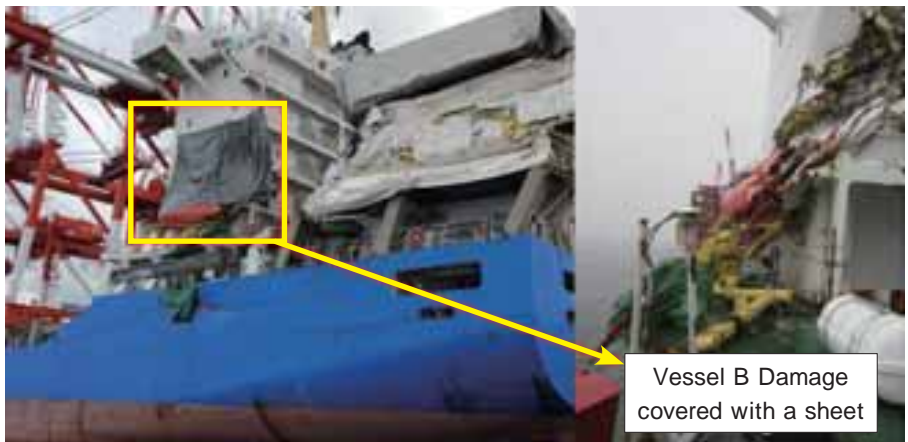
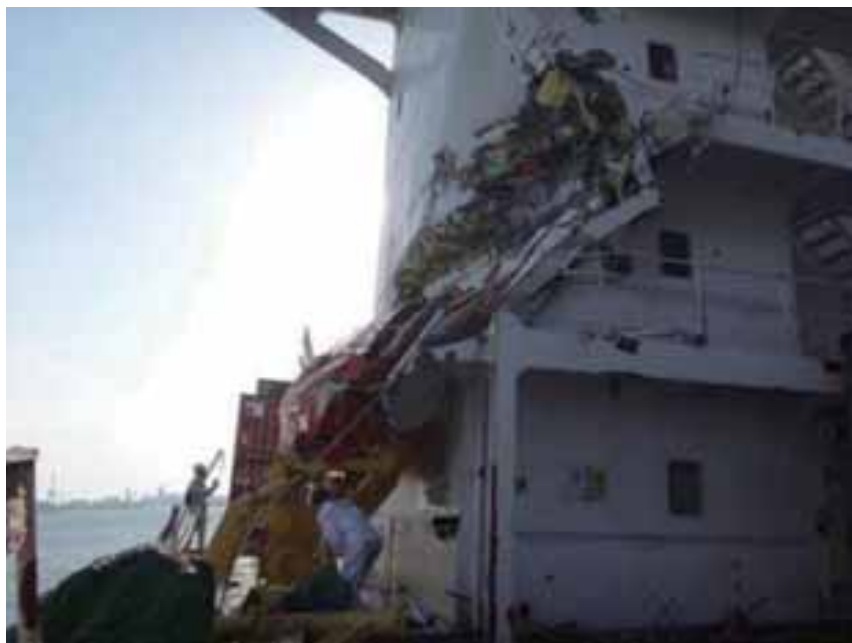
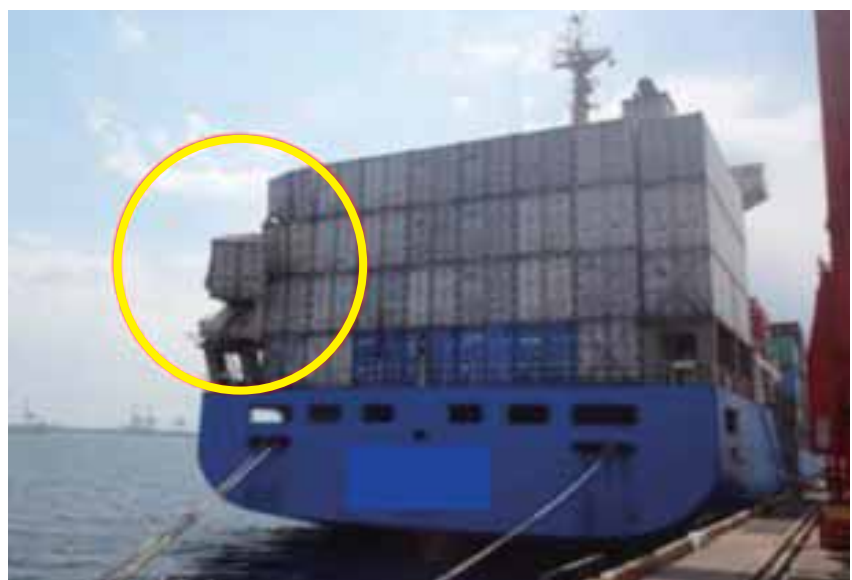
Photograph 27

■As for Vessel B, her accommodation spaces at the astern of port side and the shell plating on the port side was cracked.(Photograph 27)
