5 - 2 Summary and Damage Sustained to a Vessel (Cargo ship E)

5 - 3 Summary of Oshima Bridge (Figure 40) and the Damage Sustained (Photograph 41)

§6 4M4(5)E Analysis of Bridge Collision = Accident =

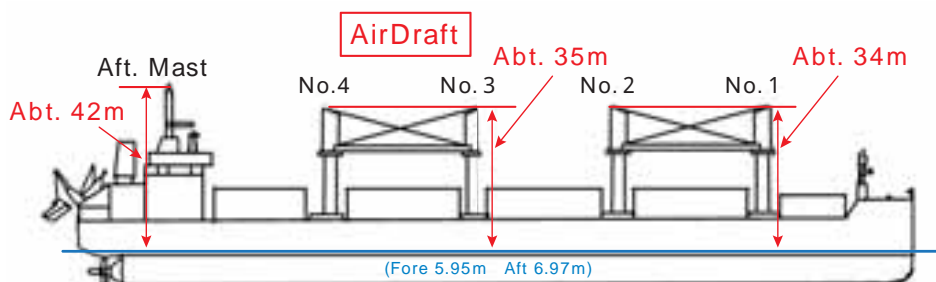
Fig. 38

No.1, No.2, No.3 cranes and the aft mast sustained damage. Air Draft (height from the water surface) is as shown in Figure 38.

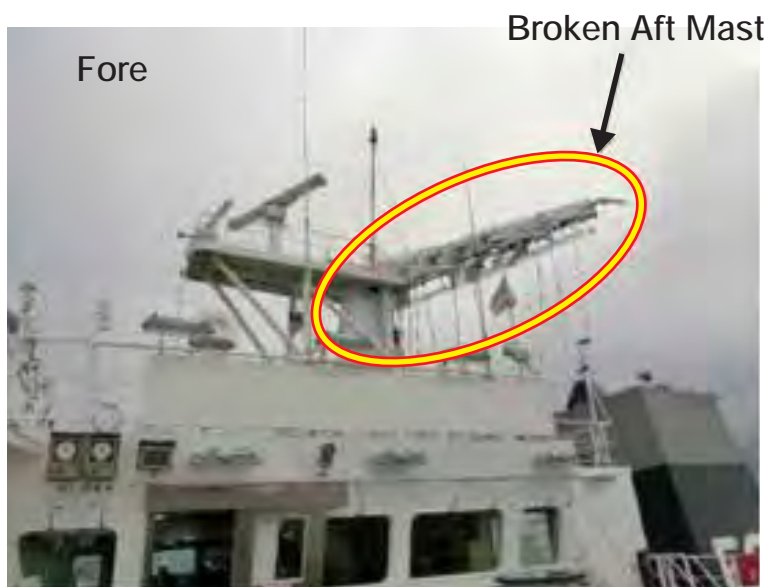
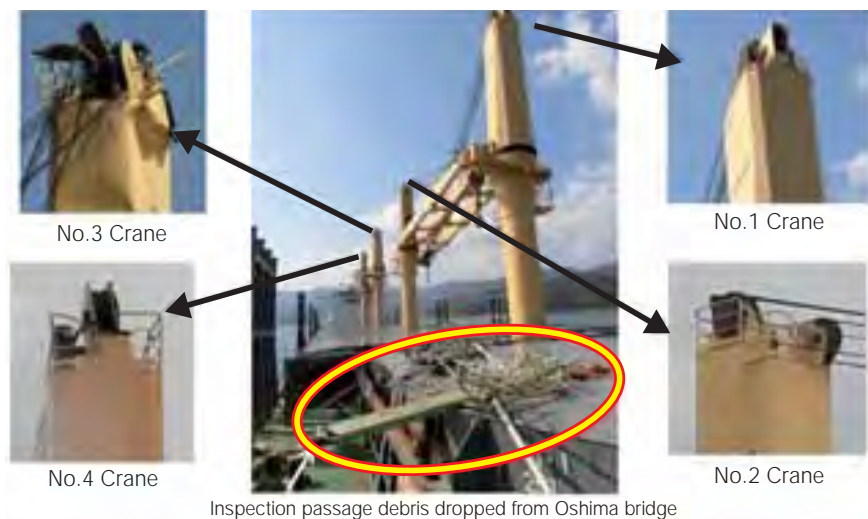
Photograph 39

Figure 39 illustrates damage sustained.

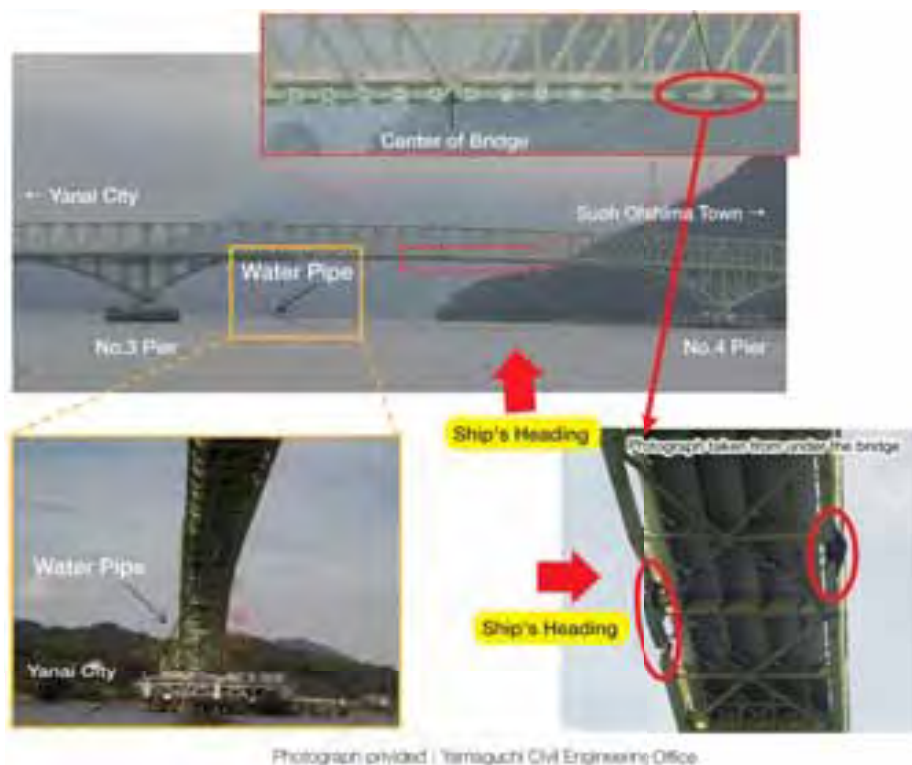
Photograph 41

Bridge sustained cracks and depressions in the bridge girders, and an inspection corridor which was situated under the girders dropped down damaging a water mains pipe, power and communications cables etc.

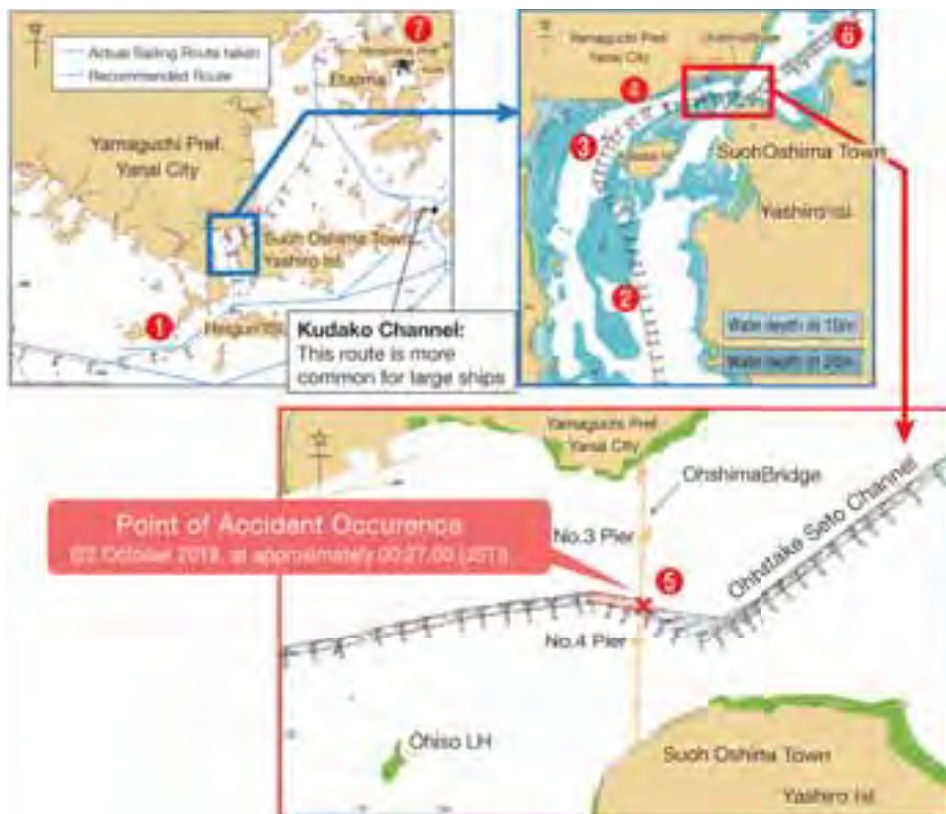
Fig. 42

On the day of the accident, at around 22:00 on October 21, Master E ascended the bridge in the vicinity of Figure 42 in preparation for navigating the Obatake-Seto channel, and commenced ship handling command.

At 00:00 on October 22, the duty was taken over by 2/O E at the point of 1 nautical mile south of Kasasa-jima.
