§5 Case Study Bridge Collision Accident

Reference : Japan Transport Safety Board Report (MA2019-10-2)

Let's analyse the Ōshima Bridge Damage in Yamaguchi Prefecture that occurred on October 22, 2018.

5-1 Accident Summary

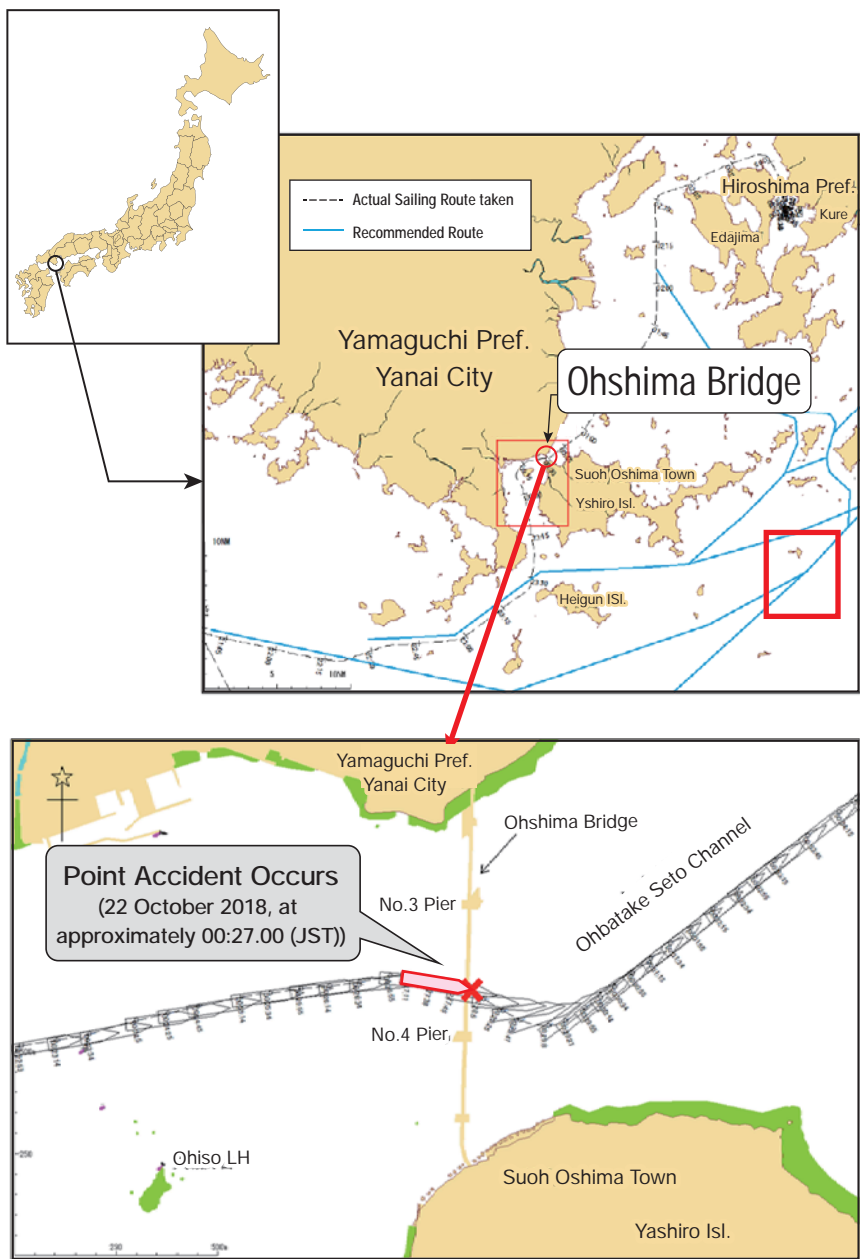
Fig. 24

On the 22nd of October 2018, at approximately 00:27 (JST), Cargo ship E (25,431 G/T) collided with Ōshima Bridge while navigating Obatake-Seto channel, heading from the port of Onsan (South Korea) to Etajima of Hiroshima Prefecture (navigating to the east). 3 cranes out of 4 on the vessel sustained damage. On the other hand, Ōshima Bridge sustained cracks and depressions in the bridge girders, and a water mains pipe ruptured as a result of the inspection corridor dropping down on it. Consequently, all areas of Oshima Town suffered approximately 40 days without water, and in addition, power cables and communications cables were also damaged.

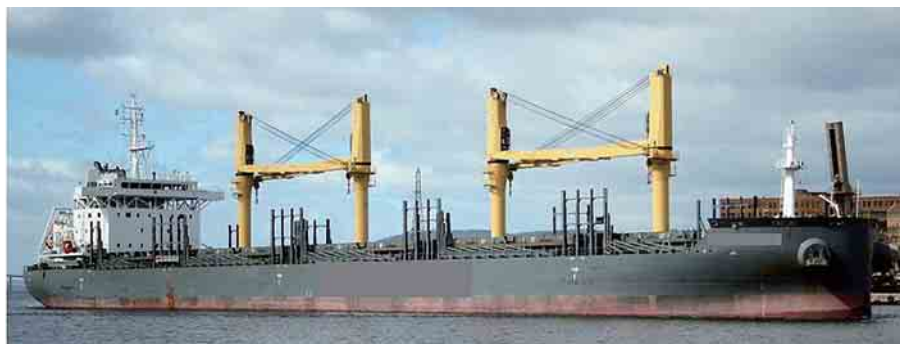
Photograph 8

Gross tonnage	: 25,431 G/T
L×B×D (Length)(Breadth)(Depth)	: 180m×30m×15m
Port of origin	: The port of Onsan (Korea) on October 19, departed at 08:30
Port of destination	: Etajima, Hiroshima Prefecture Private berth
Cargo	: Oxidized aluminium Approximately 6,300KT
Draft	: Fore 5.95m Aft 6.97m
Crew arrangement	: Total number of 21(12 Indonesian, 4 Filipino, 2 Russian, 1 Turkish, 1 Indian and 1 Ghanaian)
Ship's Bridge on duty personnel at the time of the accident.	: Master E, 2/O E and AB E
Master E	: Indonesian national at the age of 44 joined as crew in 1998 and became Master in 2016 with a crew change at Qingdao (port before last) on October 16. He had a great deal of experience manoeuvring in the Seto Inland Sea area as a Master, but it was his first time to manoeuvre in the Obatake-Seto channel.
2/O E	: Indonesian national at the age of 26 joined as crew in 2012 and boarded Vessel E from July, 2018. It was his first time to serve on board as 2/O.

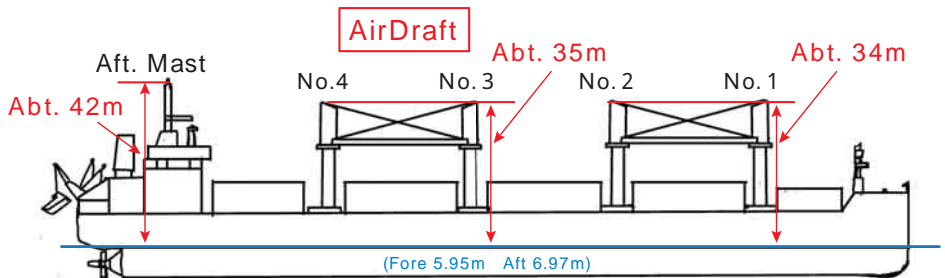
Fig. 25

No.1, No.2, No.3 cranes and the aft mast sustained damage. Air Draft (height from the water surface) is as shown in Figure 25.

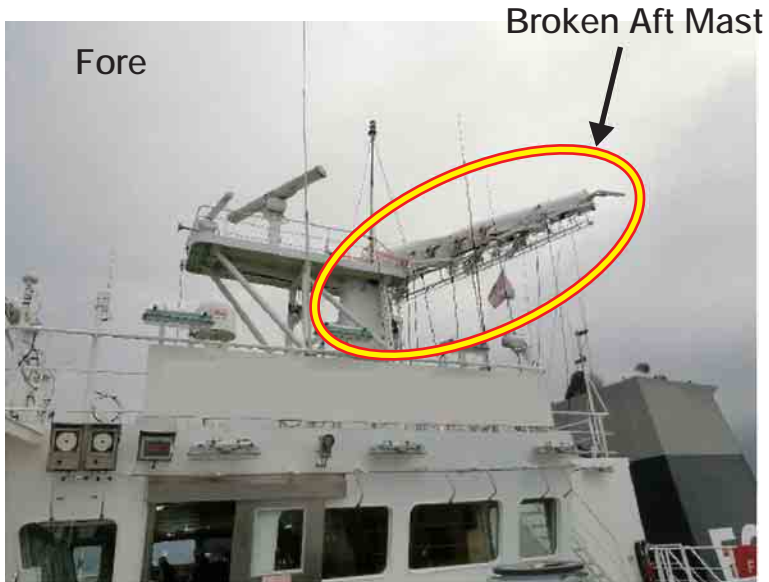
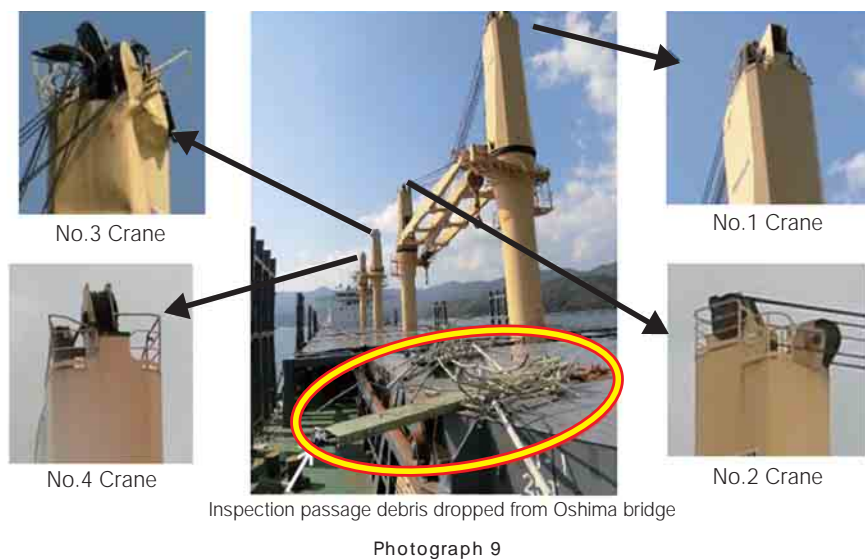
Air Draft (Fig. 25) and Damage (Photograph 9)

Photograph 9 illustrates damage sustained.

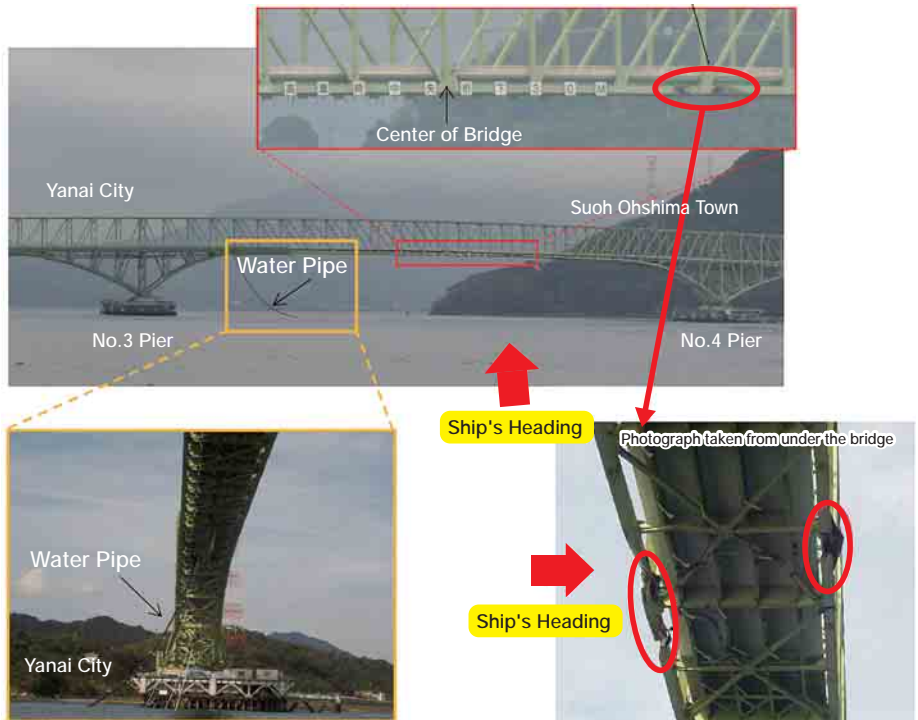
Photograph 10

Bridge sustained cracks and depressions in the bridge girders, and an inspection corridor which was situated under the girders dropped down damaging a water mains pipe, power and communications cables etc.

In almost all parts of Suo-Oshima Town, 9,046 houses and 14,590 residents and local industry suffered approximately 40 days without water. In addition, in a part of Suo-Oshima Town, there were problems such as a temporary power outage, interruption of Internet connections and mobile phones, and electrical equipment such as bridge lights and so on.

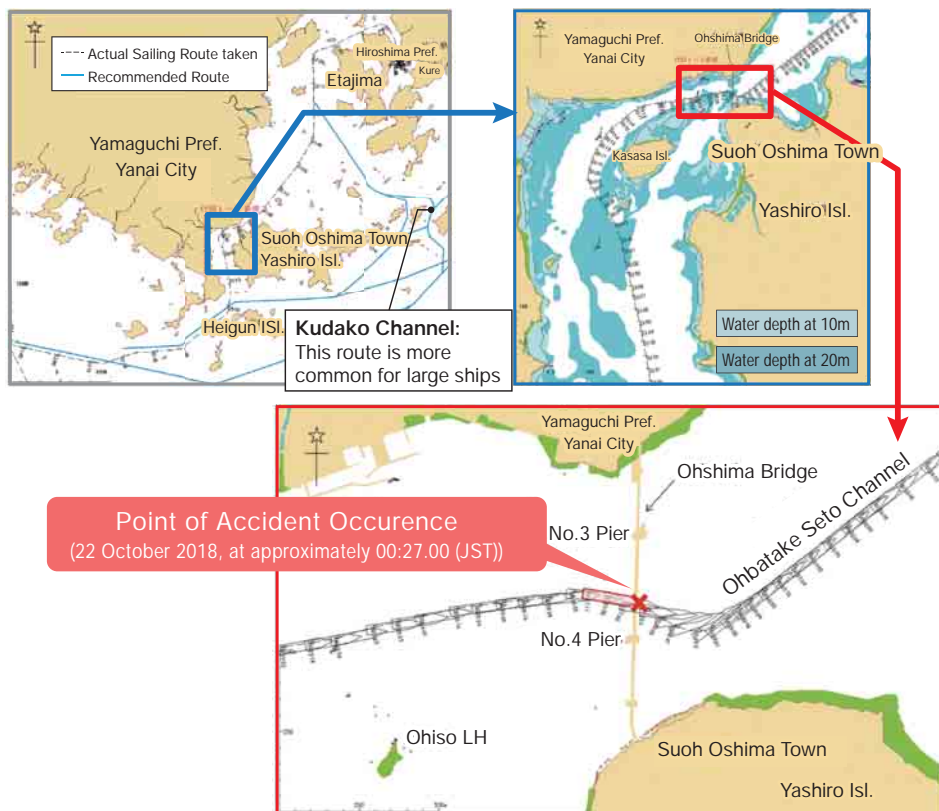
Fig. 27

Timelines and sailing route that led to the accident are summarised in Figure 27 and Table 28.

On the day of the accident, at around 22:00 on October 21, Master E ascended the bridge in the vicinity of Figure 27 in preparation for navigating the Obatake-Seto channel, and commenced ship handling command.

At 00:00 on October 22, the duty was taken over by 2/O E at the point of 1 nautical mile south of Kasasa-jima.

As Master E felt uneasy about the height of the Ōshima Bridge, he ordered 2/O E to confirm it. But he continued navigating. 2/O E tried in vain to ascertain information, regarding the height of the bridge beam using pilot directions and the ECDIS.

00:27 (approx.) on October 27, the Vessel collided with Ōshima Bridge. Master E tried to make a call to the agency but no one answered at all. Master E kept navigating because it seemed that there was no appropriate point of anchor in the vicinity and at 04:00 (approx.) he finally anchored off the Port of Kure.

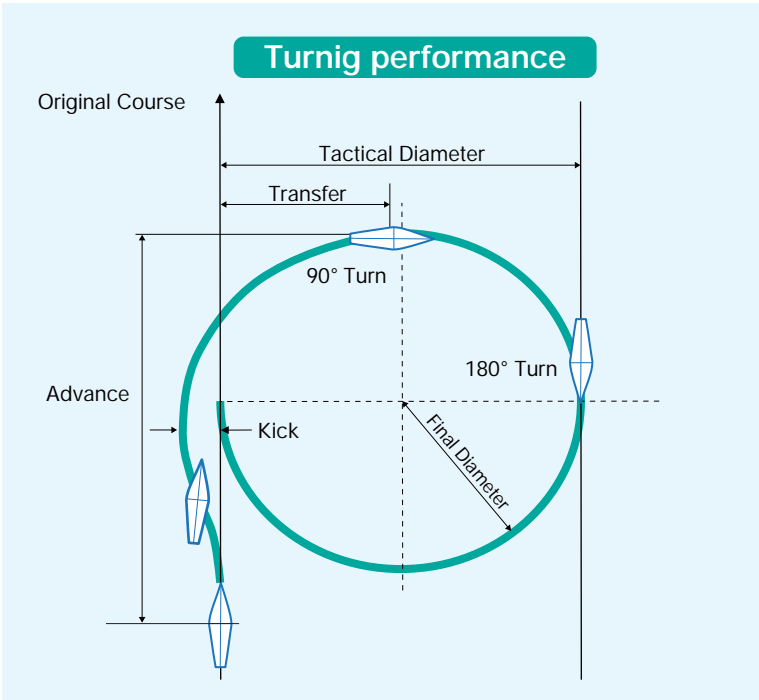
Fig. 36

The ship’s Sea Trial Results and the Turning and Stopping performance displayed on the bridge are as follows:

When operating full speed sternway during employing full speed ahead (14.3 knots), the distance forward until stopping the vessel was 2,116 meters and its time taken was 9 minutes and 53 seconds.
