# §4 Case Study of Oil Spillage Accidents

## 4-1 Oceangoing Vessel Case

Ship type: General cargo ship  
approx. 19,000 G/T

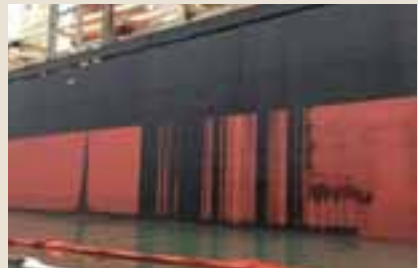
Photograph 9: Hull Spoilage of Vessel After Accident

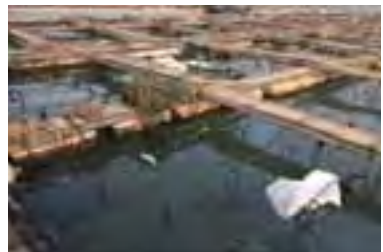
Photograph 11: Damage to Fishing Facilities

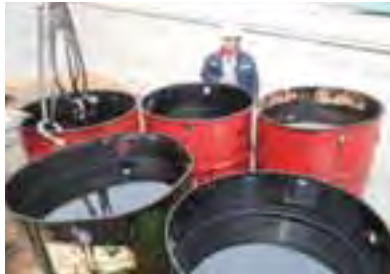
Photograph 12: Fuel Oil Recovered from the Deck

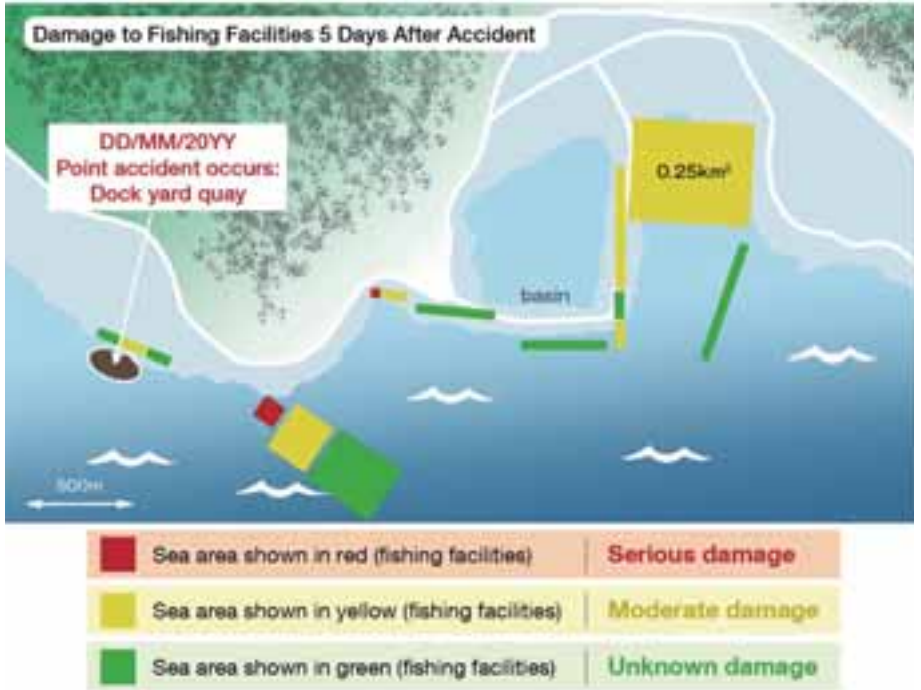
Figure 15: Damage to Fishing Facilities 5 Days After Accident

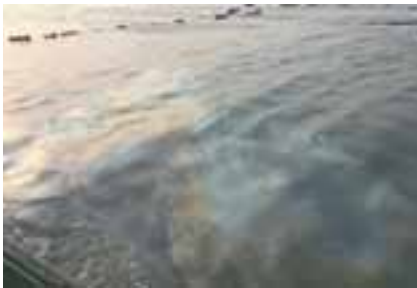
Photograph 15: Fuel Oil Spilled on the Sea

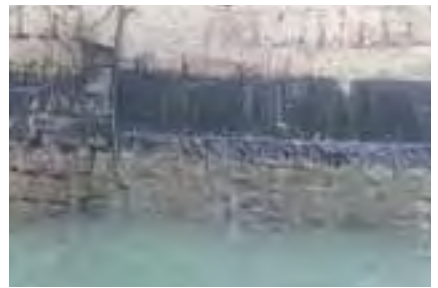
Photograph 16: Fuel Oil Washed Ashore against Seawall

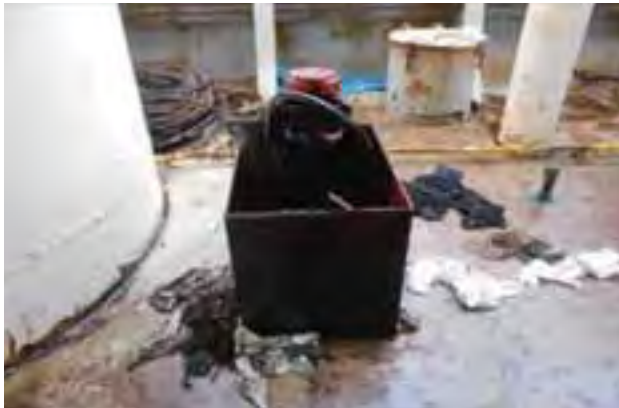
The direct cause was that the filling valve of the No.2C FO tank, which had not been scheduled to be bunkered, was not “fully closed” for some reason, but was slightly open, so that fuel from that tank entered the No.2C FO tank and overflowed through the air vent. In addition, the direct cause of the fuel oil spill overboard was, as mentioned above, according to calculations following the accident, a delay in noticing the spill from the air ventilation (no one noticed it for 22 minutes after the start of the spill) and a failure to make an emergency stop in time.

Photograph 17: No.2 C FO Tank Air Vent.

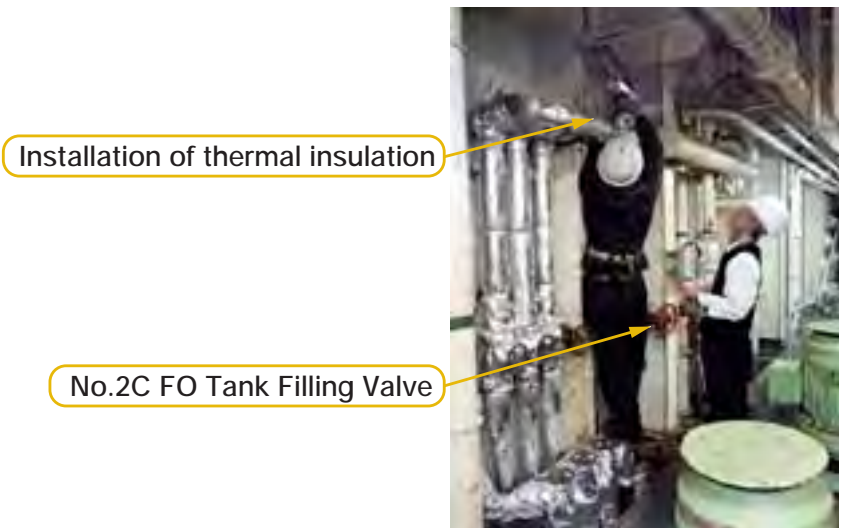
- **After the last refill of No.2C FO tank, the filling valve was confirmed as being closed.**
- **The fuel warm-up steam pipeline equipped above the filling valve of each fuel tank in the engine room was repaired, including the installation of insulation, as dock work.**
- **Under normal circumstances, a stepladder should be used to carry out repairs. The pipe work was carried out using a stepladder scaffolding, but the subsequent work of fitting the insulation only was simple enough for a dock worker, who was not in charge of the pipe work, who climbed over the Filling Valve of No.2 FO Tank by putting his foot on it.**
- **It is assumed that the closed valve was opened at that time.**

Photograph 18: Insulation Installation

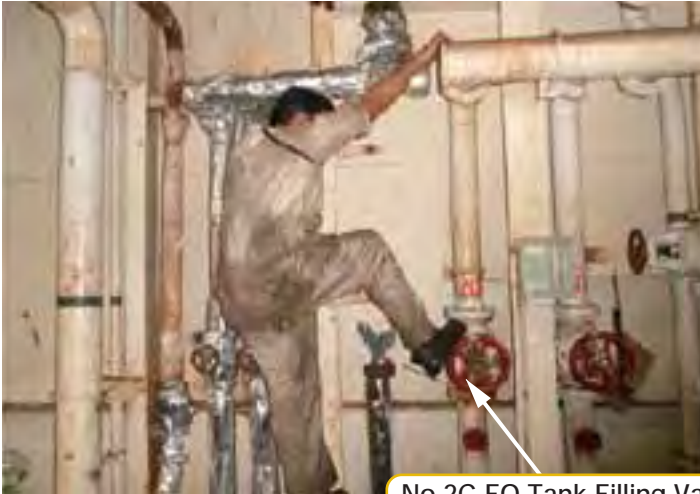
Photograph 19: Reason Why No.2C FO Tank Filling Valve Opened

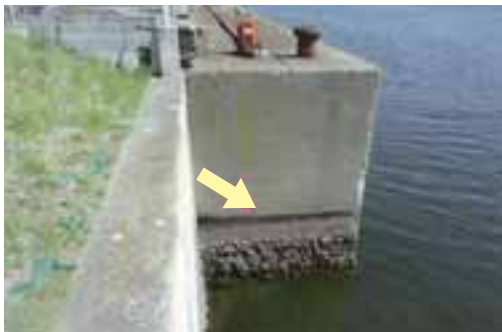
Photograph 22: Seawall Spoilage by Oil Washed Ashore

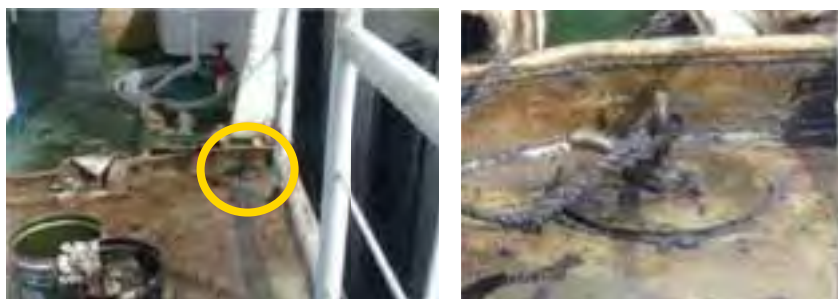
Photograph 23: Seawall Scupper Spoilage Caused by Oil Leakage

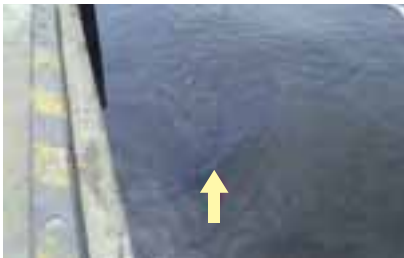
Photograph 26: Spilled Oil on Sea Surface

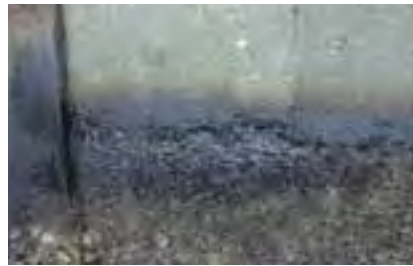
Most of the spilled oil was recovered by the evening of the day of the accident, but some was spread by the current. Later, the oil reached a seawall and the inside of a quay apron within a radius of approx. 3 km. It took 16 days to spread the oil and clean up the damaged seawall, resulting in a loss of almost the same amount as that of the first day's recovery service fee. Fortunately, fishing facilities were not damaged.

Photograph 27: Quay Wall Spoilage

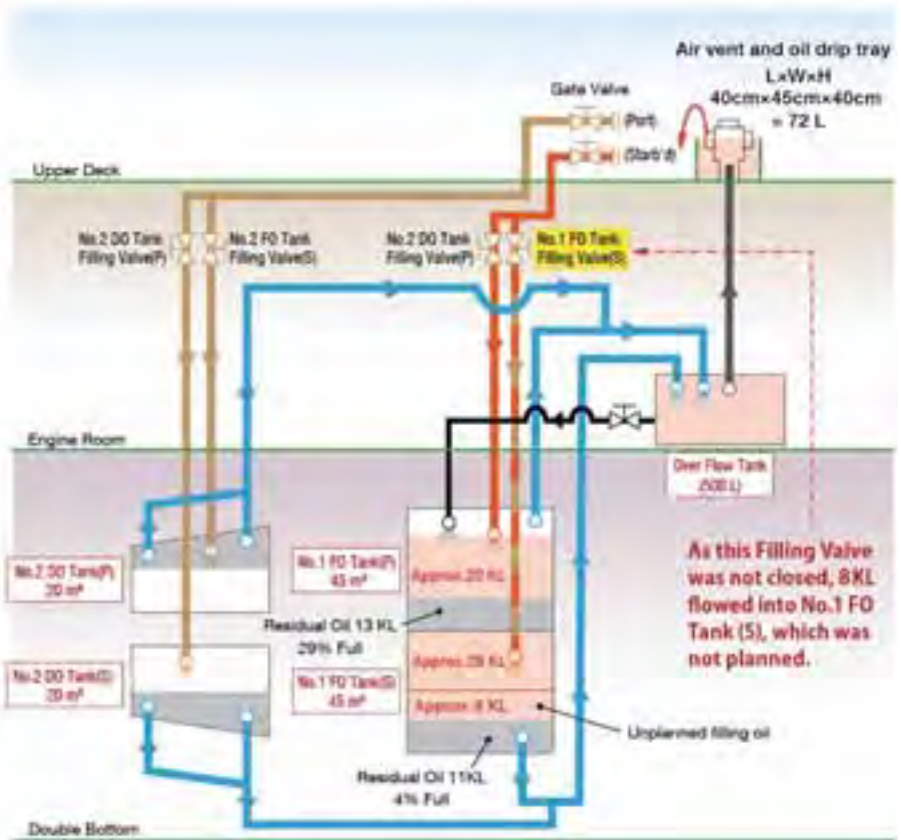
Figure 17: Pipeline for Bunkering and Arrangement of Tanks

The original plan was to receive 27 KL of C-type fuel oil in No.1 FO Tank (on the port side) and then switch the valve to receive the remaining 28 KL in No.1 FO Tank (on the starboard side). However, the filling valve on the starboard side was open and approximately 8 KL that was supposed to go into the port tank went into the starboard tank. Without noticing this error, when a further 28 KL was added to that (into the starboard side tank), it overflowed. Figure 17 illustrates this pipeline.

- ▶ At 09:10, C-type fuel oil bunkering started and the No.1 FO Tank (P) with 13 KL of residual oil started receiving 27 KL as originally planned.
- ▶ However, as Filling Valve of No.1 FO Tank (P) was not fully closed, some of the pumped C-type fuel oil (7-8 KL) flowed into No.1 FO Tank (S) with residual oil at 11 KL.
- ▶ At 09:30, the Chief Engineer received a report from the barge that 27 KL had been pumped and assumed that the total amount of oil had been pumped to No.1 FO Tank (P) as scheduled. So he did not carry out confirmation sounding. After opening the filling valve of No.1 FO Tank (S) and closing the filling valve of No.1 FO Tank (P), starting to receive the remaining 28KL.
