中国 Lanshan 港 ・養殖場の拡張が付近航行船舶に及ぼす危険性について一追加情報

Circular Ref No.: PNI1305

Date: 13 Dec 2013

Subject: Update on Expanding of Local Fishery Farms Which Brings Danger to Safe Navigation of Vessels at Lanshan port, China ---- Follow-up Advice

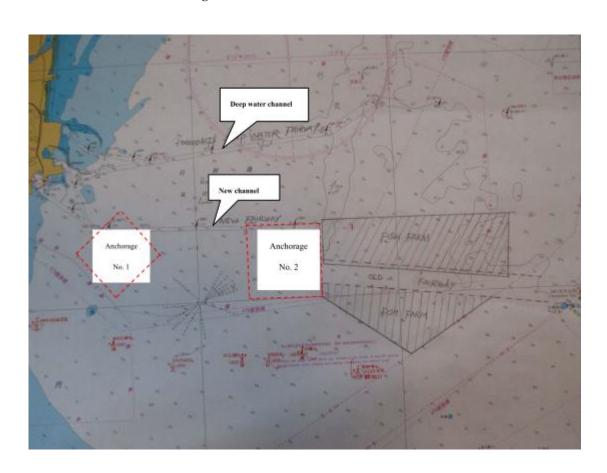
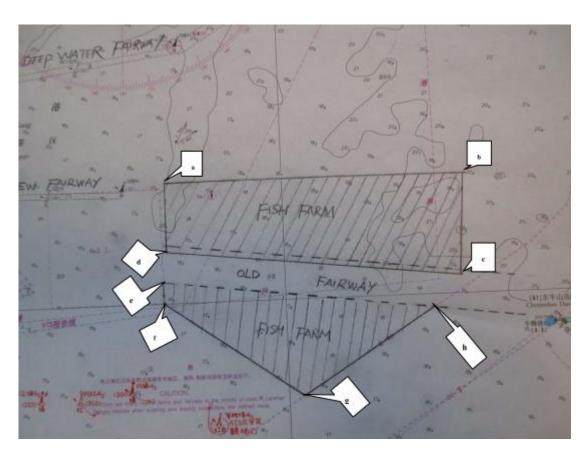
養殖場の正確な位置は不明ですが、2013年1月~11月の養殖場損傷ケース、そして現地養殖業者に対する調査の結果、養殖場の現在の位置は以下の略図の通り、拡張しているものと推測されます。

- a. Lat. 35-03.2N / Long. 119-36.3E
- b. Lat. 35-03.2N / Long. 119-45.8E
- c. Lat. 35-00.5N / Long. 119-45.6E
- d. Lat. 35-01.3N / Long. 119-36.3E
- e. Lat. 35-00.0N / Long. 119-36.0E
- f. Lat. 34-59.2N / Long. 119-36.0E
- g. Lat. 34-57.4N / Long. 119-40.6E
- h. Lat. 34-59.6N / Long. 119-44.6E

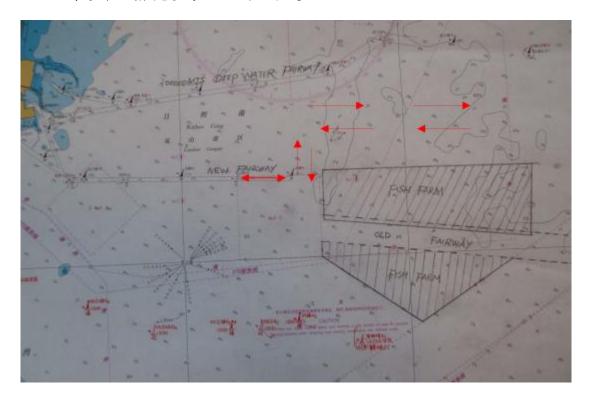
これまでの航路(旧航路)は No.2 錨地の東側に位置していますが、同航路の両側には多くの養殖場が存在することから、MSA は最近では Lanshan 港に寄港する船舶に対して養殖場の北側を通って No.2 錨地に向かうことを推奨しています。また、MSA は Lanshan 港に寄港する船舶に対し、VTS に連絡をとり、 VTS の指示に従って航行するよう強く推奨しています。

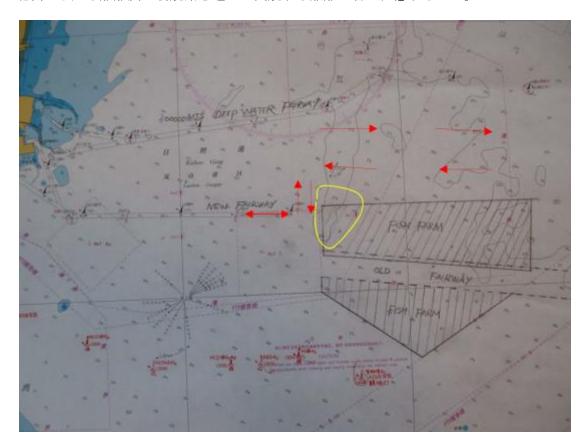
- 1) 過去数カ月のクレーム発生状況をみると、旧航路の両側及び No.2 錨地の東側で養殖場関連のクレームが最も多く発生していることが明らかであり、付近航行船舶はこれらの海域では特に注意して航行すること。
- 2) Lanshan 港に寄港する際は、新航路に近づく数海里手前の時点で Lanshan VTS に寄港する旨を報告し、必ず VTS の指示に従って航行すること。
- 3) MSA が新航路を導入し、新たな航海ルートを推奨するようになった現在では、養殖場の北西部分(下記略図の円で囲った箇所)が Lanshan 港に寄港する上で最も危険なエリアとなるため、No.2 錨地に養殖場の北側から入る船舶及び新航路を通って出航する船舶は特に注意すること。

- 4) 一般的に、Lat.35-03.2N の北側及び Long.119-36.04E の西側の海域は比較的安全であるため、同海域の航行が推奨される。
- 5) 以下の連絡先で Huatai Qingdao にアシストを求めることができます。

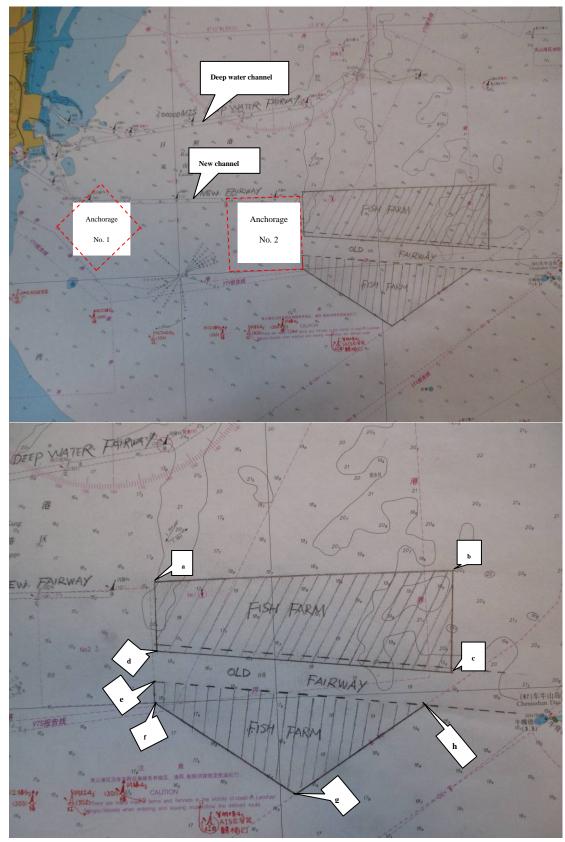
Fishery Farm Areas

Although the official exact boundary of fishery farms is unavailable to us, according to our experiences of handling fishery farm damages cases during the past several months (Jun ~ Nov 2013) and our recent enquires with the local fishery farmers, the current boundary of the fishery farms is prudently estimated to have expanded as per below sketch for your reference only:

- a. Lat. 35-03.2N / Long. 119-36.3E
- b. Lat. 35-03.2N / Long. 119-45.8E
- c. Lat. 35-00.5N / Long. 119-45.6E
- d. Lat. 35-01.3N / Long. 119-36.3E
- e. Lat. 35-00.0N / Long. 119-36.0E
- f. Lat. 34-59.2N / Long. 119-36.0E
- g. Lat. 34-57.4N / Long. 119-40.6E
- h. Lat. 34-59.6N / Long. 119-44.6E

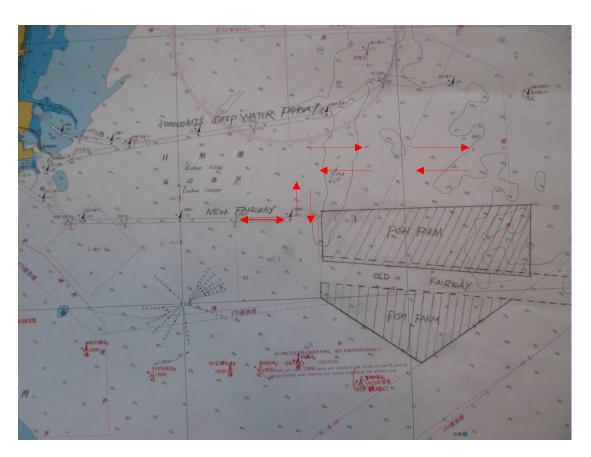
In light that the old recommended fairway is to the east of Anchorage No.2 and there are large quantity of fishery farms on both sides of the old fairway, MSA recently started to become inclined to recommend that, instead of entering into Lanshan port through the old fairway, vessels had better sail to anchorage No. 2 through the waters northern to the fishery farms area, in addition, MSA strongly suggests vessels calling Lanshan port keep close communication with VTS and proceed as per VTS's guidance.

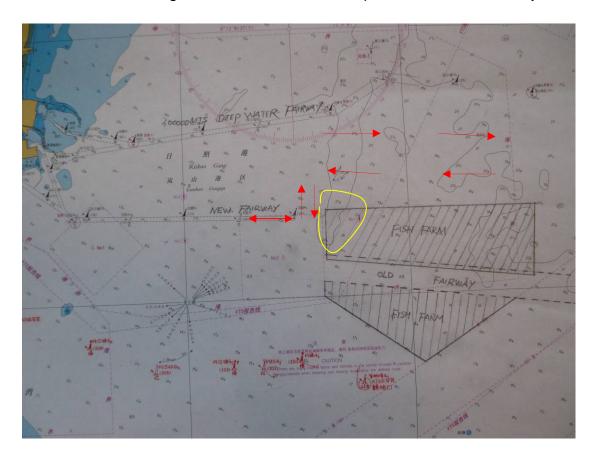
The fish farms on both sides of the old fairway and east of the anchorage No.2 are the most frequent locations where fishery farm claims occur according to our observations in the past months, which vessels should pay special attention to when sailing in the nearby area.

- 2) It is suggested that the vessels calling Lanshan port report to VTS several miles before her arrival at the east end of the new channel and strictly follow the guide of Lanshan VTS.
- 3) Since MSA recently adopted the new fairway and suggested new navigation route, the North-West part (marked with yellow line in below sketch) of the fishery farms now became the most dangerous place for ships calling Lanshan port, hence, it is recommended that the ships should pay particular attention when the inbound ships enter anchorage No.2 from the north of fishing farms or the outbound ships leave the new fairway.

- 4) Generally speaking, the navigational waters north of Lat.35-03.2N and west of Long.119-36.04E is relatively safe, hence, it is recommended that this ships had better navigate in the above waters.
- 5) Assistance can always be sought by contacting our Qingdao office at the following details:
