## バルクキャリアー積載貨物の事故防止について

### その1・・・海水漏れ事故

## Prevention of accident damage to cargo loaded on Bulk Carriers

### Case 1) Seawater damage

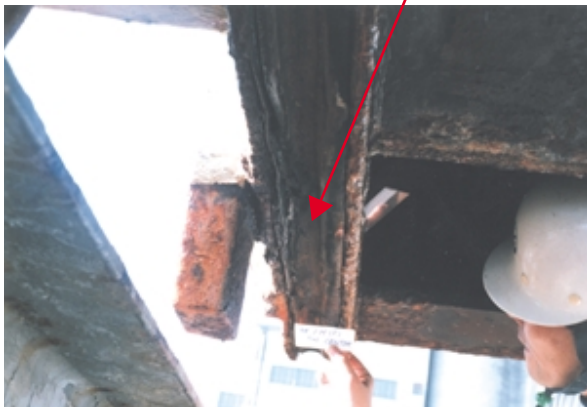
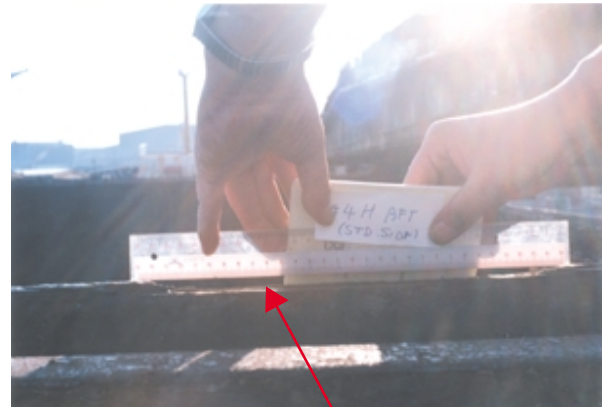
- Rubber gasketが古くなり硬化して弾性を失っているか、Permanent grooveが深くなり Compression barとのコンタクトが弱くなっているか全く接触していない。
- Rubber gasketが部分的に欠落するか破損している。

- Compression bar が曲がっているか一部が破損、又はRust scaleが異常に付着して高さが均等でない。

一般に、耐用年数は4～5年といわれています。経年とともに弾力性を失い永久変形(permanent groove等)を起こしますが、Securing devicesによる締め付け状態で、compression barがgasketに3mm以上食い込むだけの圧縮代が残っていれば、実用上水密が保たれていると言えます。従いまして、3mm以上の圧縮代が残っていないgasketは早急に交換すべきです。又、部分的な欠落・破損等を発見した場合は適切な方法で補修しなければなりません。

一方、手入れの容易な場所でもありますので、barの頂部が常に円滑な半円形を保つように保守点検を行います。

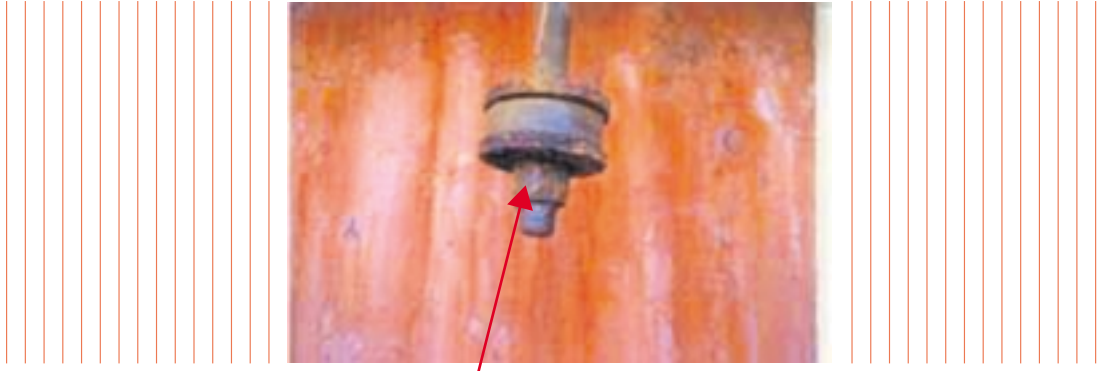
- Quick acting cleatのadjusting nutがboltに錆付き、本船において最近ネジ締め調整を行った形跡がない。
- Quick acting cleatが破損・曲損・紛失している。

Bolt に錆付いたAdjusting nut

Quick acting cleat本体が曲損・変形及び紛失している場合、新替は勿論のこと、steel washerが劣化・磨耗している場合及びrubber washerが硬化して弾力性を失っている場合も、これらを新替すべきです。又、bolt及びadjusting nutには適宜グリース等を塗布し、錆付きを防止する必要があります。

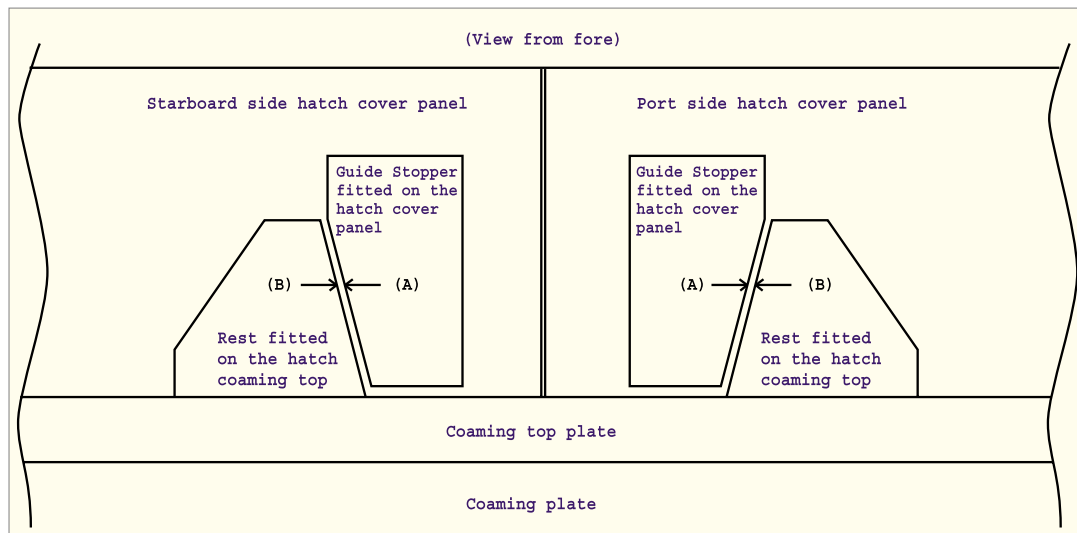
( Side rolling typeの例 )

現在、ほとんどの船舶はhatch cover securing deviceの一装置として上記図の如くGuide stopper及びRestが設置されており、その仕組みは下記の様になっています。

Guide stopper及びRestの傾斜(両者の接触面)とhatch coverの自重を利用して、Side rolling typeのhatch coverにおいては両舷のpanelsが、Folding Type(船首方向2枚、船尾方向2枚のJack knife type)においては前後のペアが互いに強く密着する仕組みになっています。従いまして、このGuide stopper及びRestの接触面(A)及び(B)が著しく磨耗すると互いのPanelの密着力が弱くなり、隙間が生じて海水が浸入することになります。

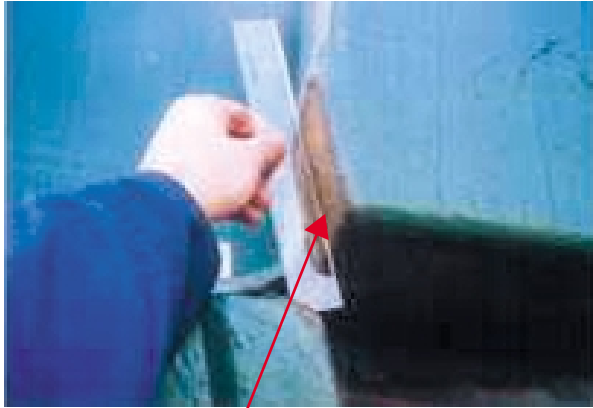
著しく磨耗したGuide stopper

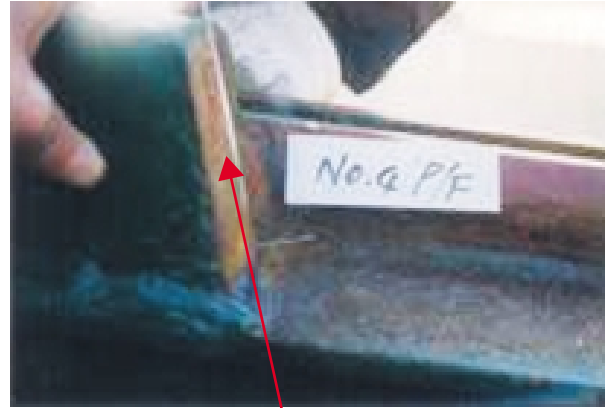
著しく磨耗したRest

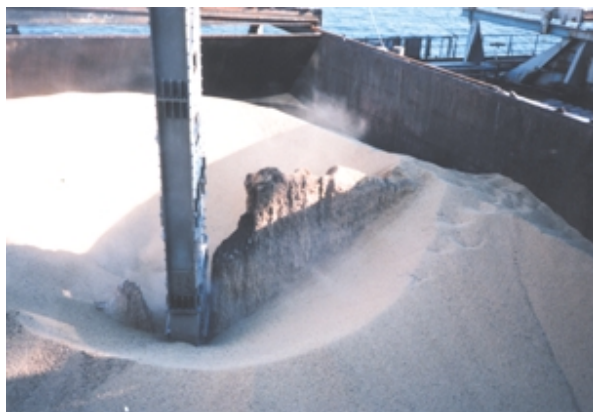
穀物類を積載した本船船倉内に、上記理由により海水が侵入した場合は、Coaming plate 内面に顕著な海水侵入の形跡が発見され、Panel接合部直下の貨物表面には帯状となった濡損貨物が、Hatch corners部には団塊状の濡損貨物が発見されます。

Side rolling typeのhatch cover で、両舷 Panels 接合部(本船Center line)直下貨物表面の受損状態。

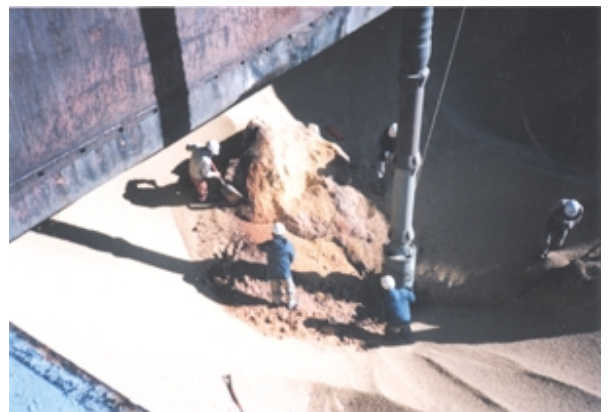
受損部分は柱状となり、Tank topまで達すると共にTank top全面に亘って拡大する場合があります。

船倉内中層部の損害貨物の状態

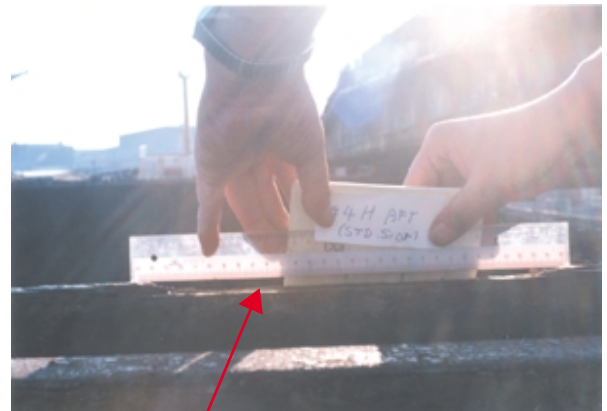
- Rubber gaskets become stiffened, lose elasticity, permanent grooves are deepened, and as a result, the strength of the contact between rubber gasket and compression bar becomes weak or they are not contacted.
- Rubber gaskets are partly missing and/or broken

- Compression bars are partly broken and/or bent, and uneven with rust scales

Though elasticity is inevitably lost with the lapse of years and permanent deformation (such as permanent groove) will start, if the compression margin when the compression bar is fitted into the gasket is more than 3mm on tightening with the securing devices, it is said that sufficient watertightness remains. Therefore, when the compression margin becomes less than 3mm, the gasket should be changed immediately, and also if the gasket is found to be partly broken or missing, it must be repaired by the proper method.

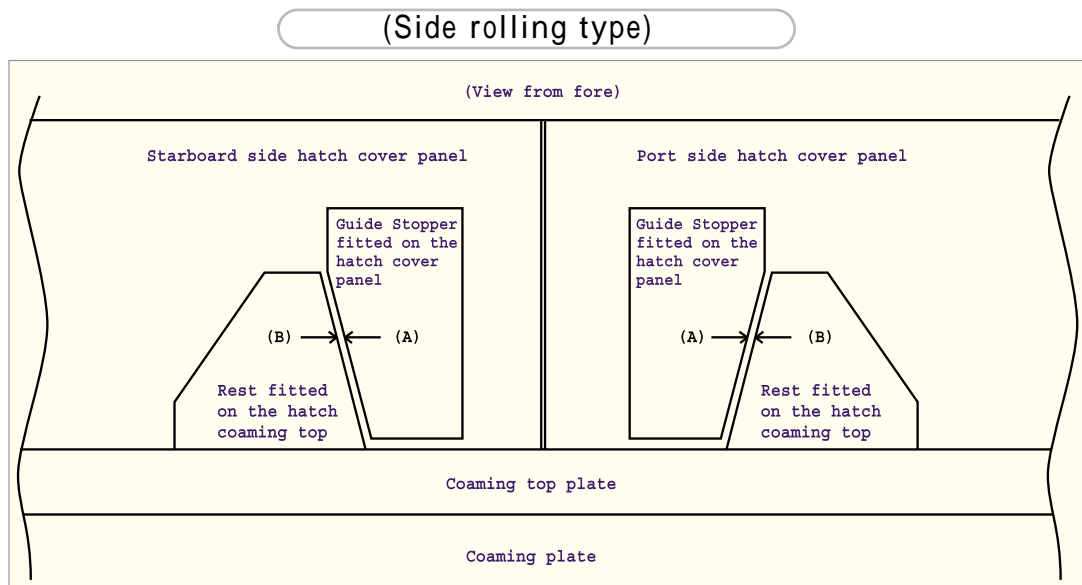
These days, most vessels are fitted with rests on the coaming top, and guide stoppers on the side/ end plates of the hatch cover panel as securing devices, as shown in the above sketch, and they work as follows :-

On hatch covers of side rolling type, the panels of both sides are held against each other strongly, and on folding type covers (two panels each fore and aft ; Jack Knife Type), the fore and after pairs are held against each other strongly, by a function of the slant (contacting) faces of the guide stopper and rest and the weight of the hatch cover panels. Therefore, if the contact faces of the guide stopper (A) and rest (B) are heavily worn-down, the strength of the contact between the panels becomes weak, and a gap(s) is created, allowing entry of sea water into the hold.

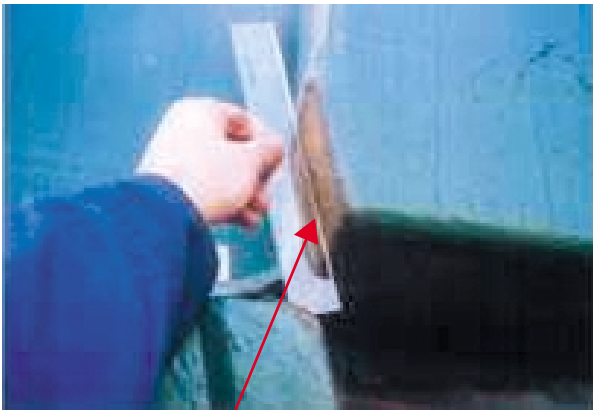
Showing heavy wear down at the contact face of the guide stopper

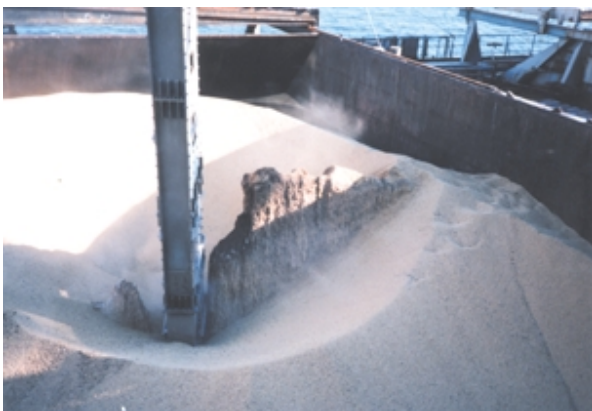
When seawater enters a vessel's hold laden with grain, as a consequence of such defects, remarkable trace showing seawater invasion are found on the inner side of the hatch coaming plate, and strip-shaped wet damaged cargo are found on the top surface just under the joins of the hatch cover panels, and lumps of wet damaged cargo are found at the corners of the hatch coaming. The damaged cargo may form pillars that reach the tanktop plate, and it may spread over the whole area on the tanktop plate in some cases.

Showing damaged cargo in the top surface just under the join of the hatch cover panels (Side rolling type)
