The Japan Ship Owners' Mutual Protection & Indemnity Association Loss Prevention and Ship Inspection Department

CASE STUDY

P&I Loss Prevention Bulletin

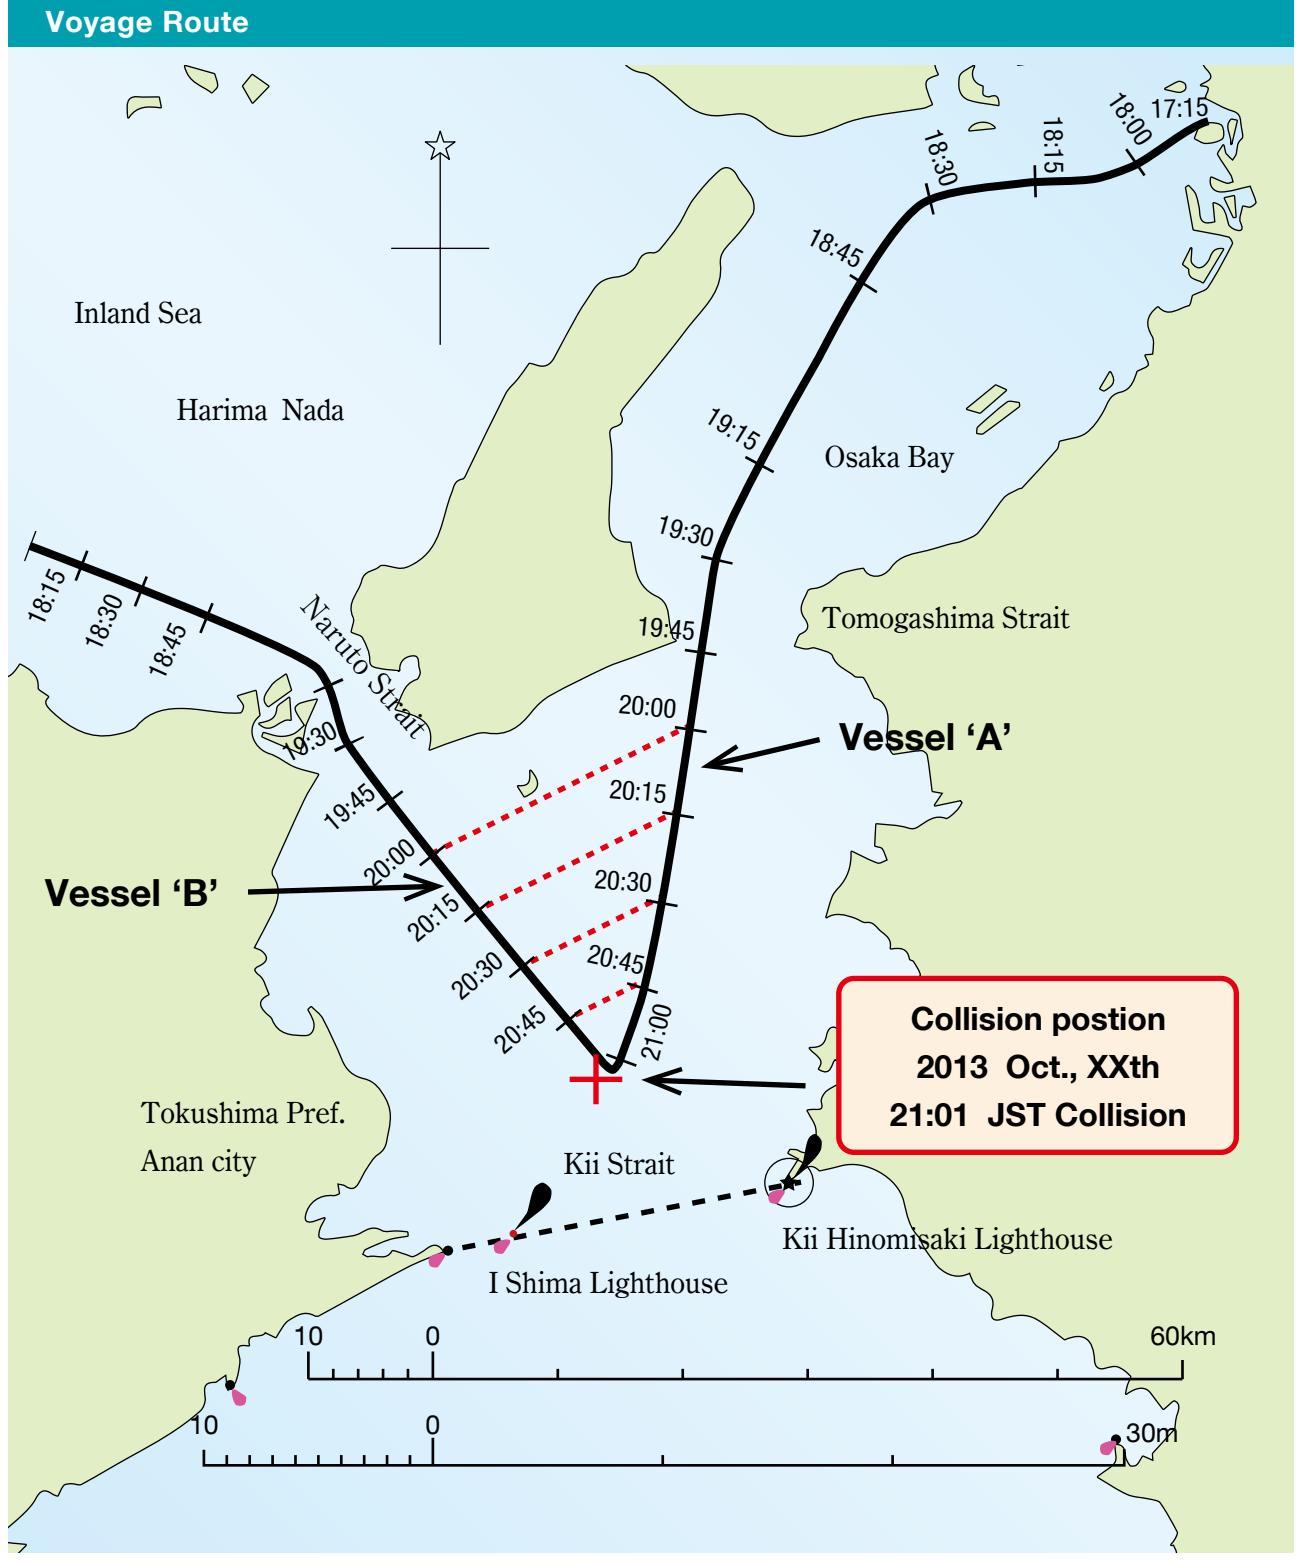
Fig. 17 Voyage Route

As a result, both vessels kept closing head-on to each other. Although it steered immediately to avoid collision immediately before the collision, the starboard side bow of Vessel A collided with the port side astern of Vessel B. Both vessels sustained damage to the hull, however, there were personal injuries. Please see Figs. 17, 18 and 19 and Table 20 for collision details and the actions that were taken by both Vessels.

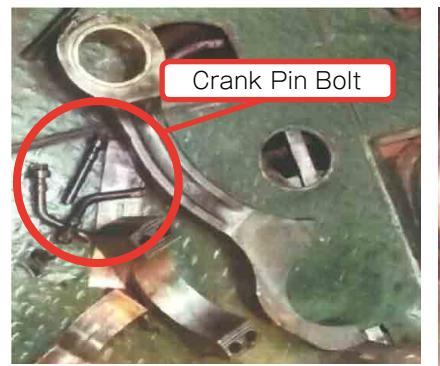
- ① The state of the four crank pin bolts at the large end of the connecting rod of No.7 cylinder are described as follows: (See Reference Picture 34)
 - (a) Two bolts were cut at the stud bolt end
 - (b) The other two bolts sustained bending damage in the middle section
- 2 Broken damage of piston and cylinder liner (See Reference Pictures 35 and 36)
- 3 Burnout of the crank pin bearing metal

Reference Picture 34 Bending loss of connecting rod

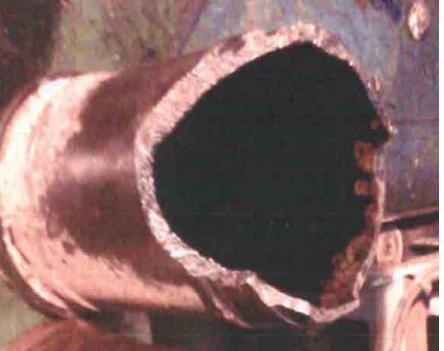
Reference Picture 35 Broken damaged cylinder liner

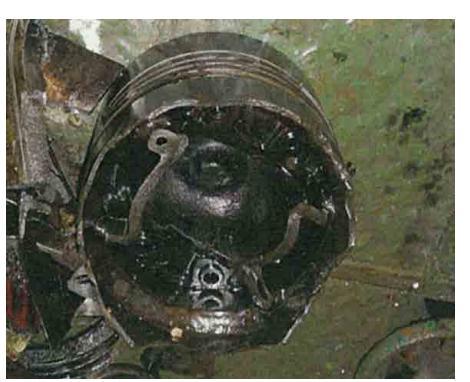
Reference Picture 36 Broken damaged piston

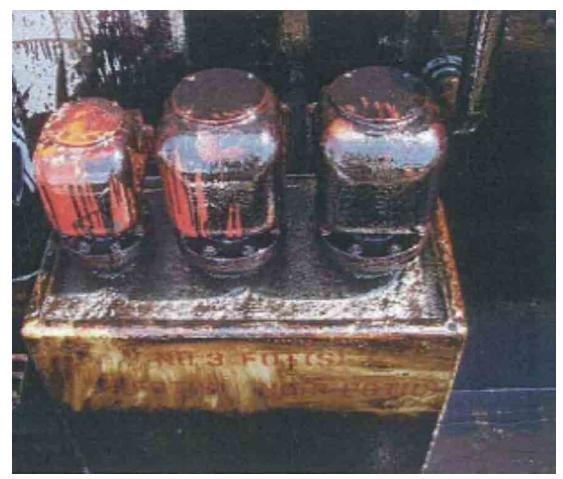
Reference Picture 39 No.3 Fuel oil tank air vent (after overflow)

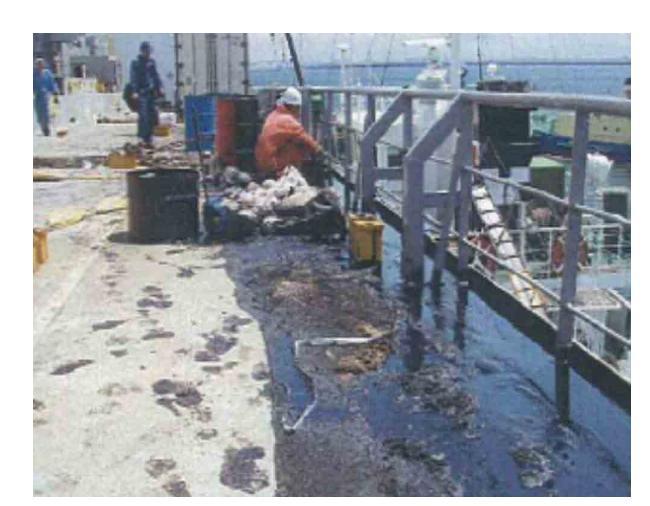
Reference Picture 40 Port side of upper deck

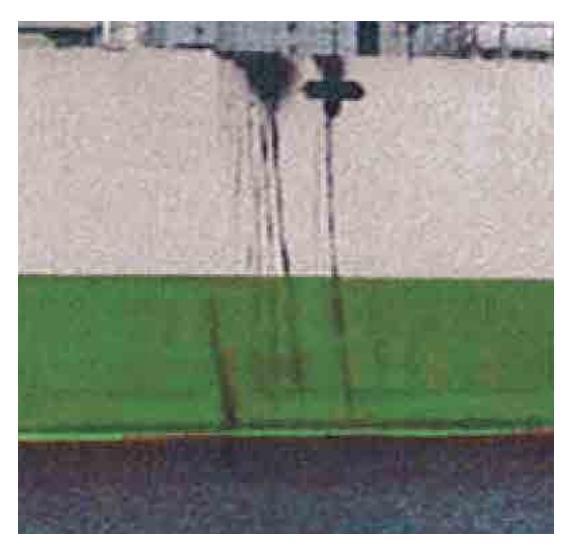
Reference Picture 41 State of oil spill overboarding
