JAPAN P&I CLUB Vol.43 July 2018 P&I Loss Prevention Bulletin

Dragging Anchor

Case Studies and Preventive Measures -

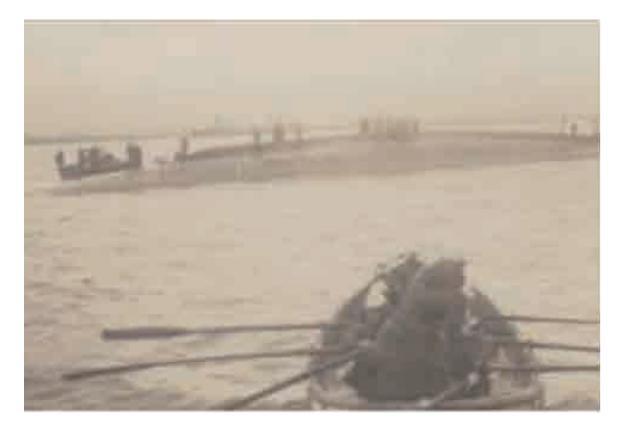
Photograph 35 "Capsized Touya Maru"

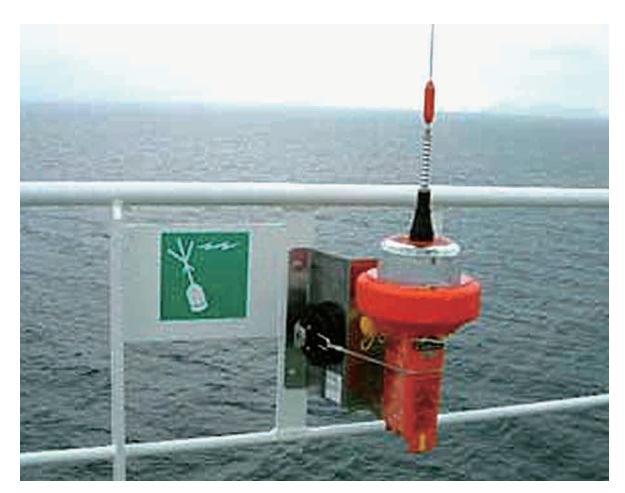
Photograph 55 EPIRB

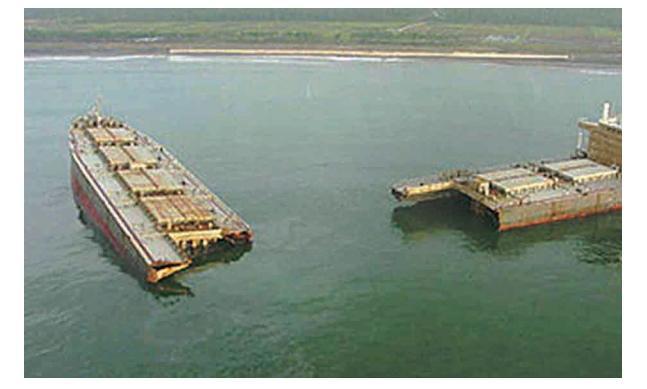
Regarding the damage, cargo holds, between No. 5 and No. 6, near the centre of the hull there was breakage and No. 2 Fuel Oil Tank under No. 5 cargo hold was damaged. Immediately, at the same time as he activated the distress signal by operating the EPIRB, the Master reported the distress to the Japan Coast Guard via international VHF radio communications.

Photograph 56 Breakage

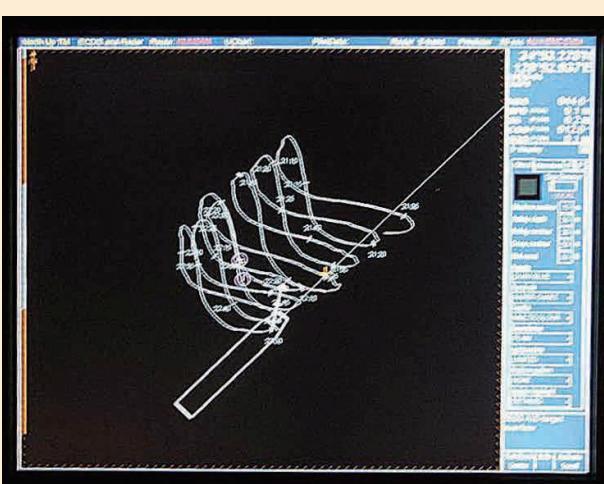
Photograph 64

Photographs 64, 65 and 66 are actual displays of the ECDIS and RADAR when the author was on board the Pure Car Carrier (PCC). It was possible to grasp the actual ship's movement using the ship's position record and the electronic displays.

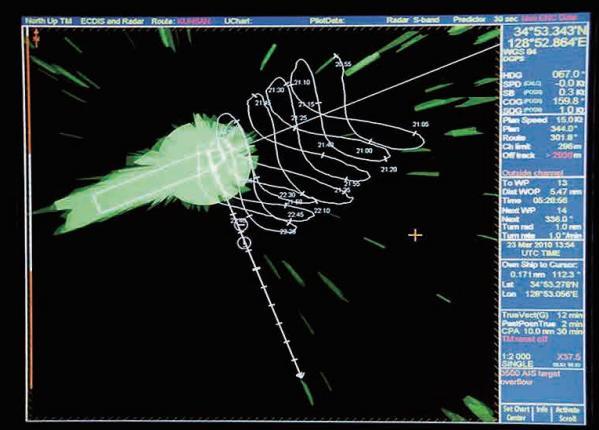
Photograph 65

This helps us understand the first stage in more detail: Dragging Anchor with Yaw and Sway.

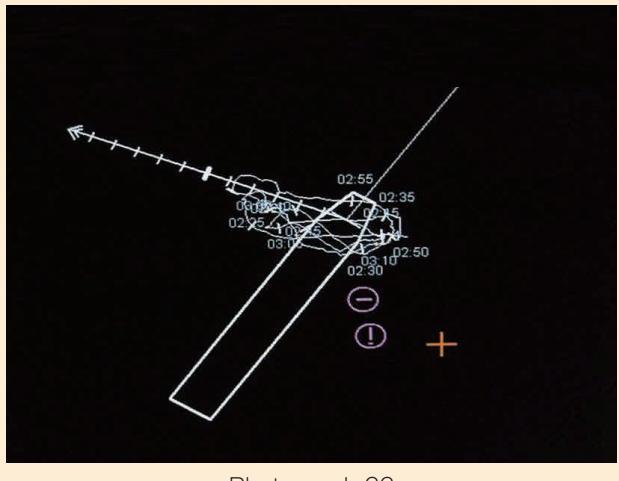
Photograph 66

This helps to solidify understanding of the first stage: Dragging Anchor with Yaw and Sway.
