## § 5 Case Study

### Analysis of an Accident

Vessel A Quay collision accident Accident timeline

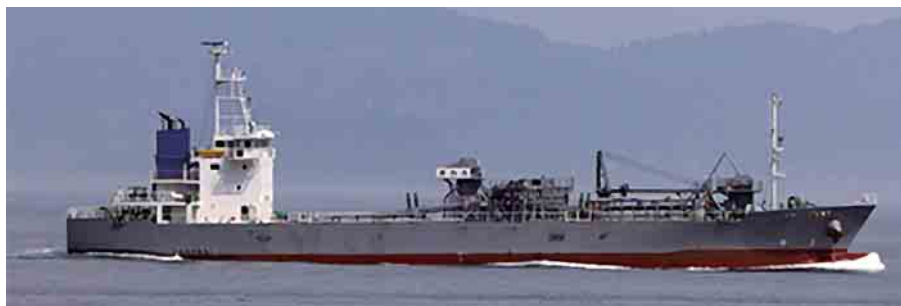
Photograph 38 Vessel A

: Vessel A(748 GT) Single-engine, single-shaft stern hull bridge type coal ash and calcium carbonate carrier equipped with bow thrusters and a VecTwin system control unit (hereinafter referred to as “VecTwin system”)

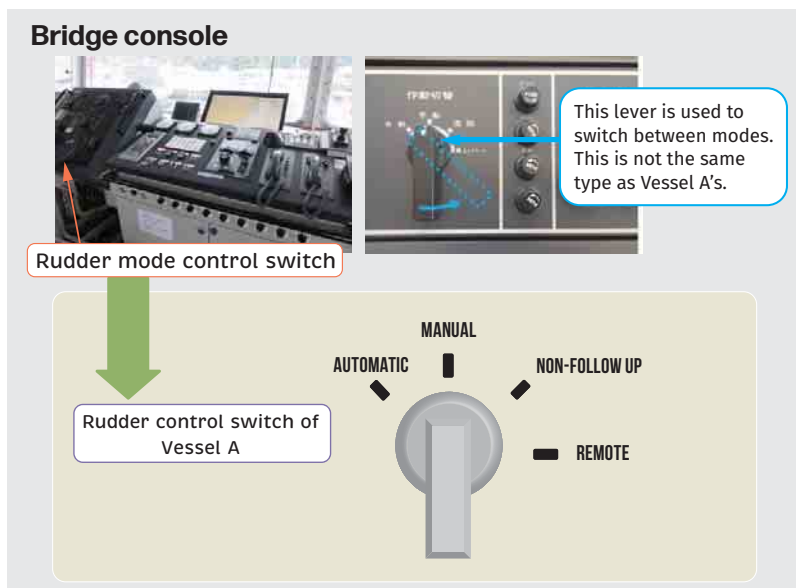
Fig. 42 Steering operation settings Rudder control switch

Moving in a clockwise direction, the rudder control switch has 4 settings: Automatic, Manual, Non-follow up, and Remote Control. The joystick can be operated when this switch is in the remote-control mode.

**In the event of turning the switch to remote mode, if the rudder switch on the control stand is not set to "Remote Control", the VecTwin Rudder will not move when trying to operate the joystick.**

However, he believed that it had switched to remote rudder control by moving it by only one notch. Actually, the rudder switch was stuck in the non-follow-up position (human characteristics: Human beings sometimes make assumptions).

- The operating instructions are to be clearly shown on the control stand and a switching procedure manual is to be created.
  - ▷ A method of instructing crew members to comply with compliance regulations by creating procedures, which is referred to as “c. Administrative countermeasures” in Attachment 4.
- The rudder switch on the control stand has been improved so that it emits an electronic tone for a few seconds when it is in the remote position.
  - ▷ This is referred to as “b. Physical countermeasures” in Attachment 4.

- When switching to joystick steering, (1) visual confirmation shall be made that the rudder mode control switch has been switched to the appropriate position, and (2) a joystick activation test shall be carried out prior to berthing manoeuvres to confirm that the switch has been successfully operated.

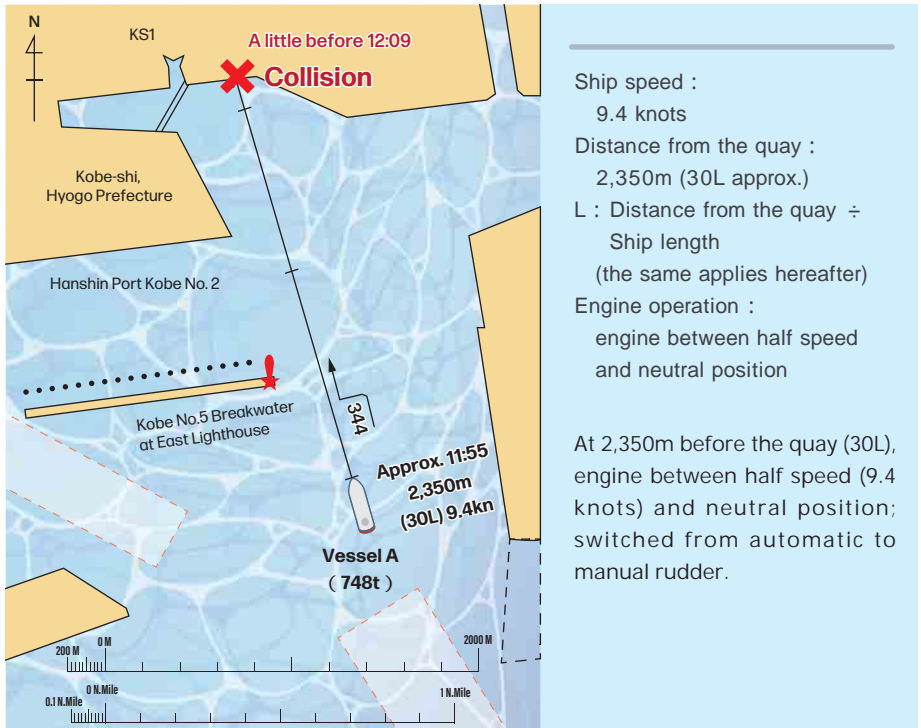
Fig. 44 Vessel A at 11:55 (approx.)

This operation itself was in accordance with standard docking procedures, but the rudder angle indicator was not checked during manual operation.

Furthermore, as there was no altered angle to the quay, and no wind tide effect, although the Master moved the steering wheel somewhat, each time he thought the rudder was moving as he operated it; he did not check the rudder angle indicator.

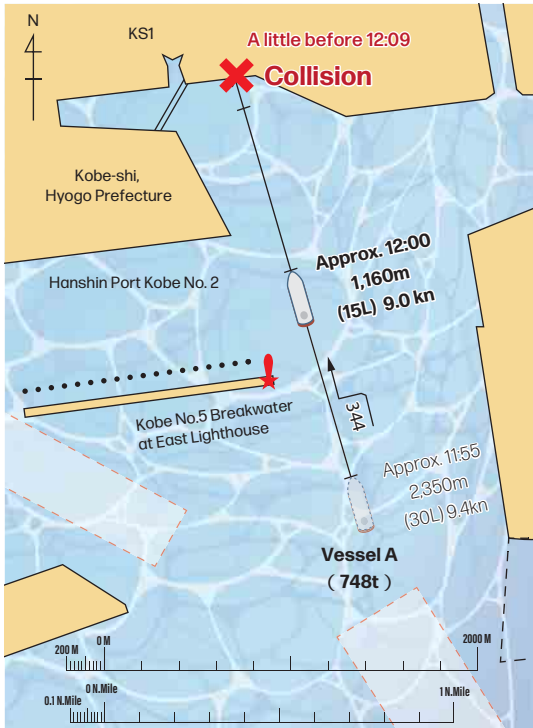
Fig. 45 Vessel A at 12:00 (approx.)

Ship speed :  
9.0 knots  
Distance from the quay :  
1,160m (15L approx.)  
Engine operation :  
from neutral position to D.Slow Ahead

The Master intended to use the joystick device to control the VecTwin Rudder system to manoeuvre the ship to the shore, and switch the rudder control to remote control. He also set the speed for D.Slow Ahead.

While he did not realise this, he moved to the port side of the bridge in front of the control stand. At this time, the VecTwin Rudder was in the neutral (hover) position (human characteristics: Human beings sometimes do not notice).

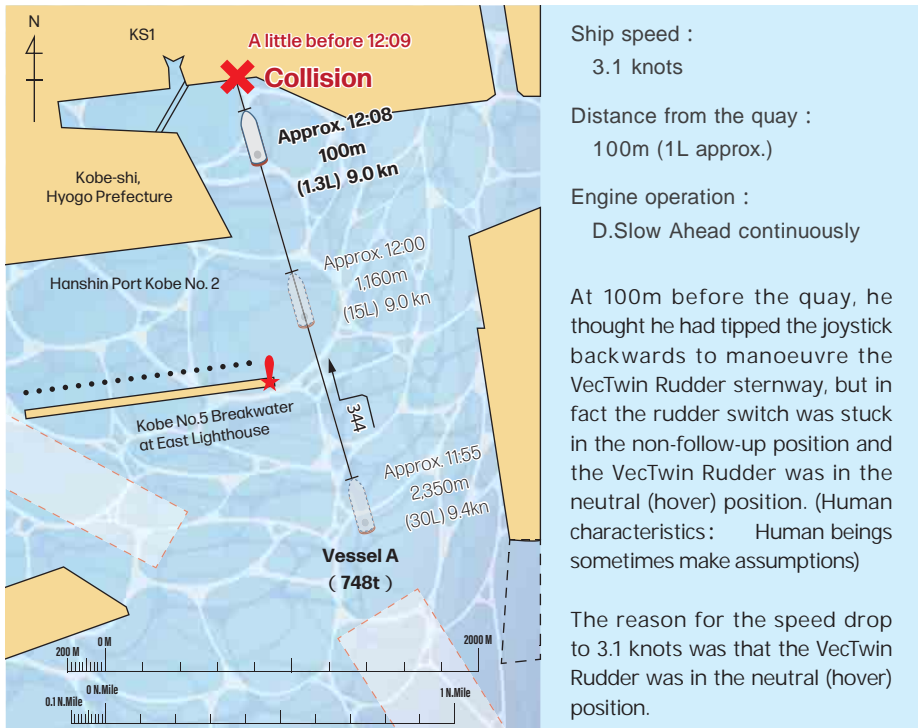
Fig. 46 Vessel A at 12:08 (approx.)

He thought he was steering the vessel with the joystick of the remote-control unit, but in fact the vessel was naturally slowed down while heading straight ahead with no wind tide effect, because the VecTwin Rudder was in the neutral (hover) position.

He was too preoccupied with the distance to the quay that he did not look at the rudder angle indicator on the VecTwin Rudder to make sure the rudders were heading sternway, but rather assumed that he could control the vessel's headway speed.

But at last, the quay was in sight, and as the speed to fetch headway was not decreasing, he tried to make sternway by increasing engine speed (not effective as it was in neutral (hover)). Then, he ordered the Bows'C/O to anchor, but the timing was too late. At this point, the Master was probably in a panic and unable to calmly judge the situation.
