# JAPAN P&I NEWS

中国—**Fuzhou** 港および **Ningde** 港沖、水中障害物に関する注意喚起

Oasis Circular No.: 2209

**Subject: China MSA issued notice of correction to chart in respect of unidentified underwater objects off Fuzhou port and Ningde port**

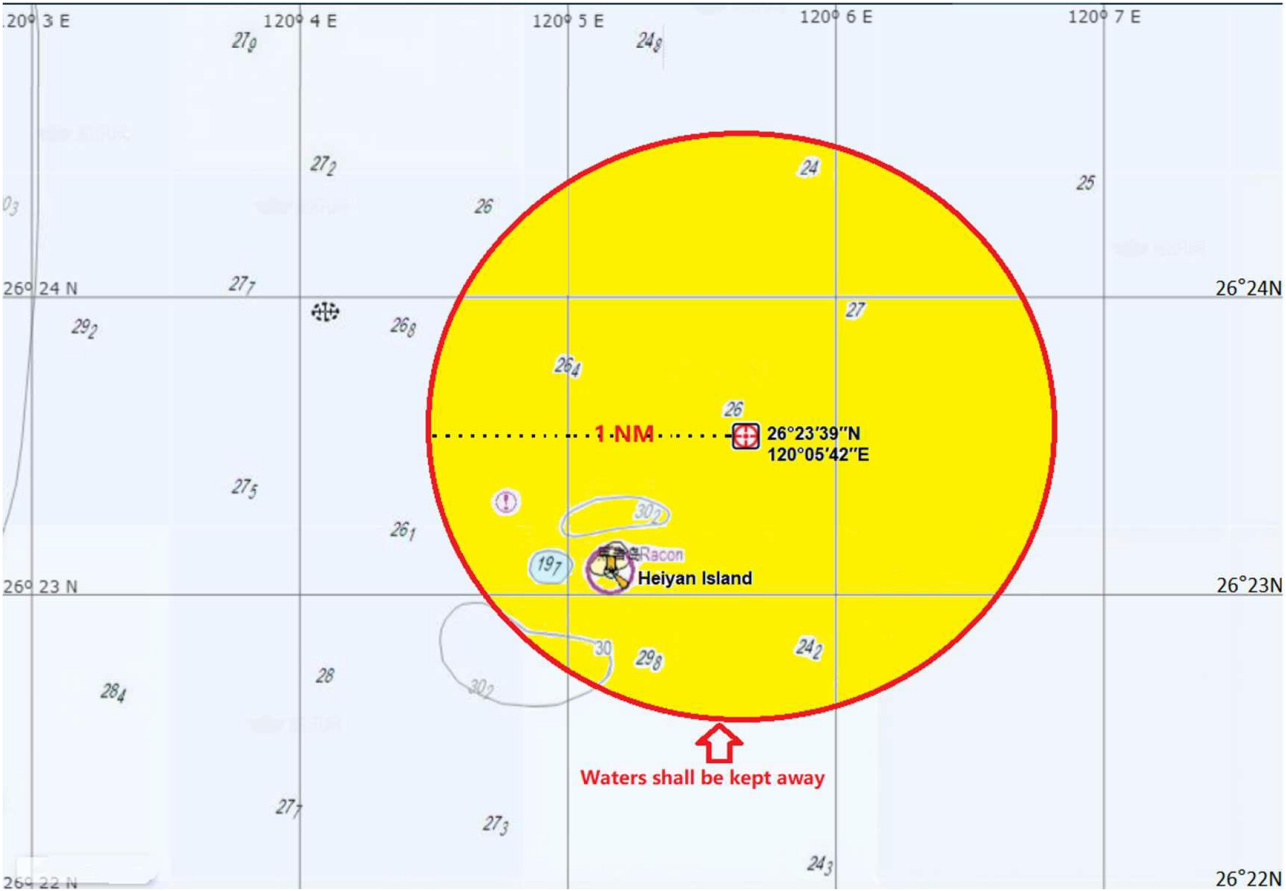
China MSA は 2022 年 10 月 10 日、中国沿岸港における航路図の修正に関する通知第 41 号を発行しました。これによると、Heiyan Island、Sanshoa'ao、Lianjiang、Taiwan Strait の北東部、 $26^{\circ}23'39''N, 120^{\circ}05'42''E$  の地点を中心とした半径 1 海里の海域に未確認の水中障害物があるため、関連する海図 (No.62001 [2022-970]、No.62151 [2022-202]、No.2310 [2022-904] を含む) を修正する必要があります。この通知は、2022 年 9 月 10 日付で Fujian MSA が発行した航行警報第 32/22 が情報元となります。詳細は以下の図のとおりです。

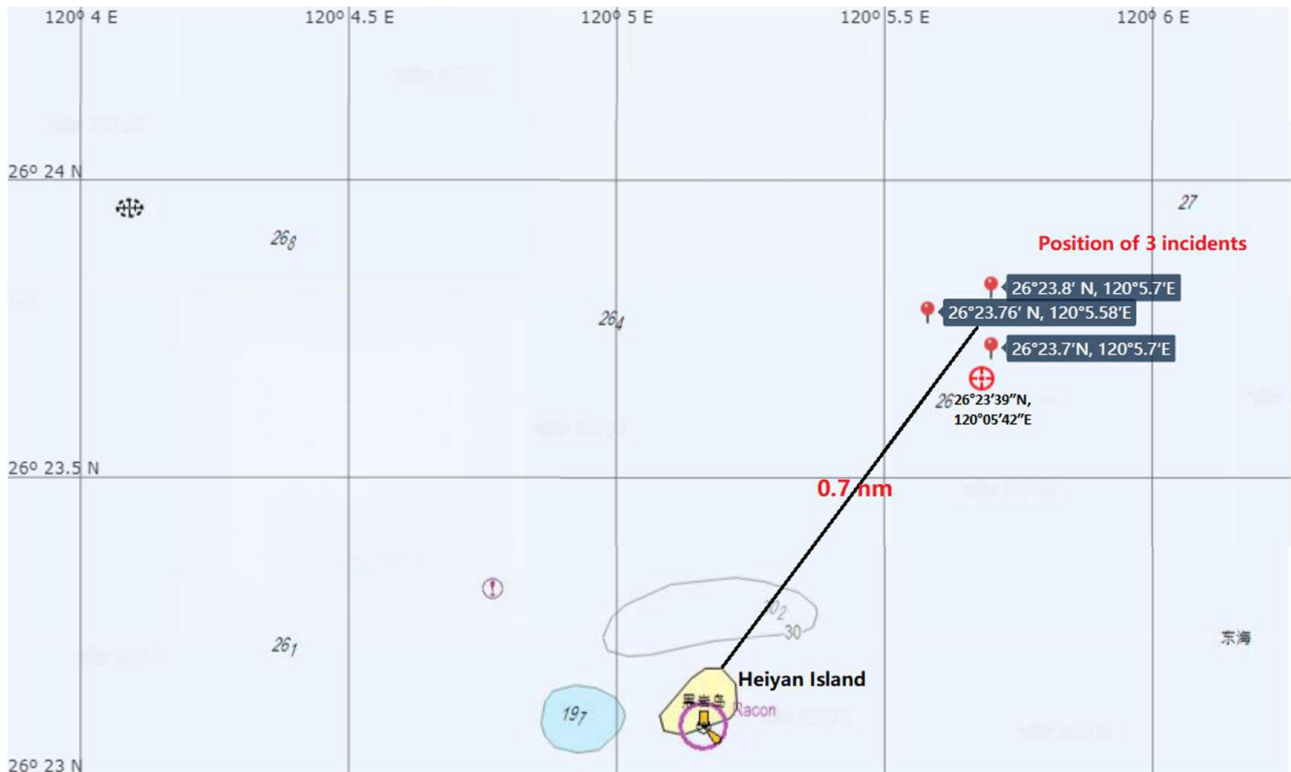
(2020年から2022年にかけて発生した3件の座礁事故の発生地点)

上記航行警報第 32/22 の発行前、2020 年から 2022 年にかけて、この海域で 3 件の重大な座礁事故が発生し、その際船体に深刻な損傷が発生、サルベージ作業が行われました。座礁時、これらの船舶の喫水は約 7 メートルから 15 メートルとさまざま、うち 2 隻は貨物を積載中、残りの 1 隻はバラスト状態でした。これら 3 隻の座礁事故の発生地点は以下の図のとおりです。

1. 26°23.7'N, 120°5.7'E
2. 26°23.8'N, 120°5.7'E
3. 26°23.76'N, 120°5.58'E

これらの水中障害物の正体については今のところ不明であり、そのため現行の航行用海図には情報が示されていません。

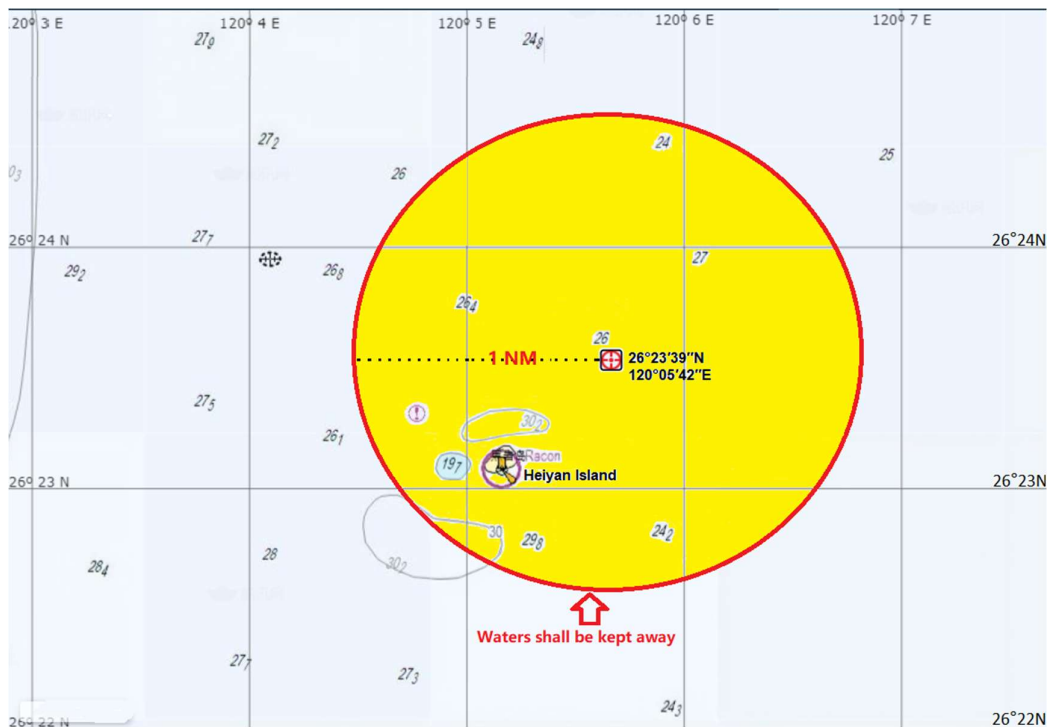
On 10 Oct 2022, China MSA issued No. 41 Notice of Correction to Channel Charts of Chinese Coastal Ports, in which they requested ships to remark the warning statement "Unidentified underwater objects were found in northeastern waters of Heiyan Island, Sansha'ao, Lianjiang, Taiwan Strait, within a radius of one nautical mile from the center of the circle: 26°23'39", 120°05'42"E" on the 3 relevant nautical charts, including No. 62001 (2022-970), No. 62151 (2022-202) and No. 2310 (2022-904). The source of this correction notice is No. 32/22 Navigation Warning issued by Fujian MSA on 10 Sep 2022. Details are illustrated as follows:

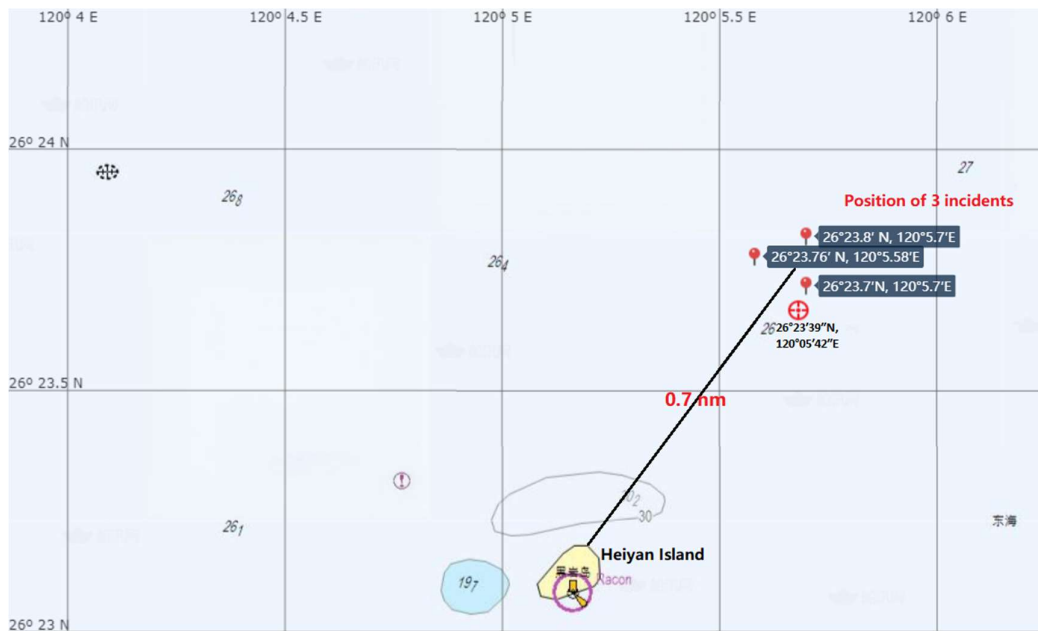
**Positions of 3 grounding incidents from 2020 to 2022**

Before the issuance of the above Navigation Warning No. 32/22, 3 major grounding accidents occurred in this area during the years from 2020 to 2022, which caused

serious damages to the ships' hulls and necessitated complex salvage operations. The draught of those ships at the time of grounding varied from about 7 metres to 15 metres, with two ships laden whilst the third one in ballast. The positions of these 3 grounding incidents are listed as follows and illustrated below:

1. 26°23.7'N, 120°5.7'E
2. 26°23.8' N, 120°5.7'E
3. 26°23.76' N, 120°5.58'E

The identity of those underwater objects are currently unknown and they are not shown in the present public nautical chart.
