JAPAN P&I NEWS

China—Unidentified Underwater Objects off Fuzhou Port and Ningde Port

Subject: China MSA issued notice of correction to chart in respect of unidentified underwater objects off Fuzhou port and Ningde port

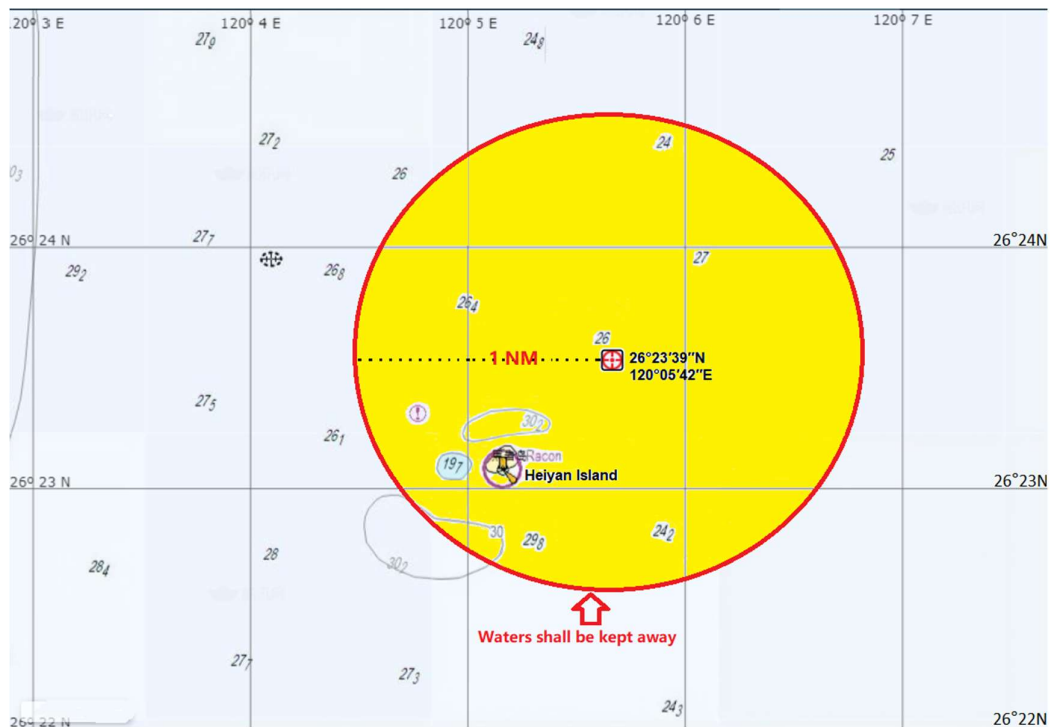
On 10 Oct 2022, China MSA issued No. 41 Notice of Correction to Channel Charts of Chinese Coastal Ports, in which they requested ships to remark the warning statement "Unidentified underwater objects were found in northeastern waters of Heiyan Island, Sansha'ao, Lianjiang, Taiwan Strait, within a radius of one nautical mile from the center of the circle: 26°23'39", 120°05'42"E" on the 3 relevant nautical charts, including No. 62001 (2022-970), No. 62151 (2022-202) and No. 2310 (2022-904). The source of this correction notice is No. 32/22 Navigation Warning issued by Fujian MSA on 10 Sep 2022. Details are illustrated as follows:

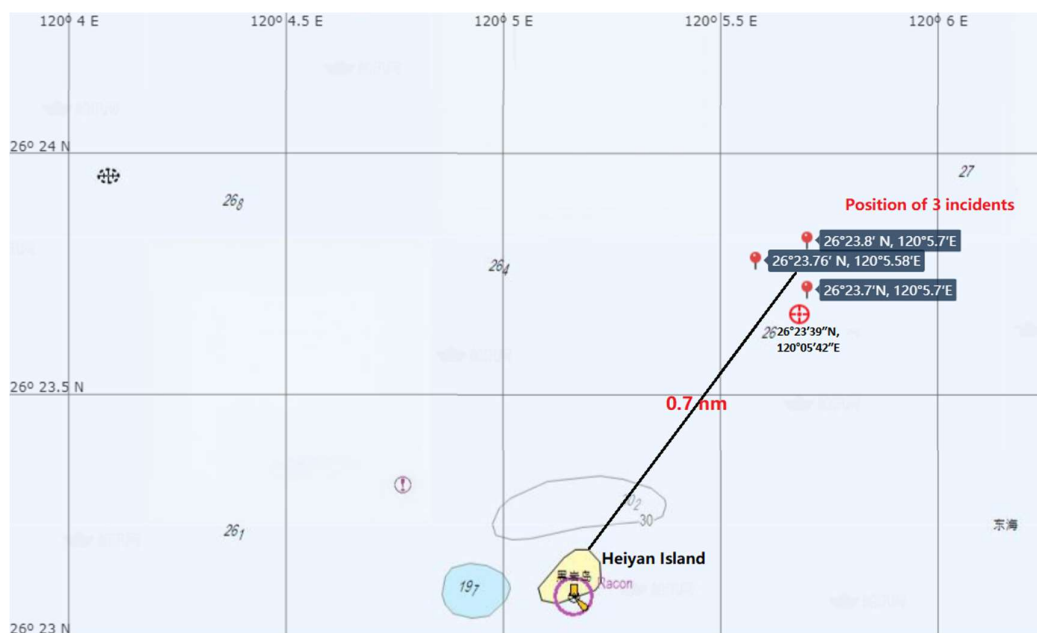
Before the issuance of the above Navigation Warning No. 32/22, 3 major grounding accidents occurred in this area during the years from 2020 to 2022, which caused

serious damages to the ships' hulls and necessitated complex salvage operations. The draught of those ships at the time of grounding varied from about 7 metres to 15 metres, with two ships laden whilst the third one in ballast. The positions of these 3 grounding incidents are listed as follows and illustrated below:

1. 26°23.7'N, 120°5.7'E
2. 26°23.8' N, 120°5.7'E
3. 26°23.76' N, 120°5.58'E

Positions of 3 grounding incidents from 2020 to 2022

The identity of those underwater objects are currently unknown and they are not shown in the present public nautical chart.

Ships which plan to call Fuzhou Port (including Luoyuan Port, Kemen Port, Huadong Shipyard and Ningde Port (including Zhangwan Terminal, Datang Powplant Terminal, Dingxin Terminal, etc) shall add the above warning statement in the nautical chart before the voyage commences and keep away from those waters when the ship enters into or departs from the aforesaid terminals and shipyards. A map of this area is appended below for your ready reference.

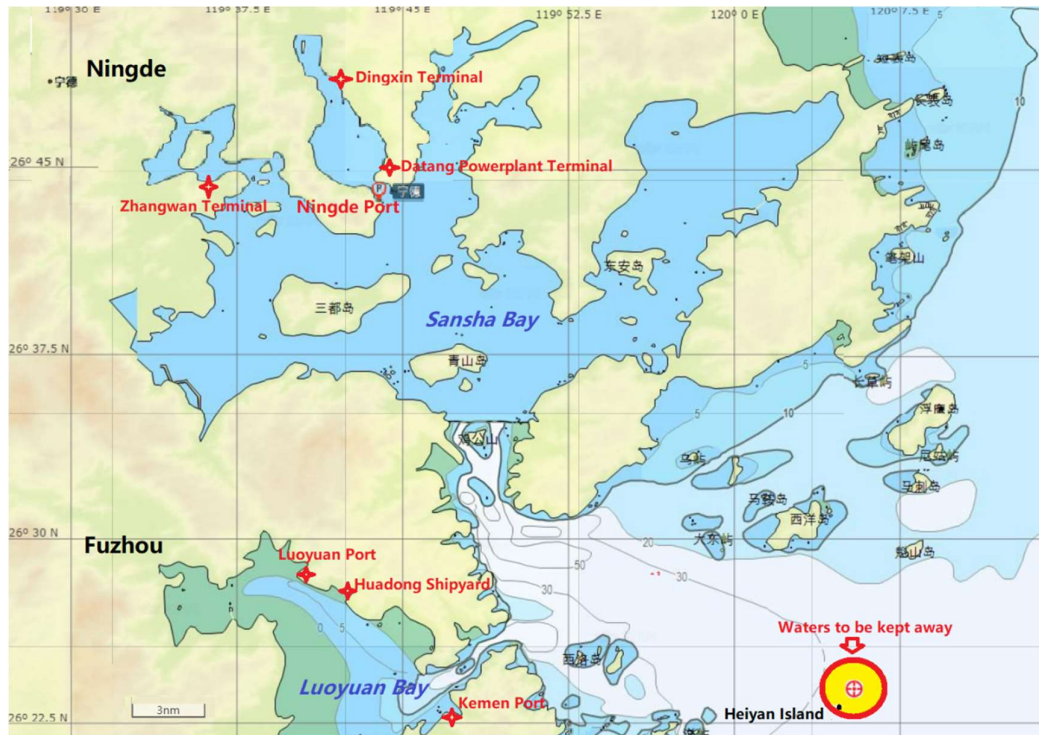
Terminals/shipyard of Fuzhou Port and Ningde Port
