JAPAN P&I NEWS

中国—渤海および黄海における漁船との衝突事故に関するハイリスク水域について

Oasis Circular No.:2308

Subject: High risk water areas which are frequent locations of collision incidents between vessels and fishing boats in Bohai Sea and Yellow Sea

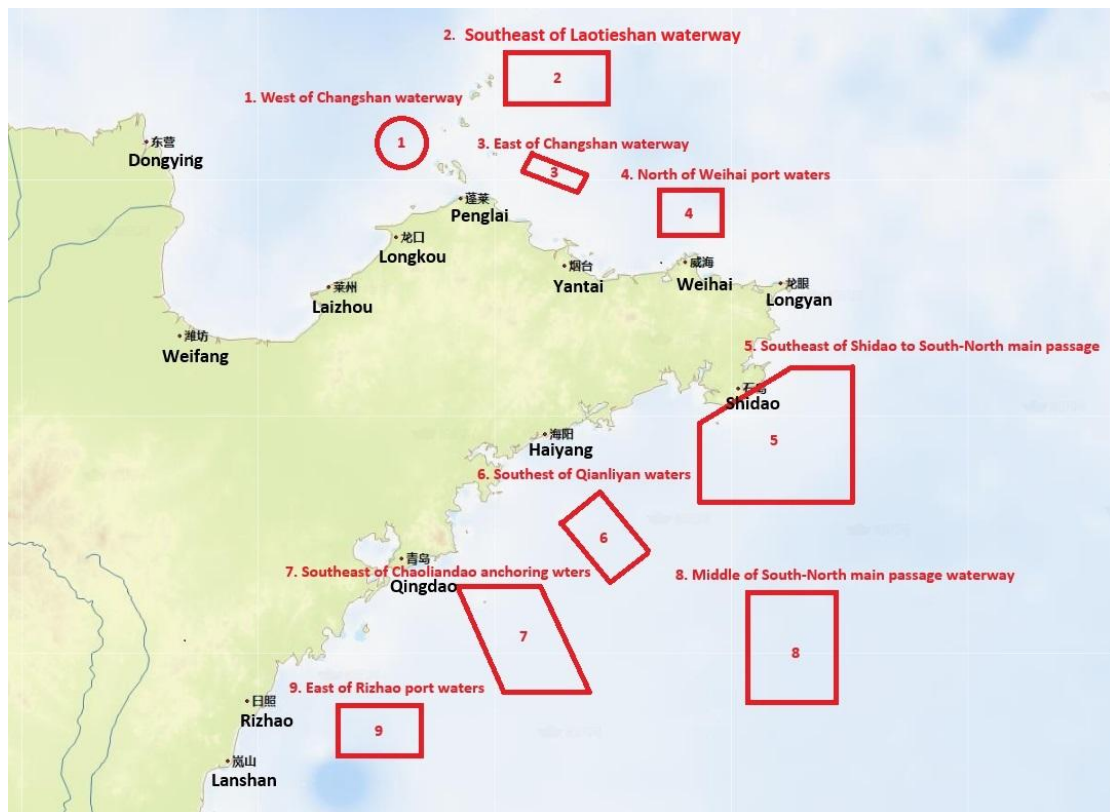
Nine high risk areas in Bohai Sea and Yellow Sea

Main risks: Intersection area for vessels from/to Tianjin, Huanghua, Binzhou, Dongying, Weifang, and Longkou ports of Bohai bay and Laizhou bay with quite a few fishing boats. About 5 collision incidents between merchant vessels and fishing boats happened in the past 10 years.

Main risks: Heavy traffic with vessels and fishing boats passing through. Besides, one passenger route within this area. About 7 collision incidents happened in this area in the past 10 years.

Main risks: This area is located at the northern part of Yantai port west harbour, where vessels entering and/or leaving Yantai port and vessels passing through Changshan waterway will come through. In addition, many fishing boats operate in this area. About 4 collision incidents between merchant vessels and fishing boats happened and 1 collision incident between two merchant vessels also happened in the past 10 years in this area.

Main risks: This area is outside the coverage of Chengshantou VTS. Vessels passing through ship's routing area of Chengshantou to southern ports of Bohai Bay must transit through this area where there are many vessels and fishing boats. About 5 collision incidents between merchant vessels and fishing boats happened and 1 collision incident between two merchant vessels also happened in the past 10 years in this area.

Main risks: Dense traffic in South-North main passage with mainly passing by vessels. Many fishing boats carry out operation in southeast of Shidao area, so there is a high risk of collision incidents. About 17 collision incidents between merchant vessels and fishing boats happened and 4 collision incidents between two merchant vessels also happened in the past 10 years in this area.

Main risks: This area is located at the junction of Yantai and Qingdao with sea routes from Chengshantou southern parts to Qingdao port. There are plenty of vessels and fishing boats which coming from/to Rushan fish farm or the T-shaped estuary. A new offshore wind power site is located in the northern part of this area, which makes the navigation environment more complex. About 3 collision incidents between merchant vessels and fishing boats happened in the past 10 years.

Main risks: This area is outside the coverage of Qingdao VTS, where more than 7,000 vessels per year drop anchors before entering the ports. The long distance from shore makes it difficult to communicate smoothly via AIS. About 3 collision incidents between merchant vessels and fishing boats happened and 1 collision incident between two merchant vessels also happened in the past 10 years in this area.

Main risks: This area spans across the jurisdiction of Qingdao, Dongjiakou, and Rizhao and the shore based AIS cannot cover or effectively connect. There is a lot of merchant vessels passing by, as well as large fishing boats engaging in fishing operations or anchored in this area without maintaining proper lookout. Furthermore, the Rizhao - South Korea passenger route passes through this water area too. About 8 collision incidents between merchant vessels and fishing boats happened and 1 collision incident between two merchant vessels also happened in the past 10 years in this area.

Main risks: There are many vessels and fishing boats in the east water area of Shijiu port and Lanshan port of Rizhao. Fishing boats frequently navigate through channels and/or anchorage in the port area. As large tankers often anchor here, there is a high risk of collision between vessels and fishing boats under poor visibility. About 2 collision incidents between merchant vessels and fishing boats happened in the past 10 years.

1. Get familiar with the starting times and ending times of the fishing ban periods. Carry out relevant safety training on the characteristics of fishing areas and fishing boats.
2. Avoid the traditional fish farms and fishing areas. When choosing a route, vessels shall be properly away from shore, apply the recommended routes carefully and strictly follow the relevant ship routing system.
3. Fully comply with relevant provisions of COLREGS 1972 and Safety Management System, ensure there is proper and sufficient lookout, keep a safe speed and take early avoidance actions.
4. In the process of avoiding fishing boats, ship officers shall consider the particular operational characteristics of the fishing boat involved. If effective radio

communication cannot be established between the vessel and the fishing boat, all other available means shall be used to warn the fishing boats of the risk of collision.

5. Be familiar with the safety guidelines for preventing collision between merchant ships and fishing boats in Chinese coastal waters issued by China MSA on 06 May 2021. (See attached our free English translation)

6. In case a collision incident occurs or is suspected to have occurred, rescue operation shall be immediately carried out taking into consideration various factors such as safety of the ship and her crews, the surrounding environment etc. Meanwhile, the ship shall contact the nearest VTS/MSA via VHF or their emergency telephone no. +86 12395 as soon as possible. The ship's agents, P&I Club and its correspondent should also be informed.
