JAPAN P&I NEWS

China—Special Attention is Required When Ships Navigate in the Waters of Guishan Anchorage of Guangzhou

Oasis Circular No.: 2407

Subject: Special attention is required when ships navigate in the waters of Guishan anchorage of Guangzhou, China

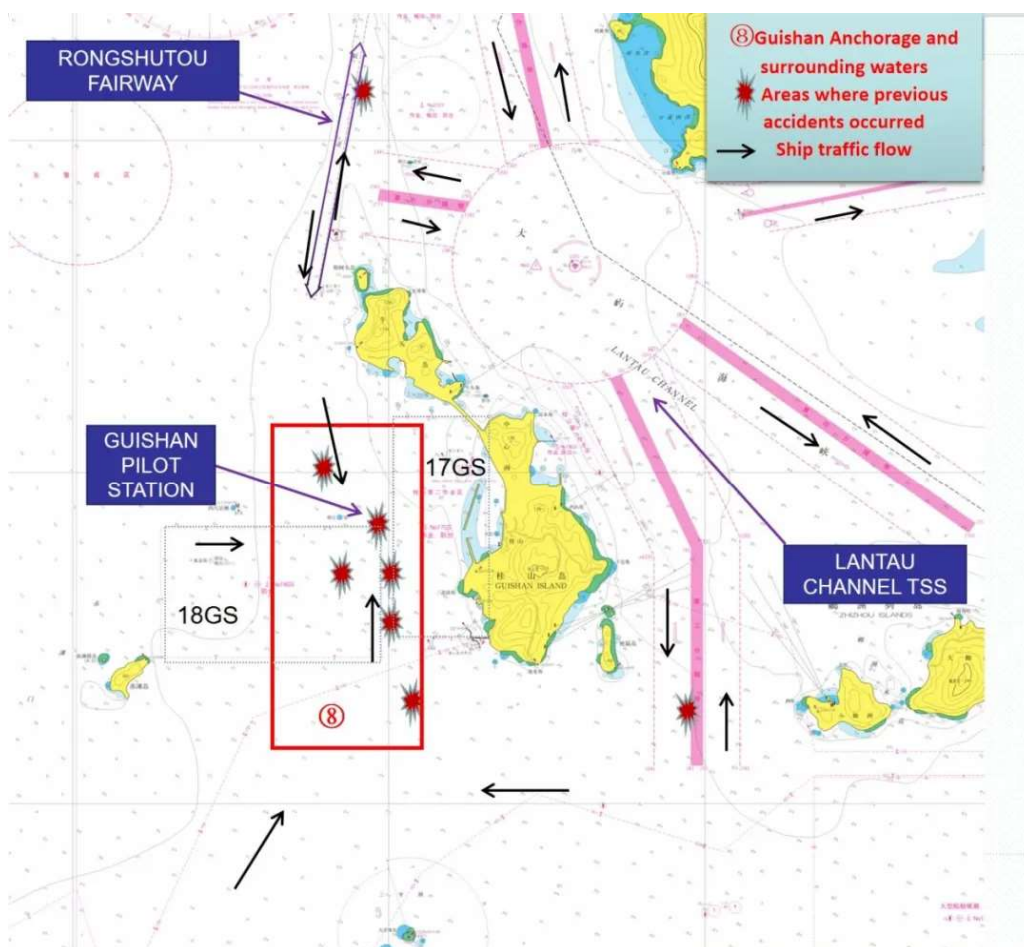
Schematic diagram of risky locations in Guishan anchorage and its surrounding waters

When flood and typhoon season approaches, currents and winds would intensify at Guishan anchorage and its surrounding waters of the Pearl River Estuary. Recently we have seen an increasing number of ship collision incidents in this area due to various reasons. The frequent accident locations are marked in the diagram below.

1. Guishan anchorage and its surrounding waters are the converging waters when ships navigate through the Pearl River Estuary. Many merchant ships anchor at the 18GS anchorage before entering the ports, and many fishing boats and offshore ships anchor at the 17GS anchorage. Both anchorages are busy with ships, which results in limited maneuvering space and difficulty in ship handling.

2. The waters between the 18GS and the 17GS anchorages are the customary route for ships entering or leaving the ports, which also serve as the boarding and disembarking points for pilots. Ships often accelerate, decelerate, or maneuver in this area for picking up or disembarking pilots, which may increase the risk of collision because of ineffective communication between ships due to language barriers.

3. Ships often cross the customary route or heave up anchor to head for various ports within the Pearl River Estuary with sudden changes in course, which easily leads to crossing situations and makes the traffic flow more complicated.

4. Ships anchored at the 18GS anchorage are relatively large. Their deck lights and the night tourism lighting of Guishan Island may cause difficulty or confusion to ships' lookout.

1. Ships shall make full use of the rudder and the engine to avoid collision incidents and slow down at an early stage if the situation cannot be assessed adequately. When anchoring, ships shall maintain strengthened lookout, be aware of the change of tides and currents and have the engine prepared in case of emergency.

2. Ships shall display appropriate lights and shapes in line with regulations, engage extra watchman on the bridge, stay vigilant, use radar for long and short-range scanning to learn the movements of nearby ships at an early stage. Ships shall maintain contact with each other via VHF in case the traffic becomes complicated.

3. Ships shall maintain constant communication with the pilot station and make preparations in advance before the pilot boards or disembarks. In the meantime, ships shall take extra care when maneuvering to avoid colliding with surrounding ships.

4. Ships shall maintain safe speed and try to avoid making large turns or acceleration. If effective communication cannot be established due to language barriers, ships shall employ all alternative measures, such as using the whistle to alert other ships, contact Guangzhou VTS via VHF08\09 or via telephone No. +86 12395 for assistance.
