JAPAN P&I CLUB

P&I ロス・プリベンション・ガイド P&I Loss Prevention Bulletin

Large Claim Analysis and Trends

～ Reducing the Number of Large Claims ～

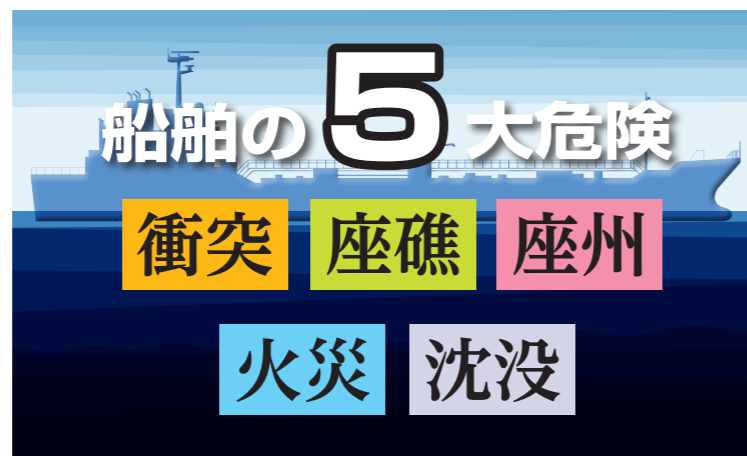
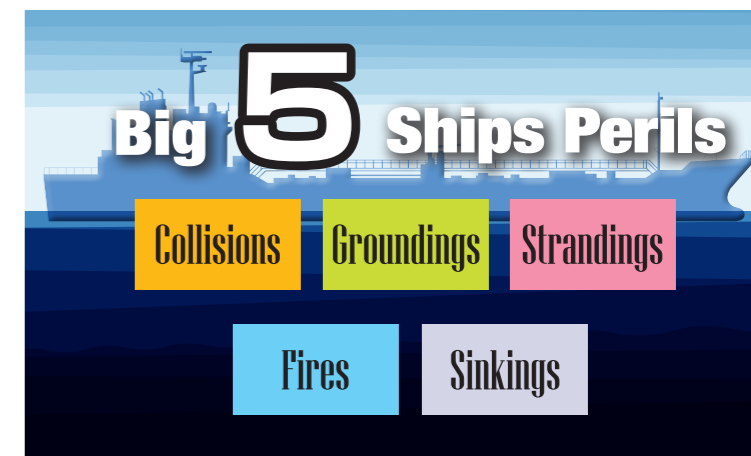
衝突は衝突相手船と衝突責任割合を決定した上で各々の損害を解決していきます。例えば衝突責任割合が40:60で本船有利であったとします。この衝突責任割合に基づいて、本船船主は相手船の損害額の40%相当を、相手船は本船の損害額の60%相当について責任を負うことになります。そして、本船の保険者は相手船の損害額の40%を保険で補償し、本船の損害の60%相当を相手船から回収すべく交渉します。

Damages for collisions between ships are decided after determining to what degrees the insured vessel and the other vessel were collision liability. For example, consider a collision where our entered vessel is 40% responsible, and the other vessel is 60% responsible for the collision. Based on this responsibility ratio, our vessel would be responsible for paying 40% of the damages incurred to the other vessel, and the other vessel would be responsible for paying 60% of the damages incurred to our vessel. Our vessel's insurer would provide compensation for 40% of damages to the other vessel, and would negotiate to claim the 60% in damages to our vessel.

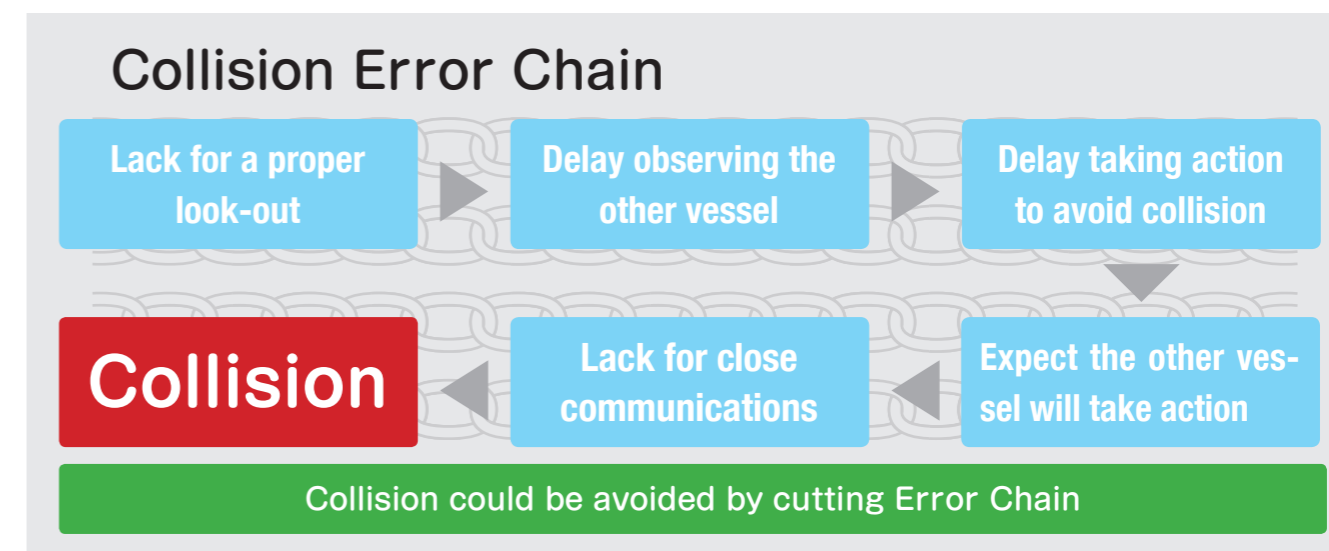
衝突案件における、エラーチェーンの参考例を示します。

Below is an example of a collision error chain.

衝突案件の場合、車の出会いがしらの衝突事故と異なり、事前に相手船を認めているケースがほとんどです。しかし、事故直前に上述したエラーを断ち切るための回避動作を一人が同時に取ることは非常に難しいことは誰にでも想像がつかます。例えば、舵を切りながら機関停止を行い、同時に汽笛を吹鳴しながらVHFで相手船を呼び出すことを一人で同時に行うことは不可能です。しかし、船舶が衝突に至るまでの過程にはいくつもの衝突回避のチャンス（エラーチェーンを断ち切る場面）があり、それらに対してどのように正確で確実な対策・動作等を取るのかということが肝要です。

Unlike with car intersection collisions, in the case of vessel collisions, the other vessel is usually spotted before the collision. However, as is apparent, it is extremely hard for a single person to take evasive measures in order to cut the error chain shown above. For example, it is impossible for one person to turn the vessel while also stopping the engines, while at the same time sounding the horn and hailing the other vessel on VHF. However, there are several chances to avoid collisions before the occur (chances to cut the error chain), and what is important is how to reliably take the right course of action and respond appropriately.

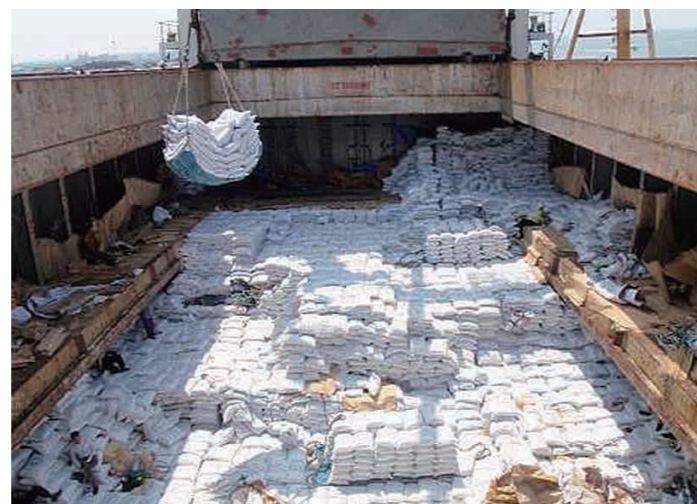
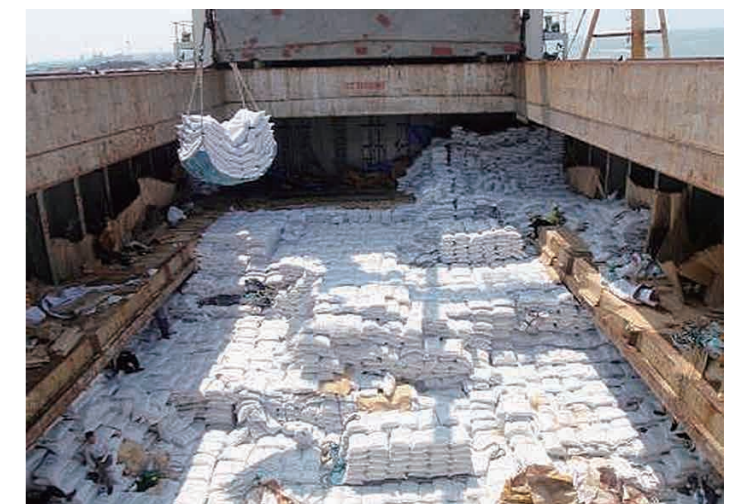
本船ハッチカバー開閉用油圧システムの不具合により、ハッチカバーの閉鎖が不可能になり、雨水がホールド内に直接浸入したことが原因です。この内、油圧配管自体にトラブルがあった二つのホールドについては、応急措置として高圧フレキシブルホースが使用されましたが、残念ながら荷役中のハッチカバーの閉鎖は間に合いませんでした。

A fault in the vessel's hatch cover operation hydraulic system made it impossible to close the hatch covers, allowing rainwater to enter the holds. For two of the holds which hatch covers could not be closed, high pressure flexible hose was used as a stopgap replacement for the hydraulic hoses, but it was not possible to close the hatch covers in time.

ハッチカバー開閉システムの日常の点検・整備不足が積荷損害発生の事態をもたらしました。これらのシステムが積荷損害に直結する重要な機器であることを認識する必要があります。

Insufficient day-to-day inspections and repairs to the hatch cover operation system led to the cargo damage incident. This equipment needs to be recognized as important equipment with a direct impact on potential cargo damage.

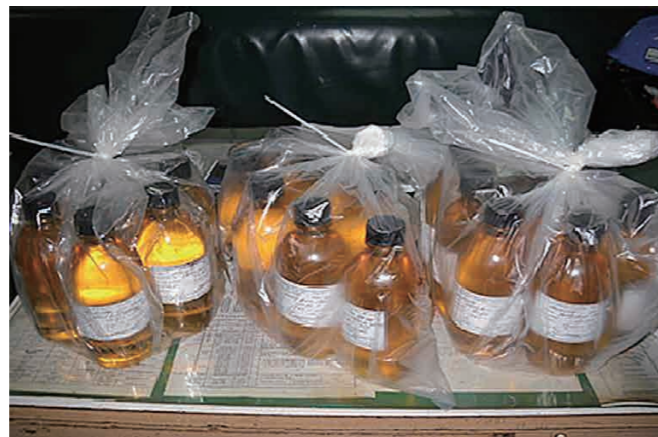
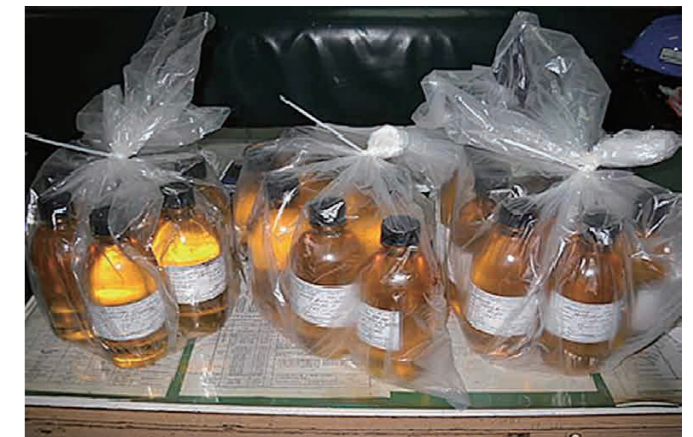
本船（ケミカルタンカー / 18,400G/T）は積荷の酢酸エチル（Ethyl Acetate）の一部を小型船に瀕取りしました。ところが、小型船のタンクから採取されたカーゴサンプルの水分含有値が正常値の100ppmに対し、4,800ppmまで上昇していることが発見されました。

上記オフスペック貨物（500MT）は、別の陸上タンクに揚げられ、格落転売されました。

The vessel (chemical tanker / 18,400G/T) discharged of part of its cargo of ethyl acetate to a smaller vessel. However, a cargo sample taken from the smaller vessels tanks showed that the water content of the cargo was 4,800ppm instead of the correct amount of 100ppm.

The off-spec cargo (500MT) was discharged to a separate shore tank and resold.

なお、瀬取り中に本船上では払い出しタンク（No.6S タンク）に隣接するカーゴタンクのタンククリーニングが行われていました。
