JAPAN P&I NEWS

Japan (Hokkaido)—Outbreak of Flighted Spongy Moth Complex

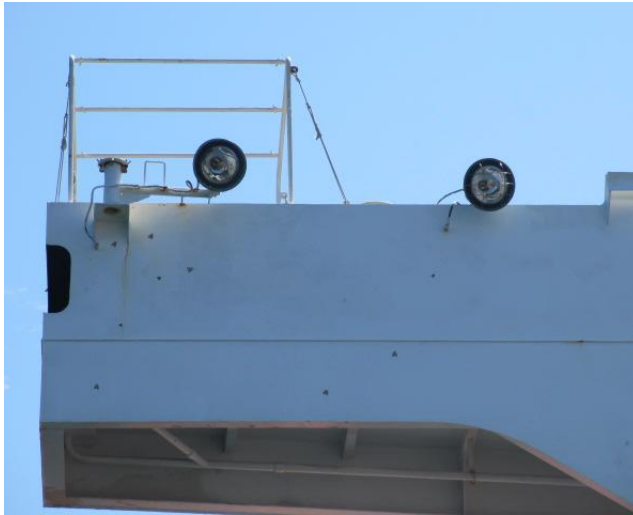
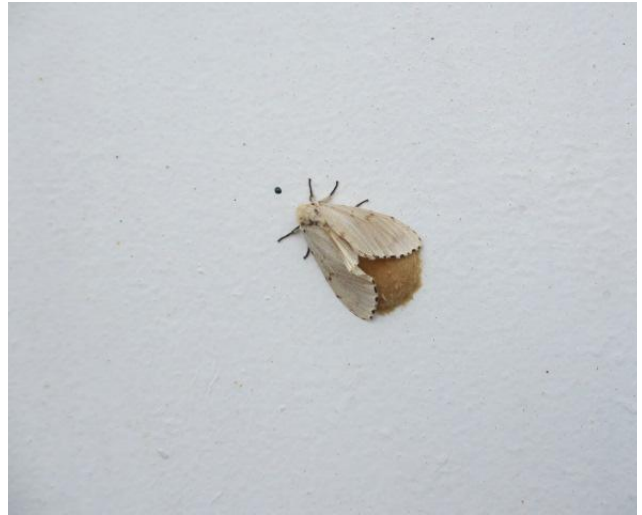
FSMC moths laying eggs near lighting equipment

FSMC egg masses tend to be deposited on uneven surfaces near lighting equipment on vessels, as well as in narrow crevices. During past infestation periods, preventive measures such as reducing vessel lighting and clearing of stowing materials on deck proved effective.

At present, masters and operators of vessels bound for regulated countries are strongly urged to conduct thorough self-inspections of their vessels and to ensure the physical removal of any egg masses if found.
