JAPAN P&I CLUB

P&I Loss Prevention Bulletin

Coastal vessels

Prevention of damage to harbour facilities and related cases

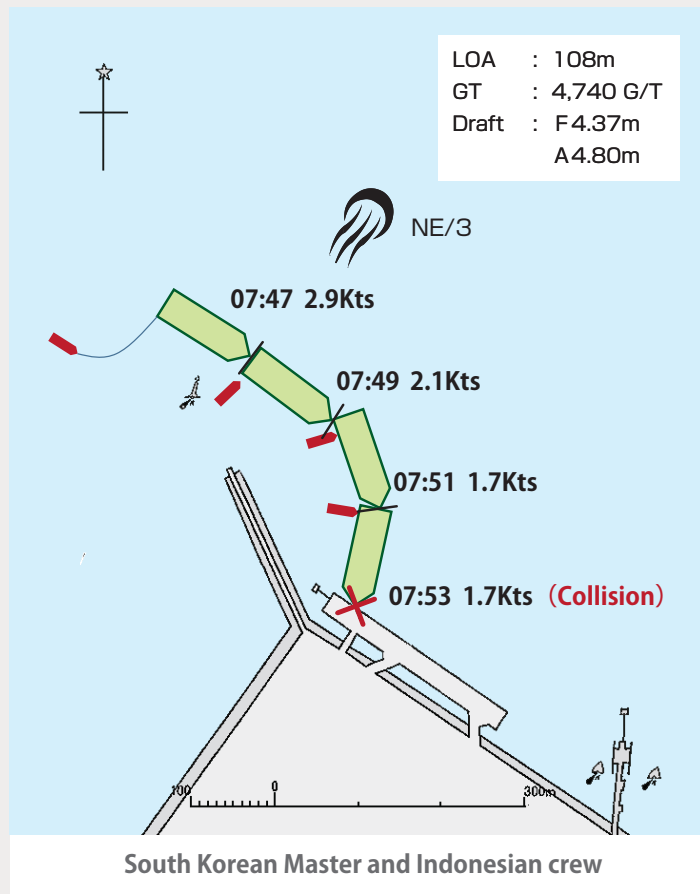
Fig. 60

Main text of judgement:	Operation suspension as pilot for a month
Cause:	The pilot did not sufficiently confirm the approaching state between the bow and quay and delayed in carrying out speed reduction arrangement. In addition, he did not adequately confirm the speed, despite the fact that it was easy for the tug boat to push stronger into the half-loaded vessel which led to the situation of increasing Head way. Also, he over relied on the approaching condition reported by the tug boat.

- ▶ **Insufficiently confirmed approaching condition between the bow and quay.**
- ▶ **Did not reduce speed at a distance of 1L (approximately 100 meters) from the approaching quay.**

There should have been no problem with the ship maneuvering skills of the pilot and the Master. However, in light of the Human characteristics mentioned above that can be the root cause, forgetfulness may suggest that re-training of BTM in order to remember be one of the effective preventive measures taken.

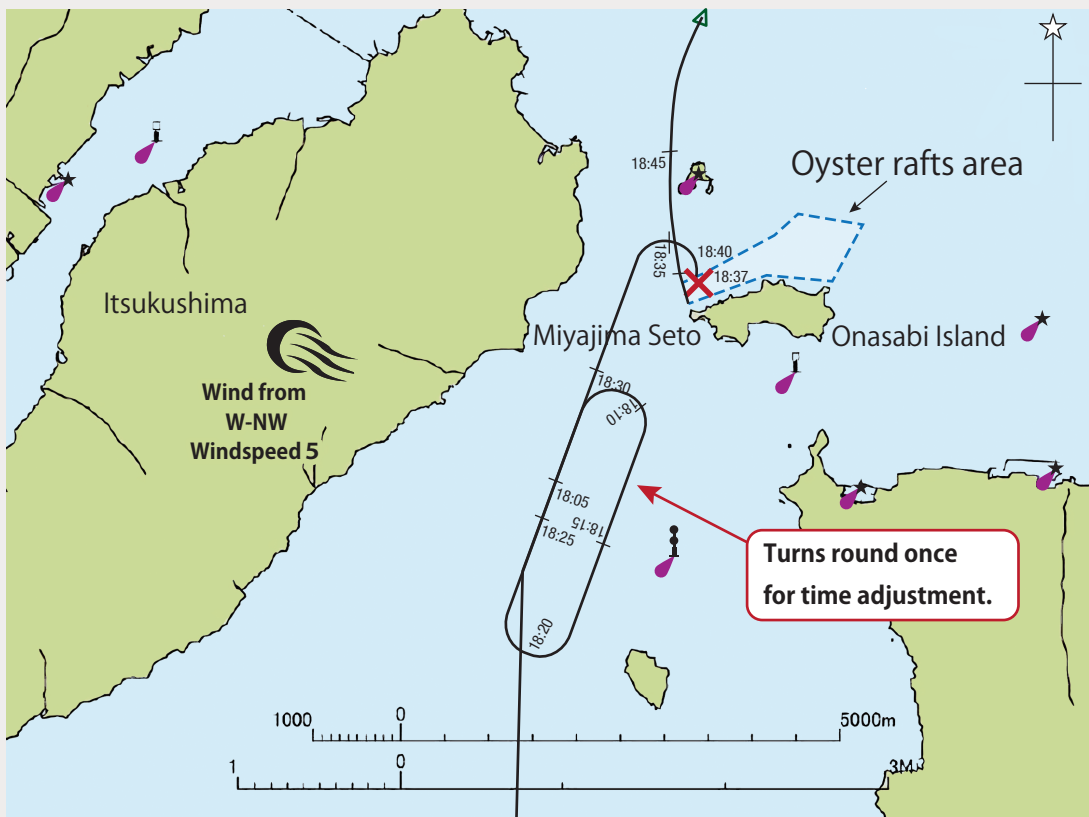
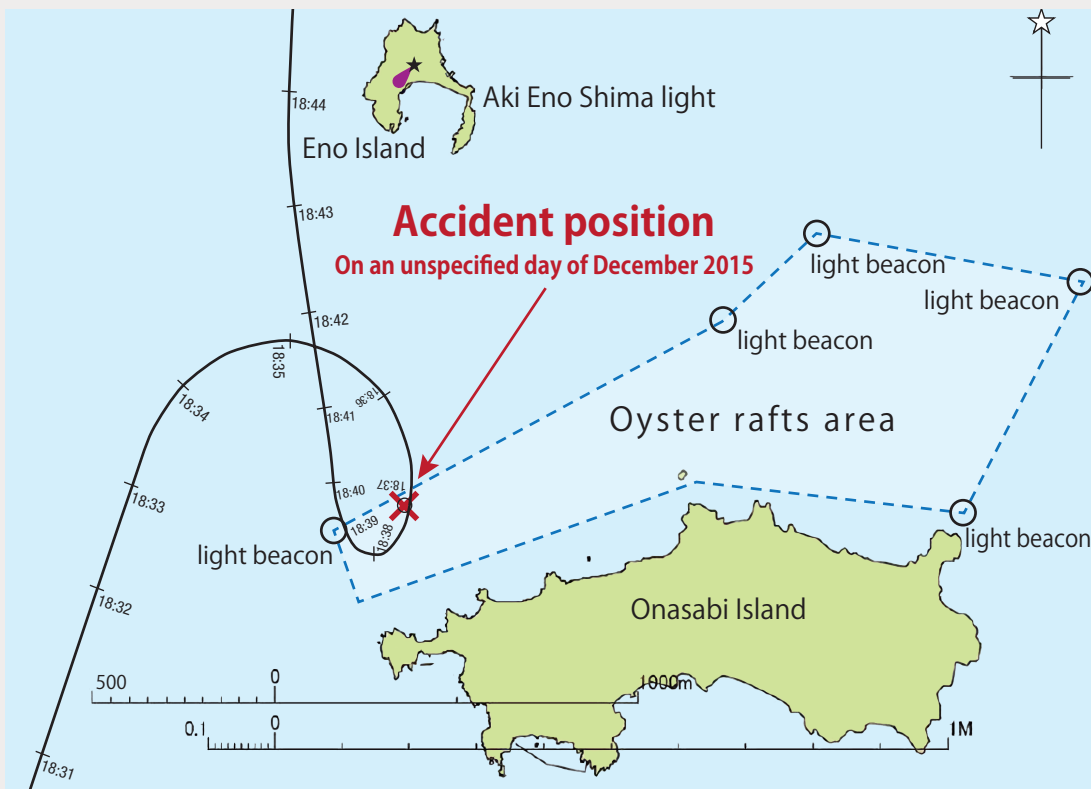
18:37	He felt a shock to the hull and realized that the vessel had collided with the oyster raft.	Master
18:40 (Approx.)	Ordered the Chief engineer to check the condition of the hull by sounding etc. After that, because no flooding was detected, she continued to navigate as before.	Master

Following the announcement of the gale warning and high wave caution, the situation was such that it was difficult to visually confirm the marked lights near the sea surface. During the passage/navigation to the north-northeast of North Asami Island Northwest offing, the Master started right turn in order to adjust the time. Because look-out was not appropriately arranged utilizing the radar, he operated the right turn without noticing the oyster raft that was situated at the North Asami Island Northwest offing, which caused a collision with the oyster raft during turning round.

Main text of judgement:	One month suspension of seamen's competency certificate as operating Master
Cause:	<ul style="list-style-type: none"> ● Insufficient hydrographic survey Neglected to conduct a hydrographic survey, such as using navigational passage information and electronic chart data to check location information of the oyster raft. ● The Master didn't think that there would be an oyster raft in the area of sea some distance away from Asami Island.

- Keep appropriate look-out by utilizing radar etc.
- In the event of operating away from of a standard charted course, check the condition of the channel beforehand using a Nautical chart etc.

In the event of time adjustment, a reduction in speed and temporary anchoring are mainly required. It is recommended that work instructions be created in accordance with the safety management manual, which state that, in the event of time adjustment by turning round, it is to proceed into a sea area where more than four to five times of the tactical diameter can be assured, and moreover, where marine traffic is not congested.

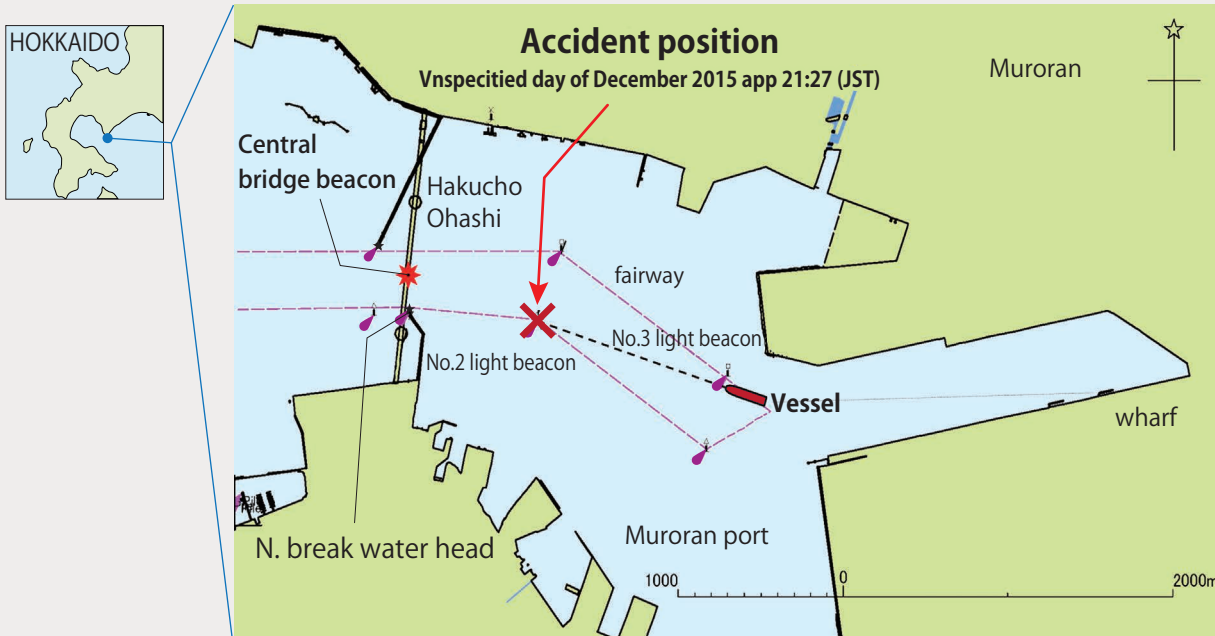
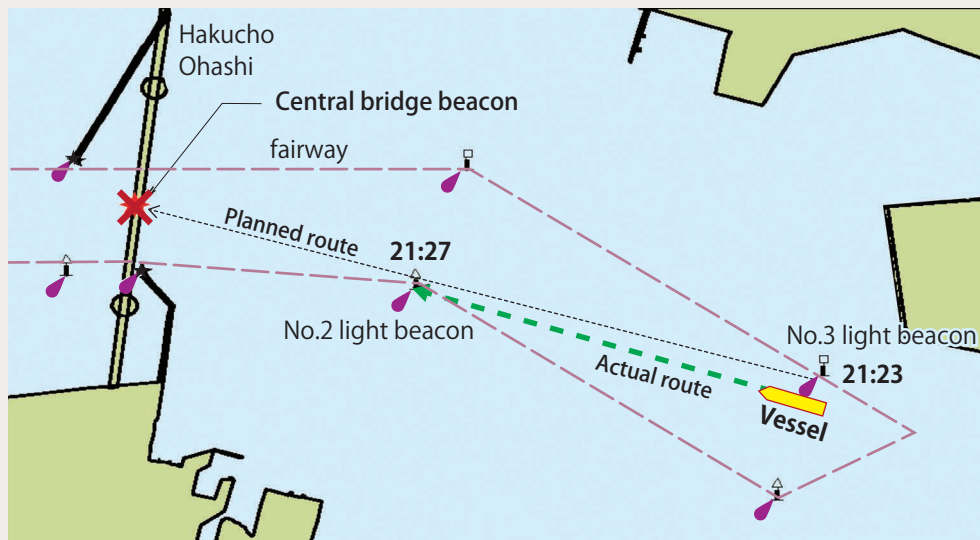
Dent with a crack at the floating part and bending damage to protective fence.

Label of No.2 light beacon: visible distance four nautical miles, red flash once every three seconds. Light height was 8.2 meters

Also, one of the causes of this accident was down to the fact that he switched off the two radars. The radars at setting ranges 1.5 nautical miles and 3 nautical miles were used after leaving the wharf until around the time of passing the vessel inbound. Because there was no record of the ship's position on the nautical chart, it is presumed that the ship's position fixing was not originally conducted.

Main text of judgement:	Official reprimand of the Master
Cause:	Duty of care was insufficient regarding the carrying out of sufficient look-out of the surroundings in order to not miss the light of No.2 light beacon located at the south of the sea route during night time. He was preoccupied with adjusting the main engine rpm, and neglected the duty of sufficient look-out.

- ▶ Accident summary
- ▶ After dismissed Departure S/B, all crew arranged at the bow are to go up to the bridge. They are also to maintain watchkeeping arrangement on the bridge until outside of harbour and system to assist the Master.
- ▶ Navigation speed that is slower than slow ahead engine is recommended in the harbour.
