JAPAN P&I CLUB

Vol.38 March 2017

P&I Loss Prevention Bulletin

Thinking Prevention of Engine Trouble

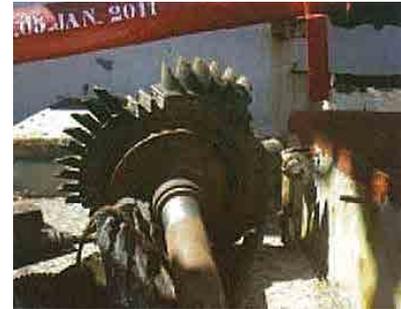
Figure 12 Damaged turbine blade, T/C explosion damage led to speed reduction in fiscal year 2011 / reference*10

The picture on the right shows the case when an explosion causes damage which leads to a speed reduction. The turbine blade on the driving side in turbo charger was damaged.

- ① The use of low quality fuel,
- ② The poor atomization of the fuel injection valve,
- ③ The dirty scavenging chamber
- ④ The contamination of the combustion chamber and exhaust system of the main engine due to incorrect maintenance,
- ⑤ The problem with the exhaust gas temperature of the turbo charger inlet,
- ⑥ The incorrect maintenance and servicing leading to damage to main engine, and so on.

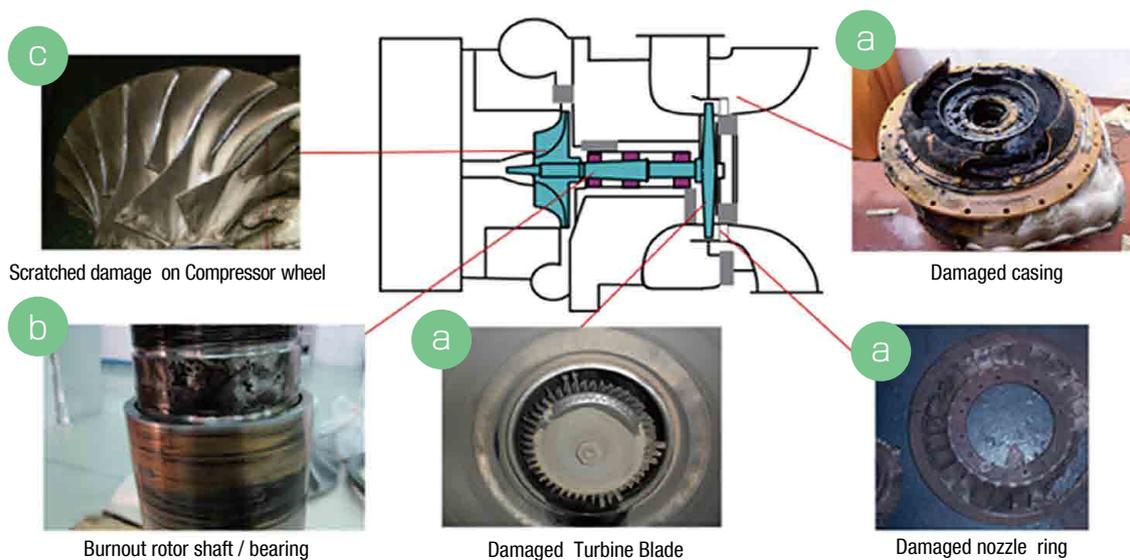
- a** To damaged turbine blades, nozzle rings, and casing and others (or damage to other parts by contact with fragments of damaged turbine blades or others)
- b** When the turbo charger rotor rotates at abnormal speed it can lead to failure of the rotor shaft and or journal/thrust bearings.causing abnormal wear and leading to heat damage and / or scratches.
- c** To occur a slight gap of alignment in the rotation of a shaft due to a damaged bearing, and to occur scratches on both compressor wheel side and casing sides when the compressor comes into contact with a casing.

Figure 14 Damaged parts caused by explosion or over run /reference*7

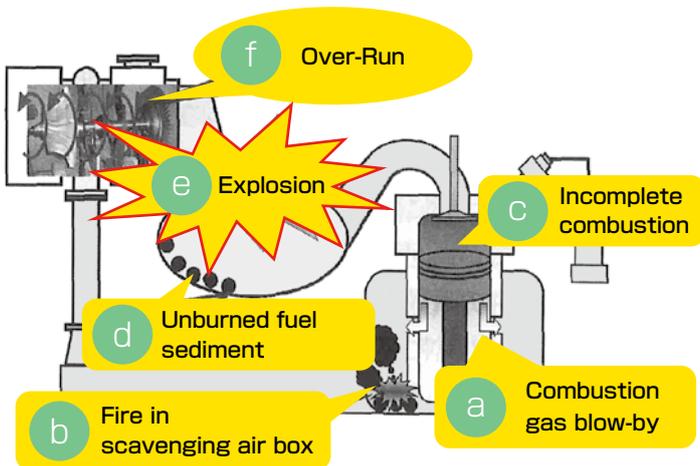
- b** As a consequence, the combustion gas blows through the piston ring and reaches the scavenging air box. At the time, if the inside of the scavenging air box has oil sediment residue therein and the oil sediment is lit, a fire will occur. (Figure 16). At the same time, air from the scavenging air box is sent into the combustion chamber with air containing CO₂ because of this fire.

- e** Next, when the fuel accumulates to a certain extent, firing or explosive combustion will occur.
- f** This causes the turbo charger to over- run.

Figure 15 Mechanism of explosion/over-run of turbochargers due to fire in scavenging air box /reference*7

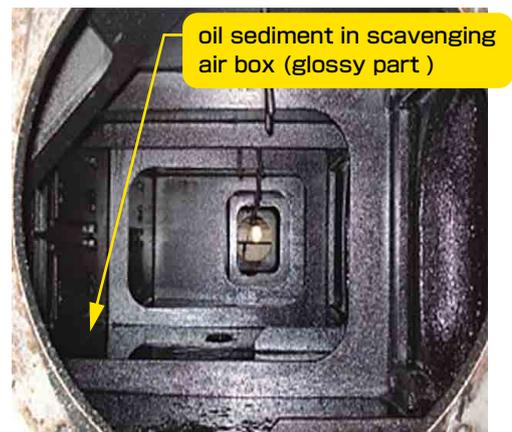
Figure 16 State of oil sediment in scavenging air box / reference *7

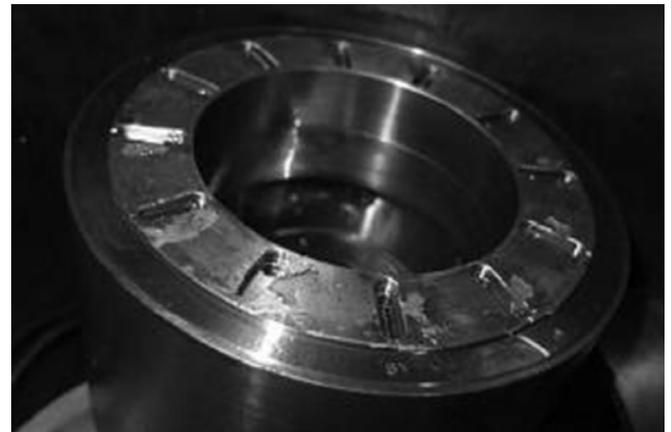
- Turbine blade: damaged (Figure 17)
- Journal bearing: burnout
- Labyrinth: damaged
- Nozzle ring: deformed (Figure 18)
- Thrust bearing: peeled off white metal (Figure 19)

As we mentioned the mechanism of explosion and over-run, described in above (4)- ② , a fire occurred in the scavenging air box and the fuel burned incompletely in the combustion chamber. As a result of this, unburnt fuel accumulated in the exhaust manifold and exploded.

Figure 19 Thrust bearing with metal peeled off / reference*7

As for the preventive measures, the problems of “Retention of oil in the manifold or scavenging air box” or “Blow-by occurrences” in (4) - ② , may be prevented by, for example, removing unburnt fuel or lubricating oil and ensuring proper maintenance. That is to say, it is important that the basic actions of inspection, maintenance and cleaning are carried out rigorously and routinely.

- To inspect and clean the exhaust pipe, manifold or turbo charger properly for preventing an explosion of the exhaust manifold.
- To inspect and clean the scavenging air box (including drain pipes) properly for preventing a fire in the scavenging air box.
- To inspect and make a maintenance (weakened and declined amount measurement) of the piston ring or piston crown regularly for preventing blow-by.
- To inspect and make a maintenance of fuel injection valves regularly for good combustion.

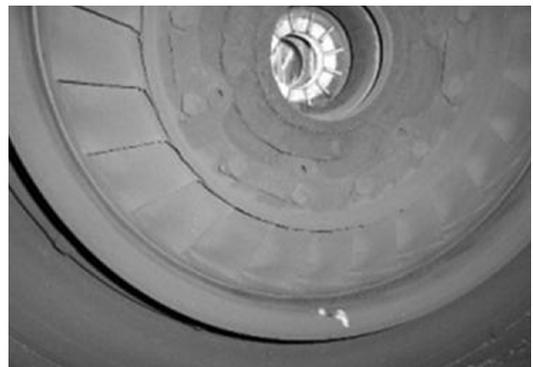
Judging from circumstance, it was impossible for the ship to self-propell. The detailed investigation was conducted after the ship was towed into the port. It was found that there was significant adhesion of carbon on the turbine blade and the nozzle ring, (Figure 20 and 21).

As for the causes of damage, the causes were related to dirty deposit due to incomplete combustion in diesel main engine and a lack of regular cleaning.

Figure 21 Carbon adhering excessively on nozzle ring / reference*7

- ① To clean stained items and to replace damaged components such as bearings and sealing and etc. (Figure 22 and 23), and
- ② To make a maintenance work of the diesel main engine (air cooler, piston ring replacement and others).

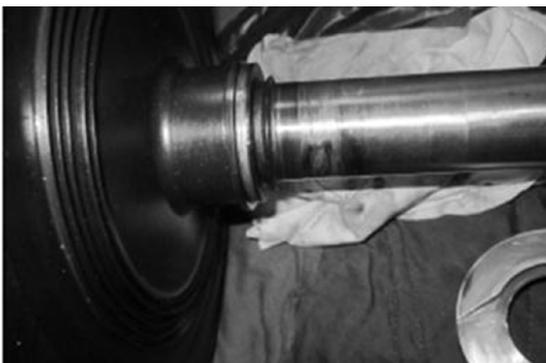
Figure 22 Scratches in rotor shaft / reference*7

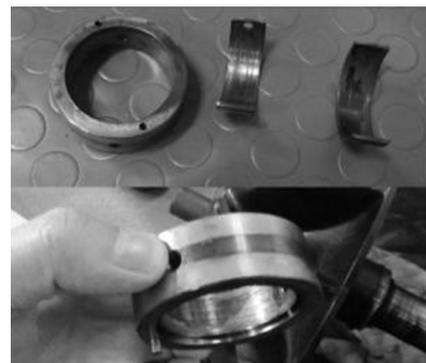
Figure 23 Slipping out of lub. oil hole on bearing / reference*7

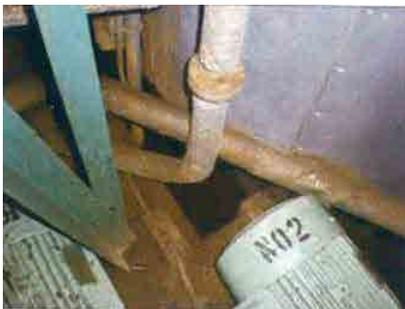
- a Internal damage of area in contact with boiler water
- b Outside damage of area in contact with combustion gas

Figure34 Lower boiler casing
(Water leakage trace from upper part)

For their damage prevention, it is important for crew “to manage and treat the boiler water (water quality check/chemical treatment/discharge of boiler water (blow-off))” and “to inspect from inside of combustion chamber”.

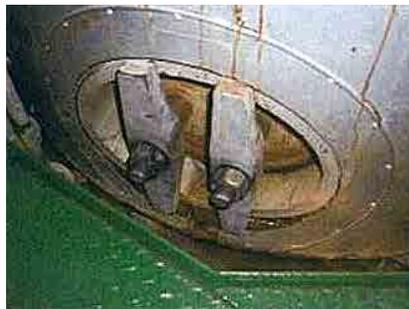
Figure35 Lower drum/manhole
(Water leakage trace from upper part)

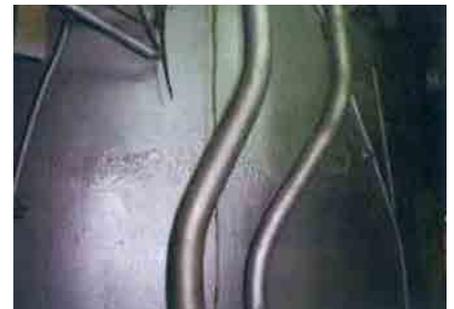
Figure36 Upper boiler casing
(Paint swelling)

It can be considered that the deformation and swelling of the upper drum of the boiler was caused by overheating when the water level in the drum decreased. Safety features such as alarms, fuel shut off, etc., should come into play, based on the automatic detection device of the drum water level transmitter when the water level decreased. However, above mentioned problems will occur if the defects of the water level transmitter are not rectified.

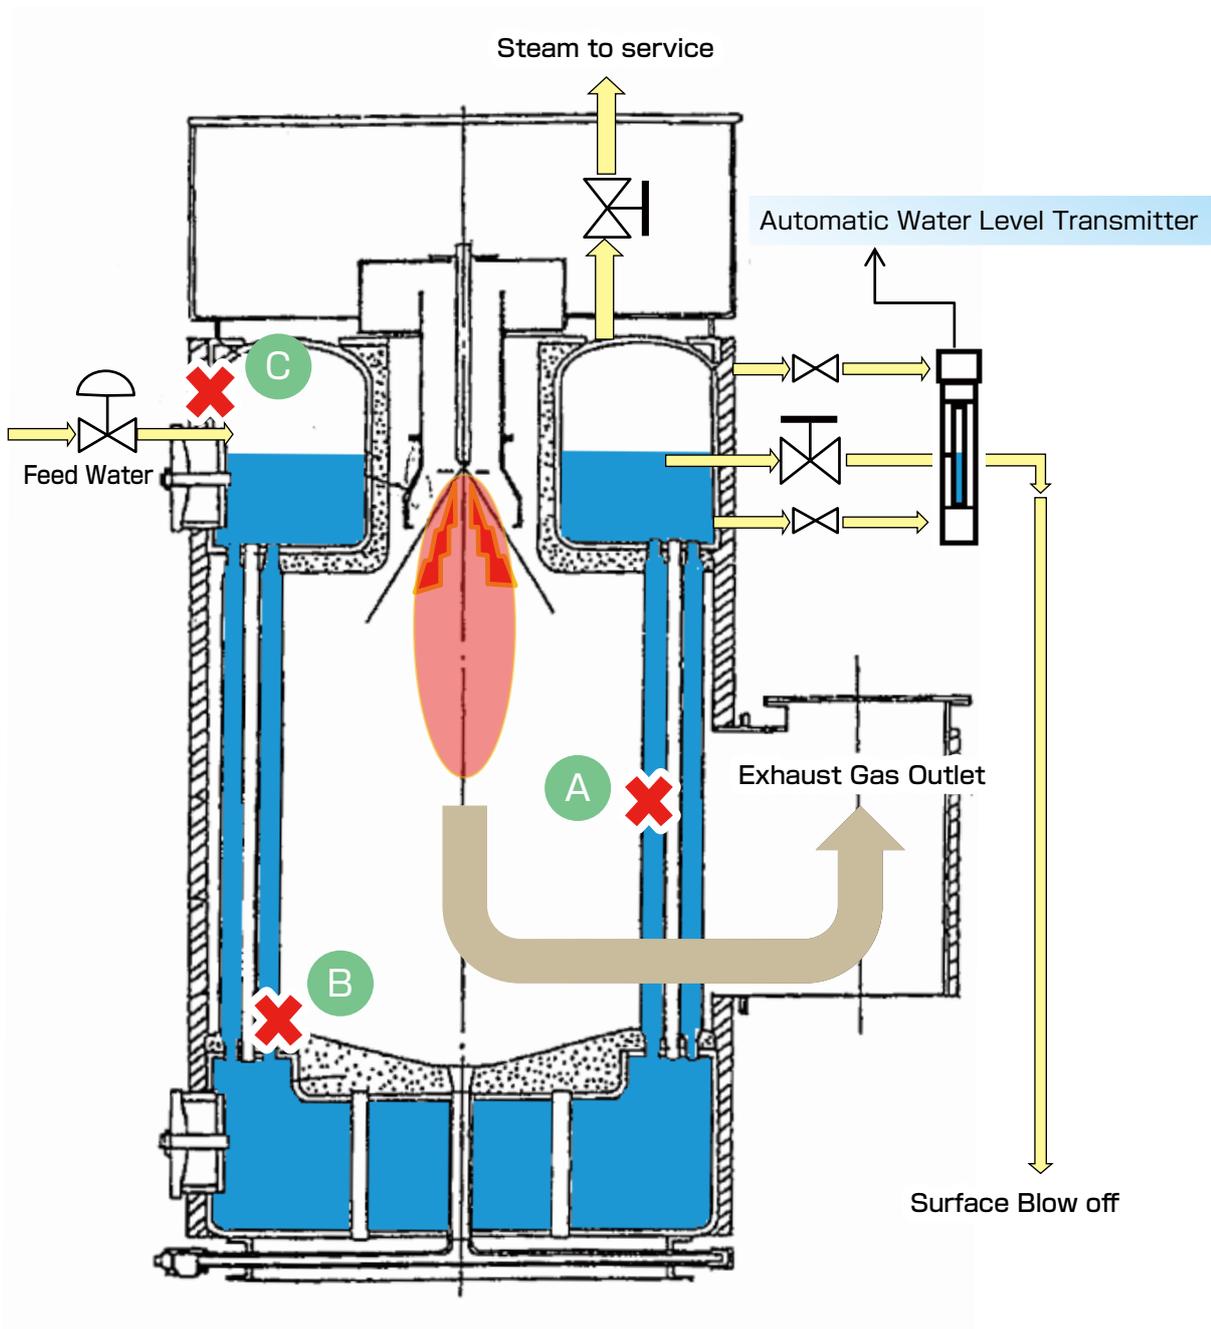
Figure 37 Cross section view of boiler

② The boiler installed on this ship is a once through boiler shown in Figure 37 “Cross section view of boiler”. Unfortunately there is no detailed information including the extent of the damaged part. Judging from the trouble situation, the main cause of water leakage might be a breakage of the water tube caused by corrosion from both boiler water and combustion gas side, and the second cause might be considered to be the deformation of a drum.

We set the damaged locations, shown in Figure 37, into three sections based on the assumed cause considered from trouble situation. We will check the important points in the order of A, B, and C.

- ③ We show automatic water level transmitter in Figure 37. Even if the automatic water level transmitter and devices related to the transmitter operate normally, and If the pipe line connected with the upper drum is clogged, it does not reflect the correct water level in the upper drum. Therefore, it is necessary for crew to clean these devices regularly for the automatic water level transmitter to operate correctly and constantly without any blockage in this pipe line.

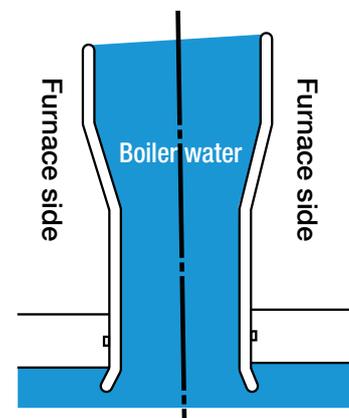
Figure40 Structure of expanding part

The boiler drum and water pipe are connected with the expansion of the tube at the end of the water tube (expanding). From Figure 40, it shows about the component drawing of the expanding junction. Leakage of water may occur due to the influence of loosening of the same junction, which led to flooding of the bottom of the combustion chamber (furnace).

In addition, the sulphuric acid is created due to the chemical reaction between the leaked water and the sulphur contained in the unburned soot residue accumulated on the side of combustion chamber, and led to sulphuric acid corrosion.

- It is necessary for crew to prevent to drop drain into the furnace if the boiler is equipped with steam soot blower. If there is the dropped drain from the soot blower, it reacts with soot and combustion gas, as similar mechanism to the previous location B (Figure 40: structure of expanding part) and the broken hole of sulphate corrosion occurs.

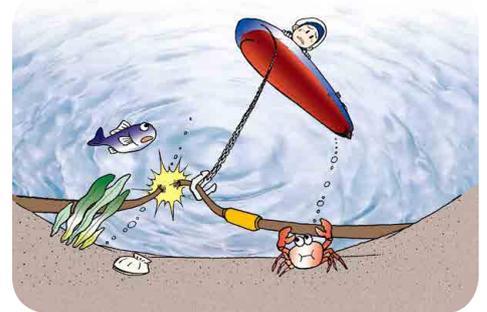
When heaving up the anchor after resolving the trouble of the diesel main engine, as shown in Figure 44 and 45, it was found that the anchor was tangled around the submarine cable (transmission line of electric power company). She anchored urgently instructed by the pilot, however, the location was prohibited area for anchoring as shown in Figure 46.

Figure 44 Image figure of submarine cable damage

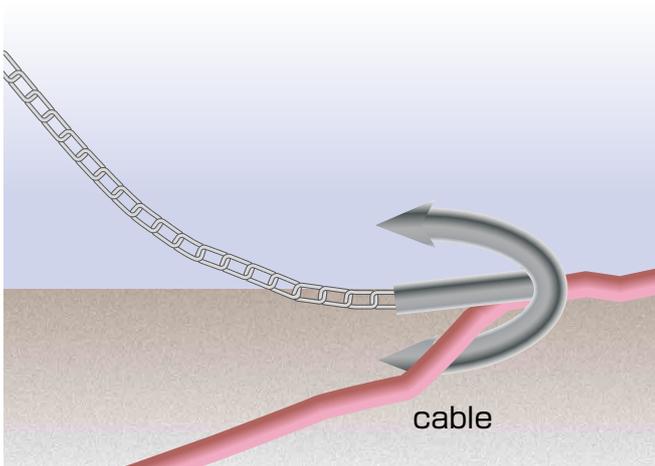
Figure45 Anchor's contacting condition to the cable

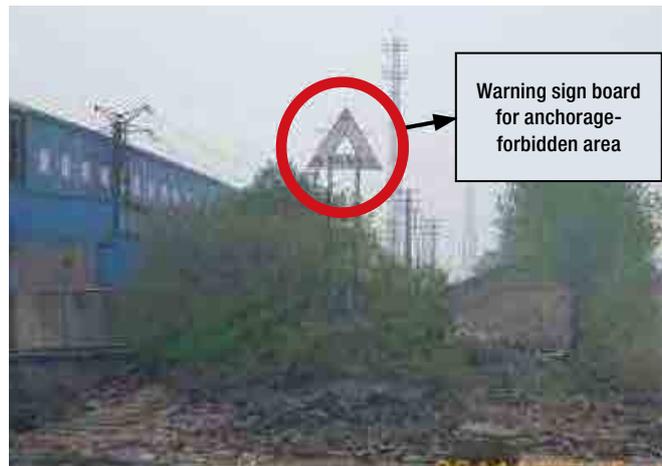
Figure 46 Warning sign board for anchorage-forbidden area

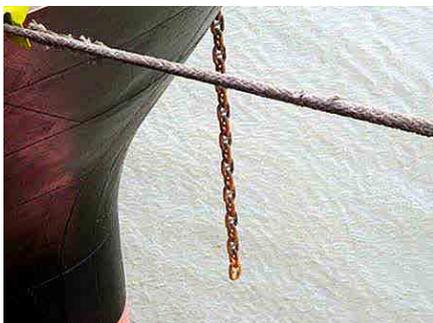
The anchor chain was cut as shown in Figure 47, and the anchor was removed from a submarine cable by a underwater company.

Figure 47 Cut Anchor chain

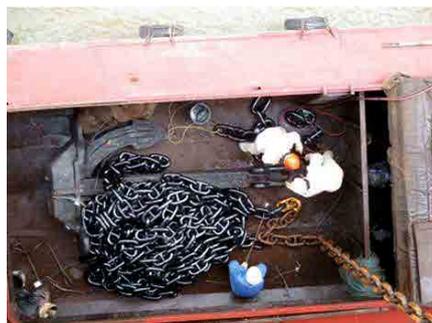
Figure 48 Connecting work of an anchor

Still, Maritime Safety Agency did not approve the departure with one side anchor only, and requested installation of new anchor and chains at the repair dock. The shipowner arranged the replacing the anchor and chains as shown in Figure 48 and 49.

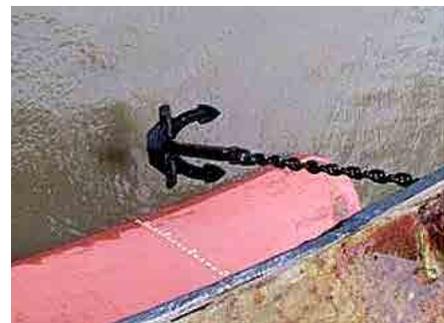
Figure49 Functional validation of anchor chain and anchors

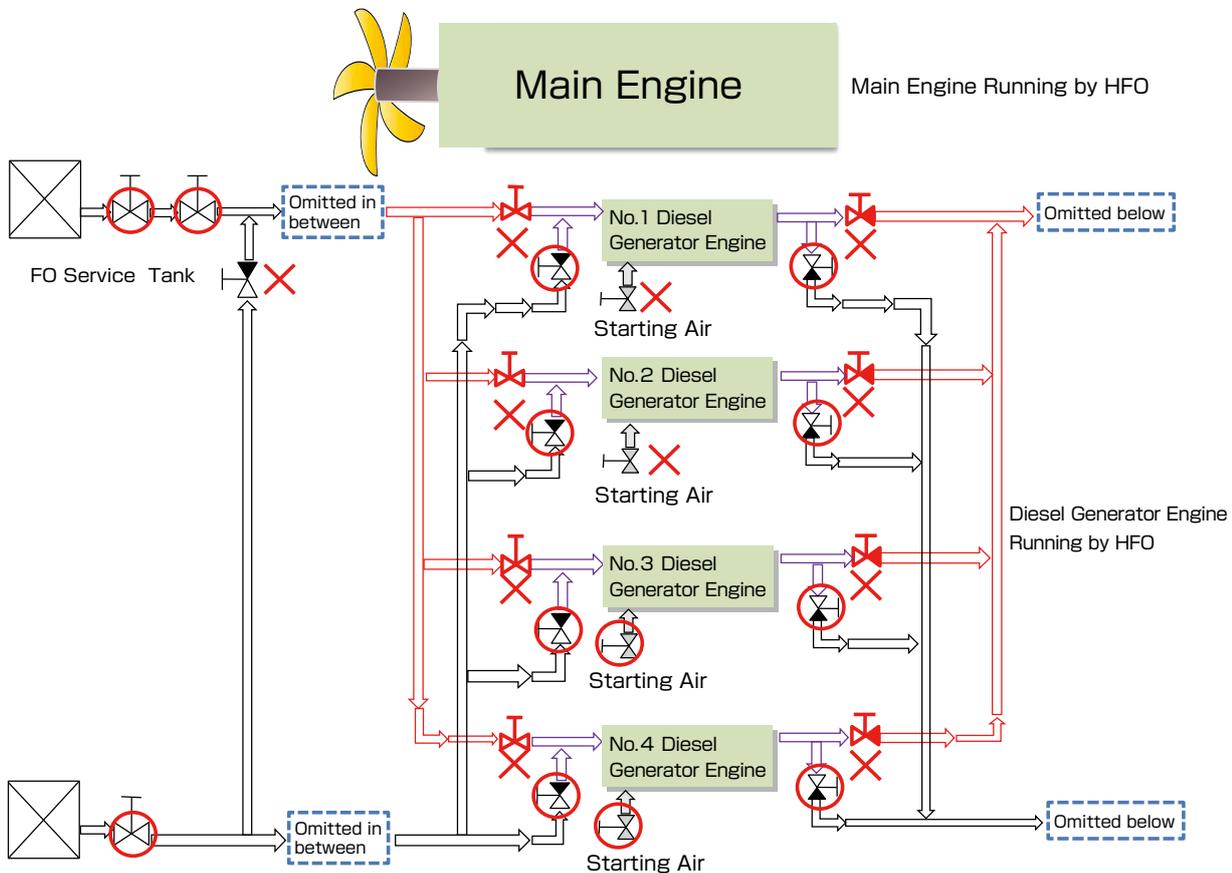
Figure 57 Outline of Fuel oil and Starting air system for Diesel Generator Engine

- The starting air valve was still closed, thus the starting air was not supplied and could not start automatically. Please refer to “Outline of Fuel oil and Starting air system for diesel generator engine “ (Figure 57).
- The engineer in charge (3/E) did not follow work instructions and operated with the starting air valve closed. However he followed work instructions from another ship, **[Breach of work instructions]**.
(Of course, the starting air valve should be closed for safety at engine maintenance work. However, if it is not opened in S/B, it cannot be started automatically.)

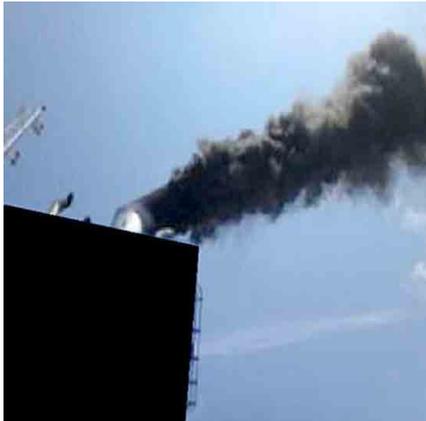
After the vessel arrived at the terminal, during unloading cargo operations, the black smoke with soot came out from funnel due to the boiler's defect. It had continued for 20 or 30 minutes (Figure 59). As a result, the soot scattered widely (Figure 60) and accumulated to the ocean, terminal, and some factories being located near the terminal (Figure 61, 62, and 63).

Figure 59 Black smoke

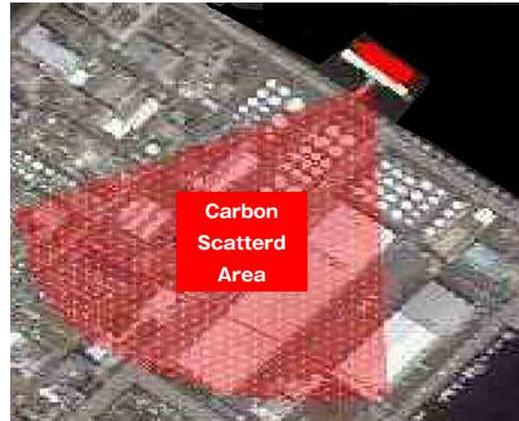
Figure 60 Scattering range of black smoke (550 m)

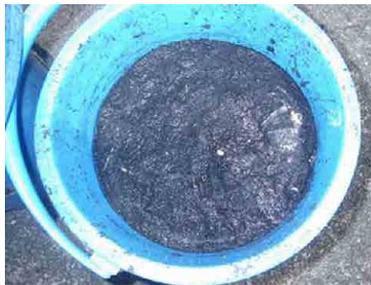
Figure 61 Cleaning up removed soot (inside bucket)

The shipowners arranged clean-up work immediately and it took for 3 days to complete.

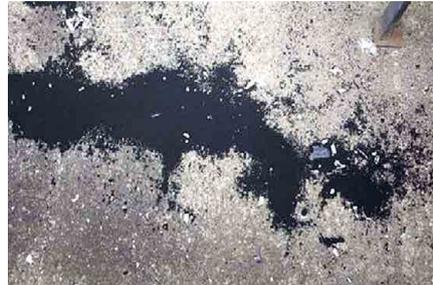
Figure 62 Soot on working passage of factory

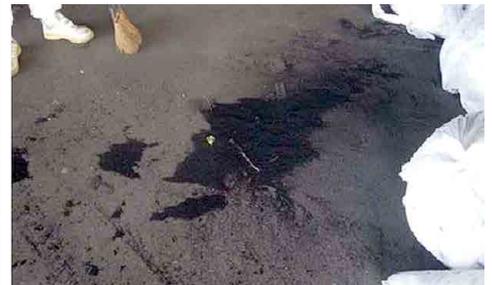
Figure 63 Soot on working passage inside factory

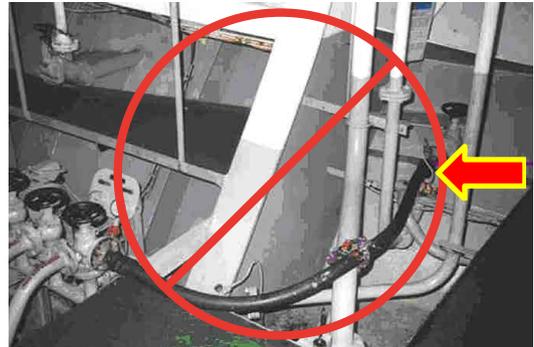
Figure 65 Magic Pipe / reference*16

- 1 A lot of oil-water-mixed bilge was illegally discharged to the sea.
- 2 Misstatement on Oil Record Book
- 3 Engineers plotted together, and for example as shown in Figure 65 they illegally install special pipes made in the vessel on bilge overboard line; they illegally put it between bilge pump and overboard valve, by-passing bilge separator, and discharged the bilge overboard.
- 4 During USCG inspection, they removed and hide the illegal pipeline, and evaded the inspection.

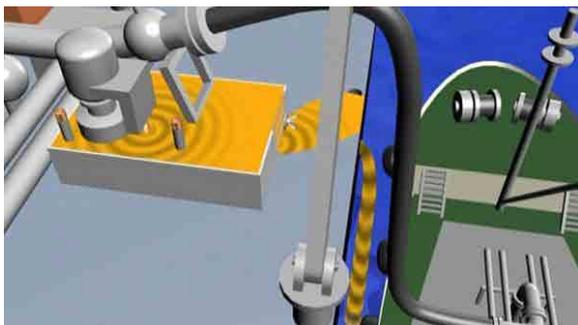
From Figure 68, it is shown that HFO was overflowed from the air vent pipe of the vessel's starboard fuel tank to the deck, and some of HFO (approx. 0.6 KL) was spilled to the sea. From Figure 69, it is shown that some of the spilled oil was getting over the oil fence extended around the vessel and diffused. Moreover, the sticky spilled oil spread both to harbour facilities and to the pleasure craft moored in the port. As a result, it took about one month to complete the cleaning work for the spilled oil.

Figure 68 Leakage Image from air vent pipe / reference*17

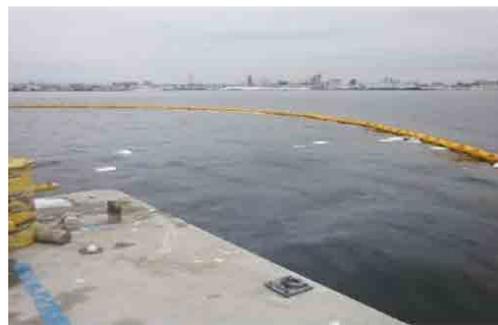
Figure 69 Vessel surround

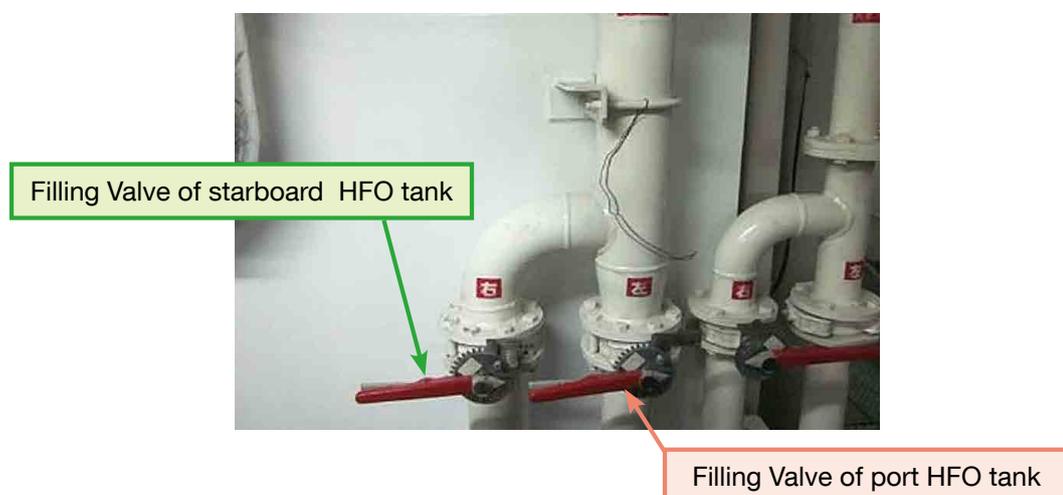
- 1 Bunkering started after fully opened the filling valve of the starboard HFO tank, Oiler A who was assigned by the bunkering plan, based on C/E's instruction, was engaged in the bunkering works.
- 2 According to the bunkering plan, when 50 kl of the filling oil was reached in the starboard HFO tank, the filling valve of the port HFO tank, as shown in Figure 70, needed to be opened and the filling valve of the starboard HFO tank needed to be closed.
- 3 However, oiler A wrongly closed the valve of the port HFO tank, and at the same time, he kept the filling valve of the starboard HFO tank fully opened.
- 4 As a result, HFO was overflowed from air vent pipe to deck, and was spilled to the sea due to exceeding the capacity of the starboard tank.

Figure 70 Arrangement of filling valve of HFO tanks for Bunkering
(Attention, Filling valve of starboard tank is located on the left side!)

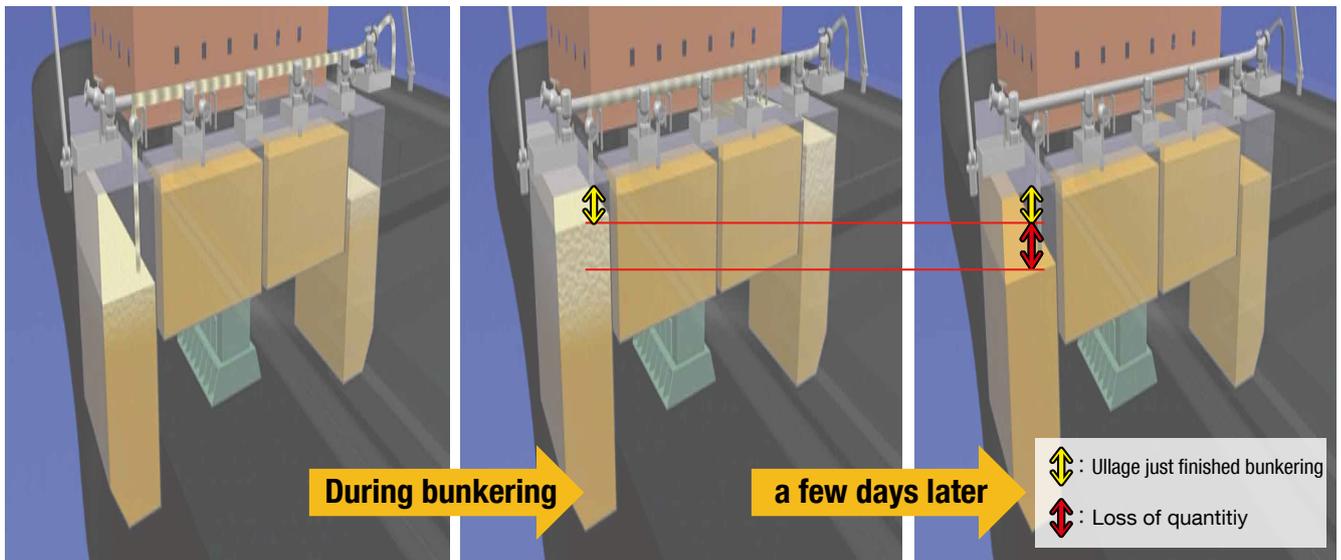
Figure 76 reference *17

From Figure 75, it is shown that fuel oil mixed with air is slightly supplied to the fuel oil tank in the middle of bunkering. At the final step of bunkering, from Figure 76, it is shown that you will see a lot of the fuel oil mixed with air in the upper part cream coloured as faked fuel level. A few days later, from Figure 77, it is shown that the bubbles will be gone, and as the actual fuel level appears, you will find the loss of volume, which will be the bubbles that have vanished.

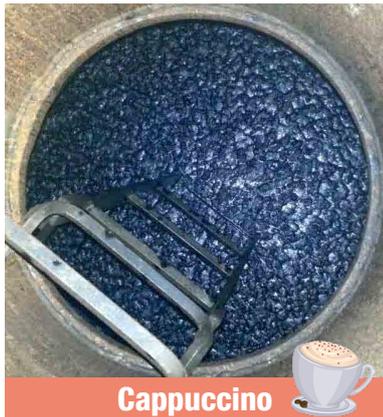
Firstly, when compare the surface condition in the tank. From Figure 78, it is shown that a rough surface is in a cappuccino state which includes air (bubbles). From Figure 79, it is shown that smooth surface is in normal state which does not include air (glossy).

Figure 78 [Cappuccino condition]
2 hours after bunkering: a lot of strong bubbles / reference*19

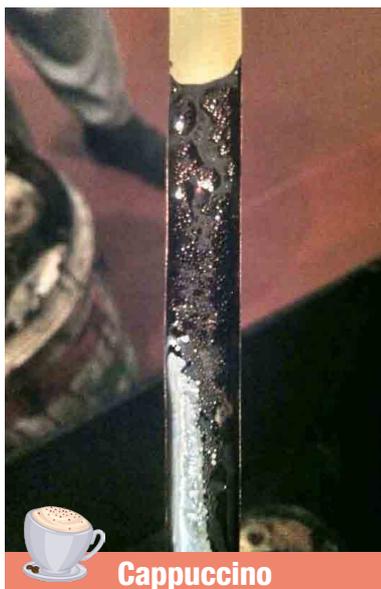
Next, when compare the surface condition on the sounding tape. From Figure 80 it is shown that the tape without gloss is in a cappuccino state which includes bubbles. From Figure 81 it is shown that the tape with clear glossy reflection is in normal state which does not include bubbles.

Figure 80 [Cappuccino status]
a lot of bubbles on the tape (without lustre) / reference*19

- ① Before bunkering check and measure the total bunker oil quantity and its temperature in the barges.
- ② Opening of ullage hatches or tank hatches should provide an opportunity to observe any foam on the surface of the bunkers. Bubble may also be detected on the ullage tape as shown in Figure 80. If there is no bubble then the oil level on the tape should appear distinct with no entrained bubbles as shown in Figure 81.
- ③ If entrained air is suspected then obtain a sample of the fuel by lowering a weighted bottle into the tank. Pour the sample into a clean glass jar and observe carefully for signs of foam or bubbles.

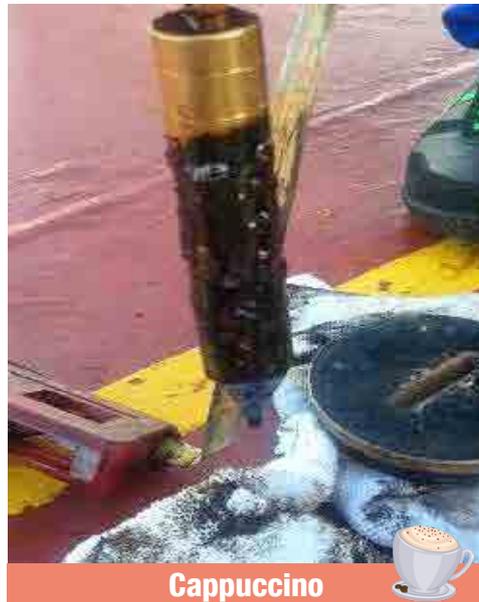
Finally, when compare the surface condition of the sounding tape's bob section (Dip weight). From Figure 82 it is shown that the state of the bob section without gloss is in the cappuccino state including the bubbles. From Figure 83 it is shown that the state of the bob section with clear glossy reflection is in normal state which does not include bubbles.

Figure 82 [Cappuccino status]
a lot of bubbles on the tape's dip weight
(without lustre) / reference*19

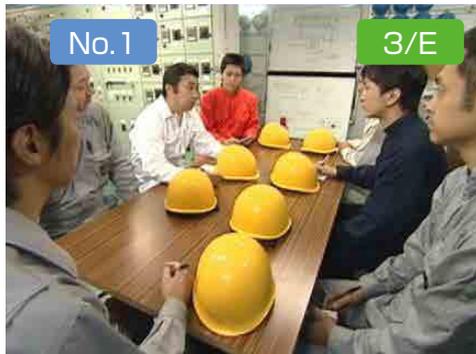
Figure 93 Advice from No.1 Oiler to 3/E

The direct cause was that residual pressure left in the strainer cover could not pull out , since the air vent pipe was clogged. As the result, the cover was blown off vigorously when engineers loosened the cover nut. Despite the person in charge followed as instructions doubtlessly, he neglected to confirm the essential state when releasing out residual pressure.

Therefore, the air vent pipe was clogged up, however engineer and crew could not let their humanly five senses work towards the following phenomenon, and then could not feel anything abnormal, which caused the trouble.

- 1 To listen to the sibilant air-borne sound which can be heard before sea water comes out from air vent pipe vigorously
- 2 To feel the temperature change coming from the change from air to sea water inside the pipe, which they could have felt if they had touched air vent pipe.

It is primitive, but it is important for crew to feel the change of state by applying humanly five senses and making a judgement, not only following instructions.

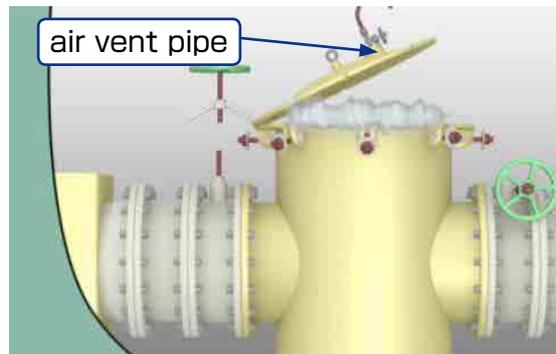
Figure 94 Sea water strainer
