Chapter 1 | Occurrence Status of Engine Trouble and Trends of Accident Causes

1.5 Details of Damaged Parts (Class NK)

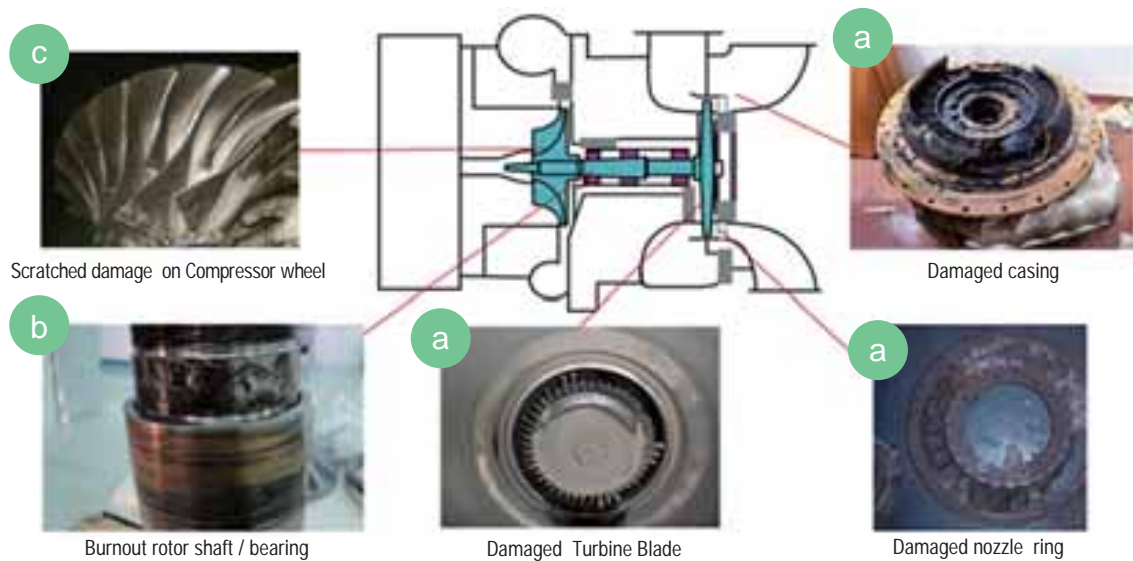
Figure 14 Damaged parts caused by explosion or over run /reference*7

From Figure 14, it shows about the influence and impact of the explosion or the over-run.

- a** To damaged turbine blades, nozzle rings, and casing and others (or damage to other parts by contact with fragments of damaged turbine blades or others)
- b** When the turbo charger rotor rotates at abnormal speed it can lead to failure of the rotor shaft and or journal/thrust bearings.causing abnormal wear and leading to heat damage and / or scratches.
- c** To occur a slight gap of alignment in the rotation of a shaft due to a damaged bearing, and to occur scratches on both compressor wheel side and casing sides when the compressor comes into contact with a casing.

If the explosion of the turbo charger is larger, both the damage will affect the turbo charger and the fire will be broken out in the engine room as the worst scenario.

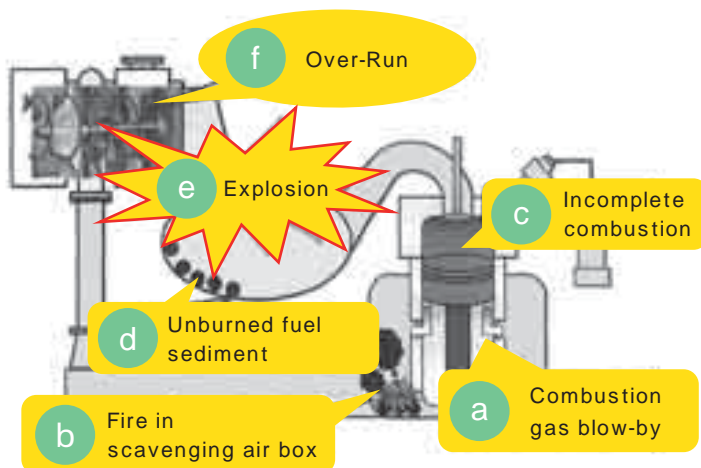
Figure 15 Mechanism of explosion/over-run of turbochargers due to fire in scavenging air box /reference*7

From Figure 15, it is shown what the mechanism of an explosion or over-run occur in order from **a** to **f** after breaking out of fire in scavenging air box.

- b** As a consequence, the combustion gas blows through the piston ring and reaches the scavenging air box. At the time, if the inside of the scavenging air box has oil sediment residue therein and the oil sediment is lit, a fire will occur. (Figure 16). At the same time, air from the scavenging air box is sent into the combustion chamber with air containing CO₂ because of this fire.

- e** Next, when the fuel accumulates to a certain extent, firing or explosive combustion will occur.
- f** This causes the turbo charger to over- run.

In addition to this, the broken hole of the piston crown, poor atomization of the fuel injection valve, or long-term slow steaming might cause of this.
