# Chapter 2 | Trend of Claims Caused by Engine Trouble In Ships Entered With Our Club

## 2.1 Trend in Our Club

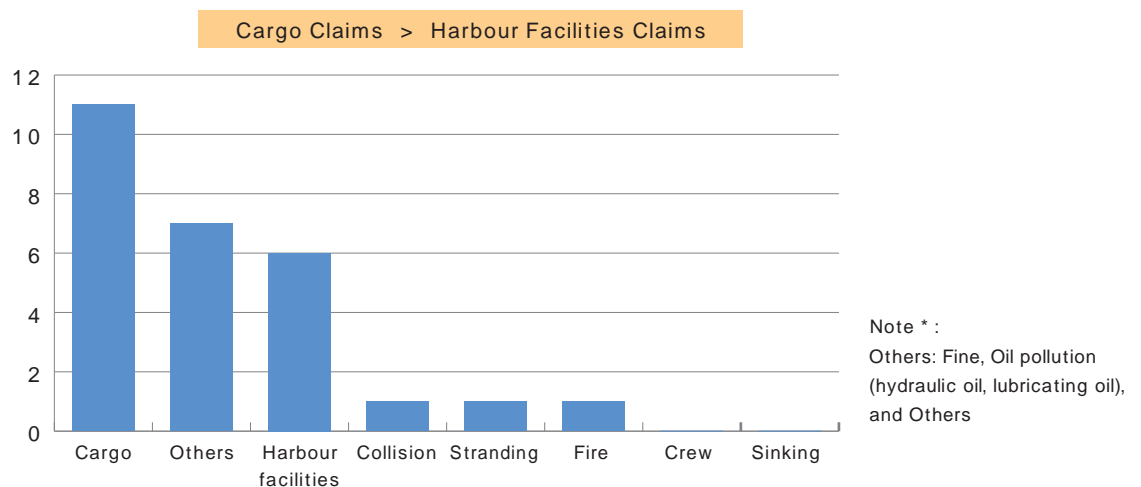
Figure 29 Trend of Claims 27 cases (2008 - 2014PY)

When we examined the 7 years of claims caused by the engine trouble from 2008 PY to 2014 PY, we confirmed 27 notable cases. According to a comparison of the number of claims shown in Figure 29, cargo claims, others, and harbour facilities claims are ranked in decreasing order of the number of claims. “Others” include the fine, and the leakages of hydraulic oil from cranes or lubricating oil from lubricating oil coolers in the engine room in addition to unclassifiable claims.

The claims number of collision and grounding is small, but if the engine trouble occurs in a heavy traffic water passage or coastal zone with a large volume of ship traffic, or harbour area, losses can be significant.

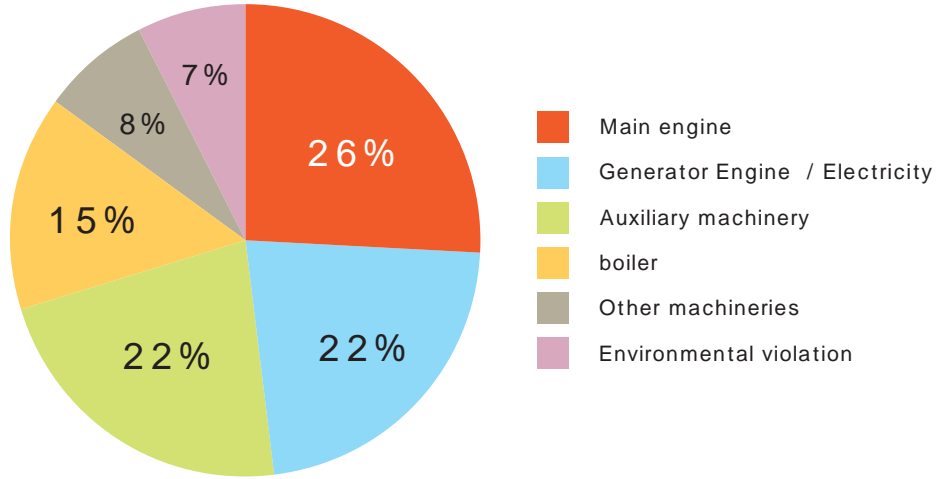
Figure 30 Percentage of direct causes by machinery

From Figure 30, it is shown that subtotal trouble of Main engine and Generator Engine / Electricity accounts for the half of the notable cases.

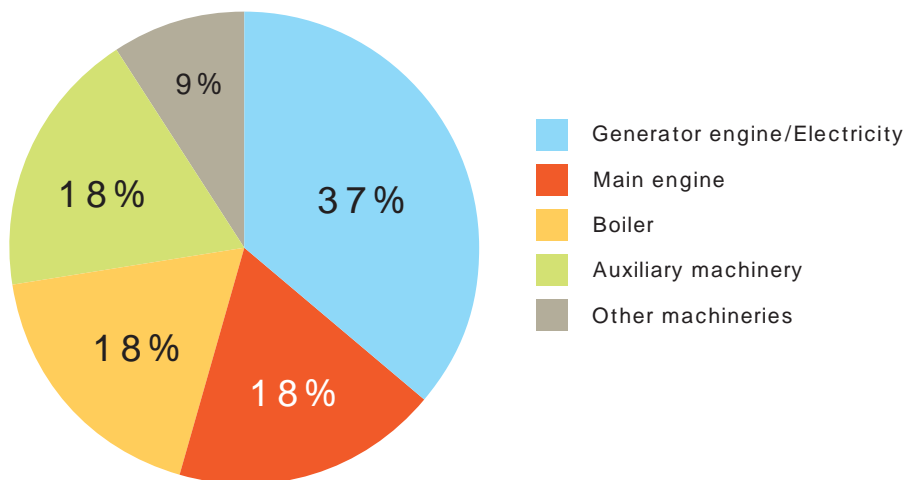
Figure 31 Percentage of direct causes by machinery leading to Cargo Claims

From Figure 31, it shows about a percentage of what machinery causes cargo claims. There are many cases involving claims to reefer cargo and reefer containers. The reefer cargo and reefer containers need the electric power to cool. Therefore, the power shortage trouble caused by Generator Engine / electricity system accounts for approx. 40% of the cases

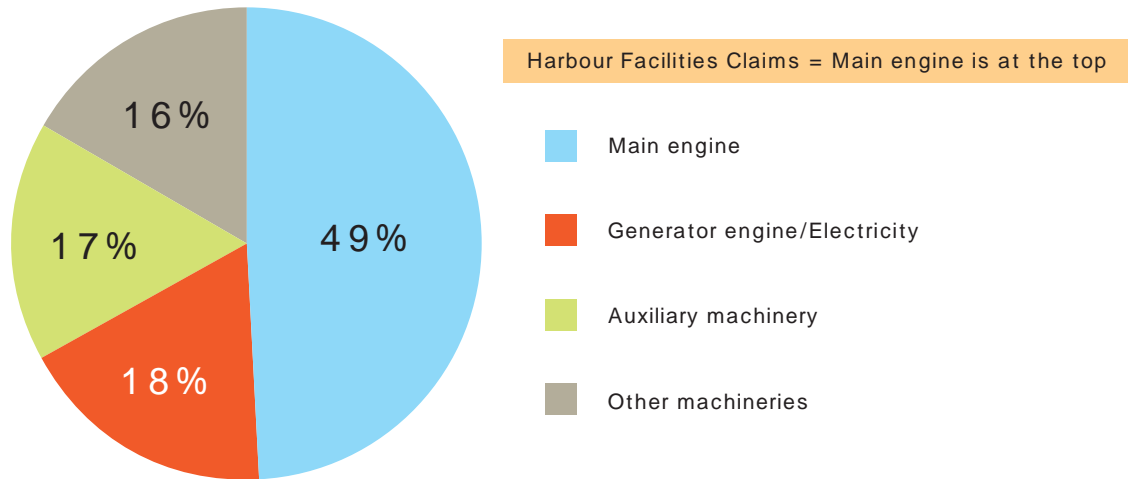
Figure 32 Percentage of direct cause by machinery leading to Harbour Facilities Claims

From Figure 32, it shows about a percentage of what machinery causes harbour facilities claims. The Main engine trouble occurring during harbour maneuvering accounts for approx. 50% of the cases.

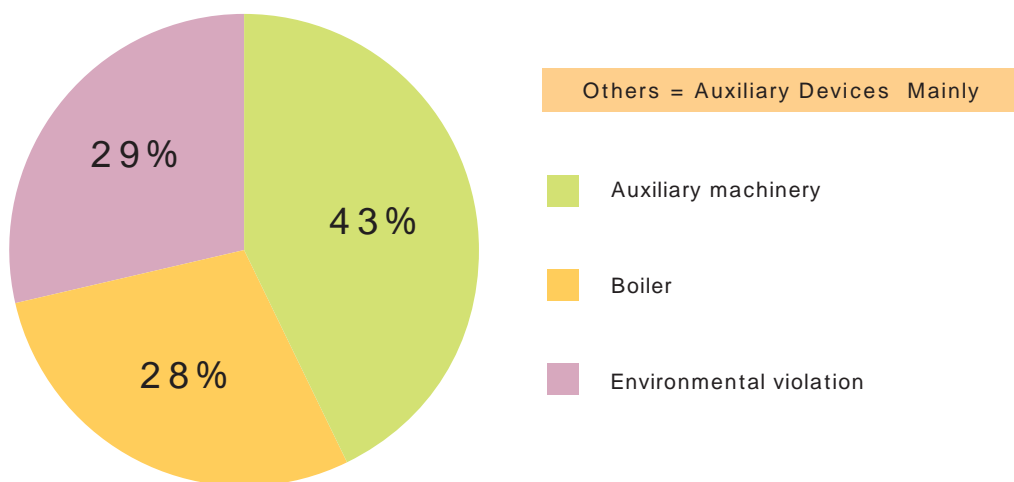
Figure 33 Percentage of direct cause by machinery leading to other claims

From Figure 33, it shows about a percentage of what machinery causes others. The auxiliary devices such as auxiliary machinery and boiler in engine room account for approx. 70% of the cases. Environmental claims by auxiliary devices including oil pollution from hydraulic oil leaking from cranes or lubricating oil from the lubricating oil cooler in the engine room, or black smoke due to incomplete combustion in a boiler.

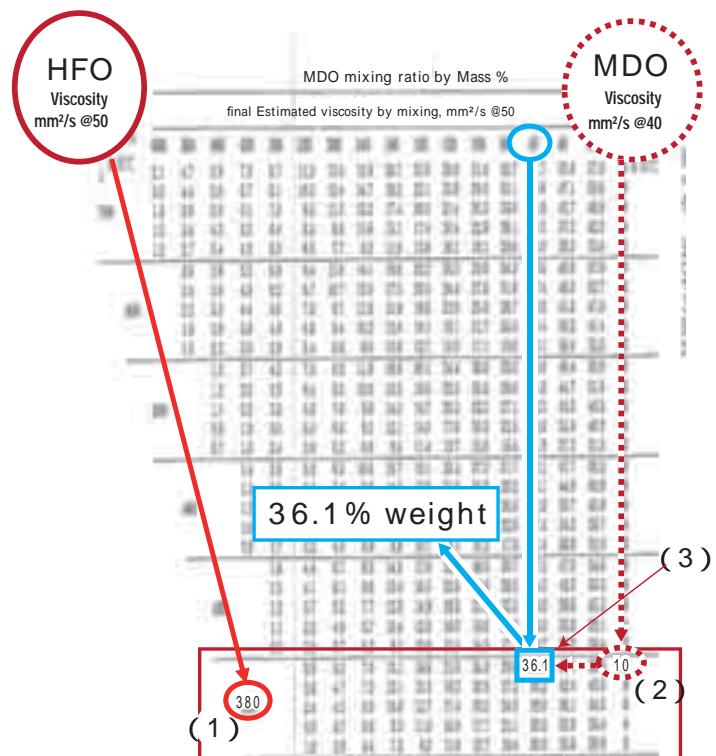
Figure 54 Estimated viscosity when mixing HFO and MDO /reference\*15 (Reference )

In order to decrease the viscosity of HFO from 380 mm<sup>2</sup>/s (cSt) @50°C to 60 mm<sup>2</sup>/s (cSt), What % (mass) of MDO 10 mm<sup>2</sup>/s (cSt) @40°C as a dilution needs to be mixed? Please refer to Figure 54.

Please search 60 mm<sup>2</sup>/s (cSt) @50°C crossing with above (2) Then you can find 36.1. showing (3) by blue line It is the read required mass%

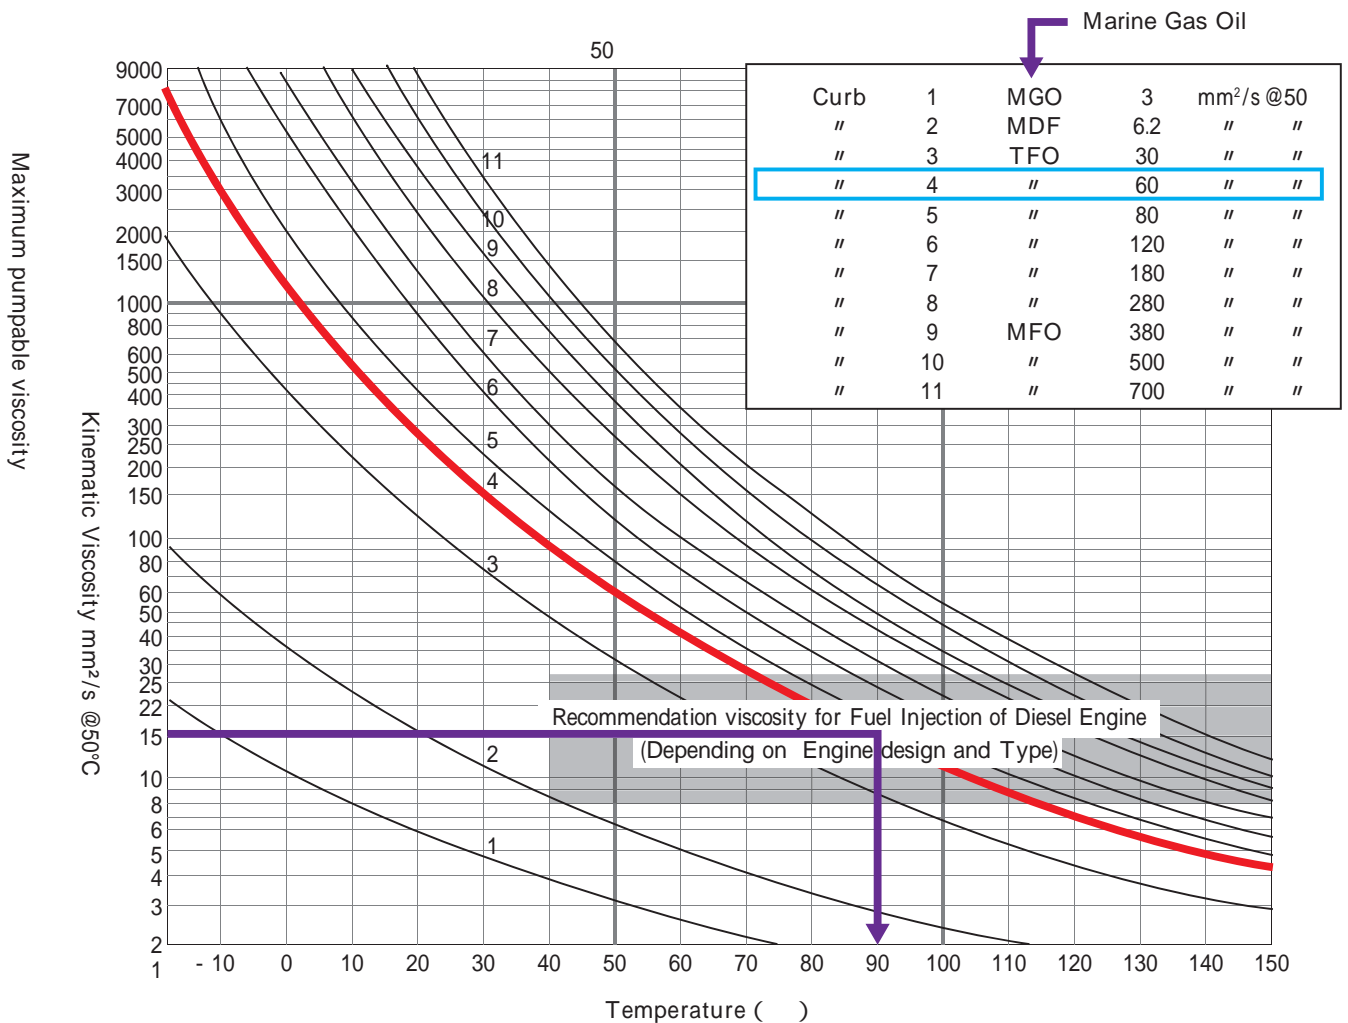
Figure 55 Diagram of viscosity/temperature of marine fuel /reference\*15 (Reference )

From Figure 55, it is shown that the relationship between temperature on the horizontal axis and viscosity on the vertical axis for Marine Fuels appears also in the engine manufacturer instruction manual. (For the bigger chart, please refer to Reference )

The following explanation is based on 60 mm<sup>2</sup>/s (cSt) which is the result from Figure 54. 60 mm<sup>2</sup>/s (cSt) is a red curved line with No.4. If the target fuel viscosity of TFO 60 mm<sup>2</sup>/s (cSt) is 15 mm<sup>2</sup>/s (cSt), the temperature can be found as 90°C by drawing a purple line.

Therefore, in this trouble case, if the viscosity in the system is 60 mm<sup>2</sup>/s (cSt), and if the situation is a continuous fuel usage, it can be presumed that the setting temperature was not too excessive.

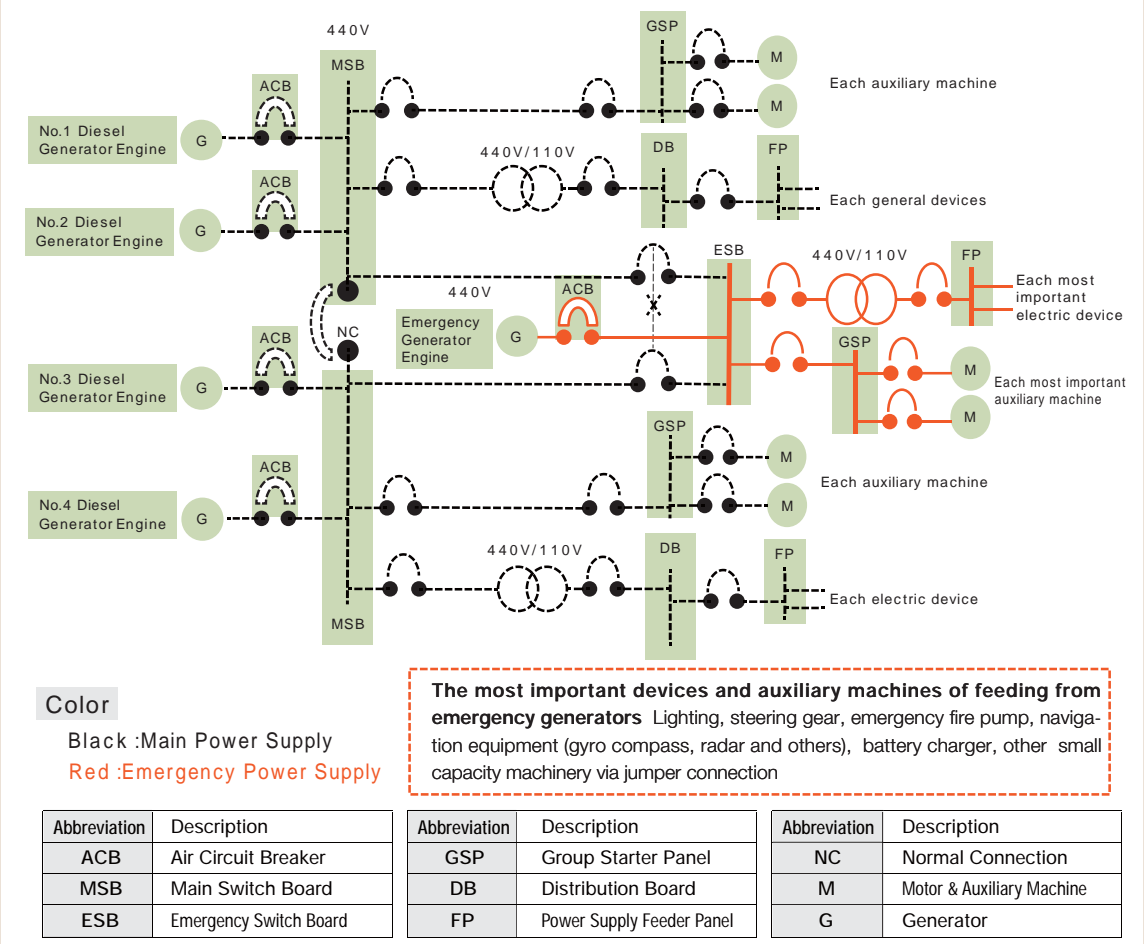
Figure 56 Outline of power supply system

As "Outline of power supply system" (Figure 56) shows, after No.4 GE had stopped, power was not supplied from the generators connected with the buses of black dotted main power lines. Then the Emergency Generator started automatically. The power from the emergency generator was exclusively supplied to the equipment, listed below, connected with the red solid lines.

Lighting equipment, steering gear, navigational equipment such as gyro compass and radar, emergency fire pump, battery charger, other small capacity machinery via jumper connection

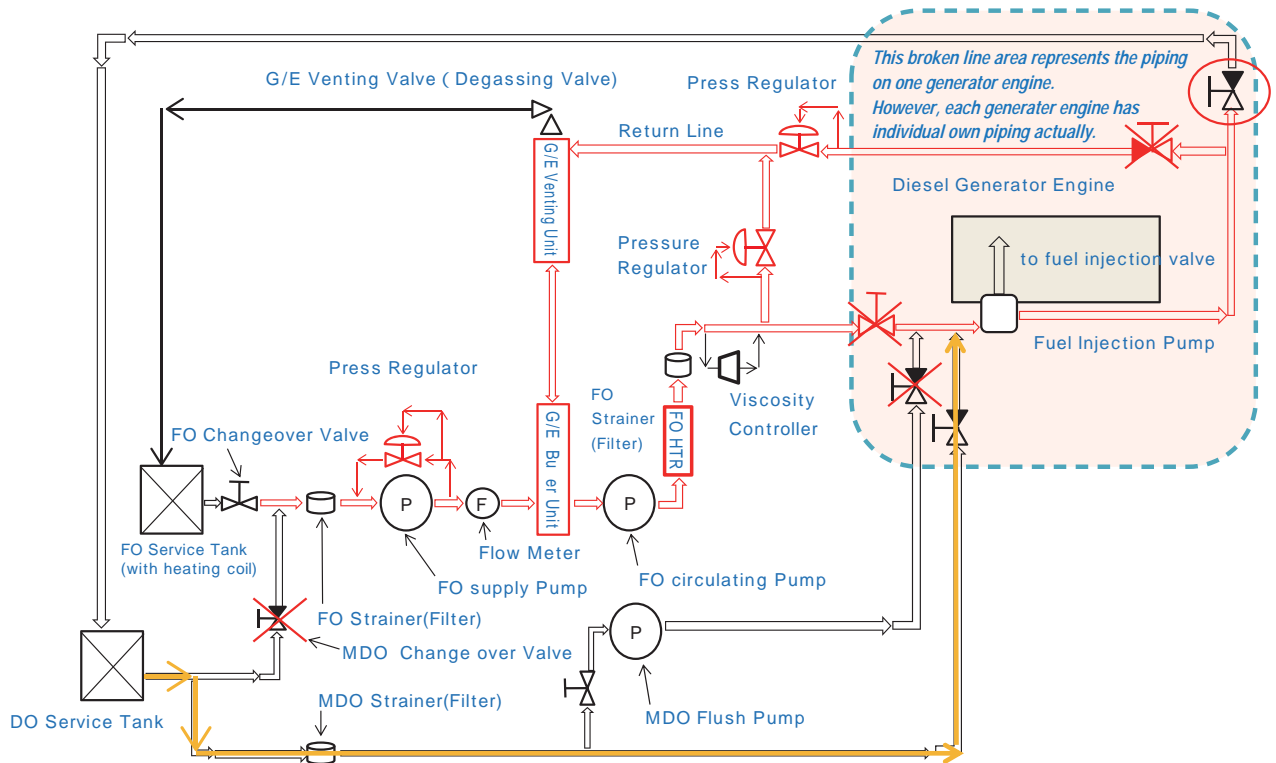
Figure 58 Outline of fuel oil supply system for Diesel Generator Engine

About fuel, as “Generators, The Yellow Line on “Outline of fuel oil supply system for Diesel Generator Engine (Figure 58)” shows, if you operate only the valve connected with the MDO service tank, the fuel oil could be supplied with gravity to the point just before the fuel supply pump directly driven by the diesel generator engine. Therefore, if the starting air is supplied into the generator, and then engine can be run, because the direct driven fuel supply pump will be driven. Then fuel will be led into the fuel injection pump, fuel will be injected into the cylinder by cam drive. About the starting air, compressed air will be filled in the emergency air reservoir by the emergency manual air compressor.

Therefore, it can be considered that it was not a single cause that brought about the long-term blackout accident, but an error chain coming from several causes.

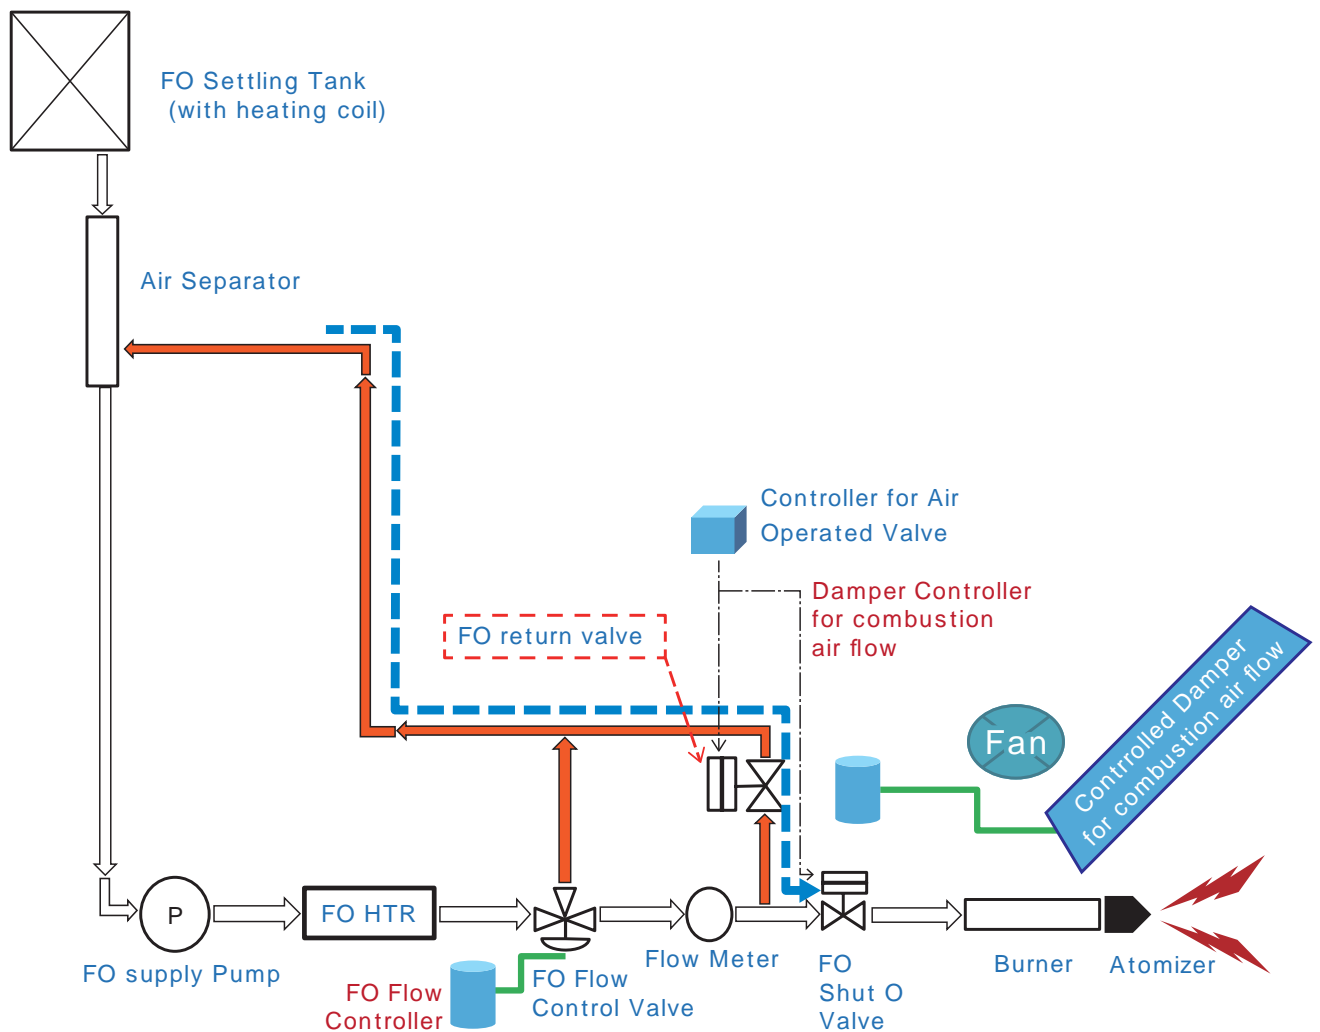
Figure 64 Outline of fuel supply system for boiler

“ Outline of fuel supply system for boiler ” as shown in Figure 64.

In front of fuel oil shut-off valve, there is the return valve driven by air cylinder, which must be closed during combustion.
