The Japan Ship Owners' Mutual Protection & Indemnity Association Loss Prevention and Ship Inspection Department

CASE STUDY

P&I Loss Prevention Bulletin

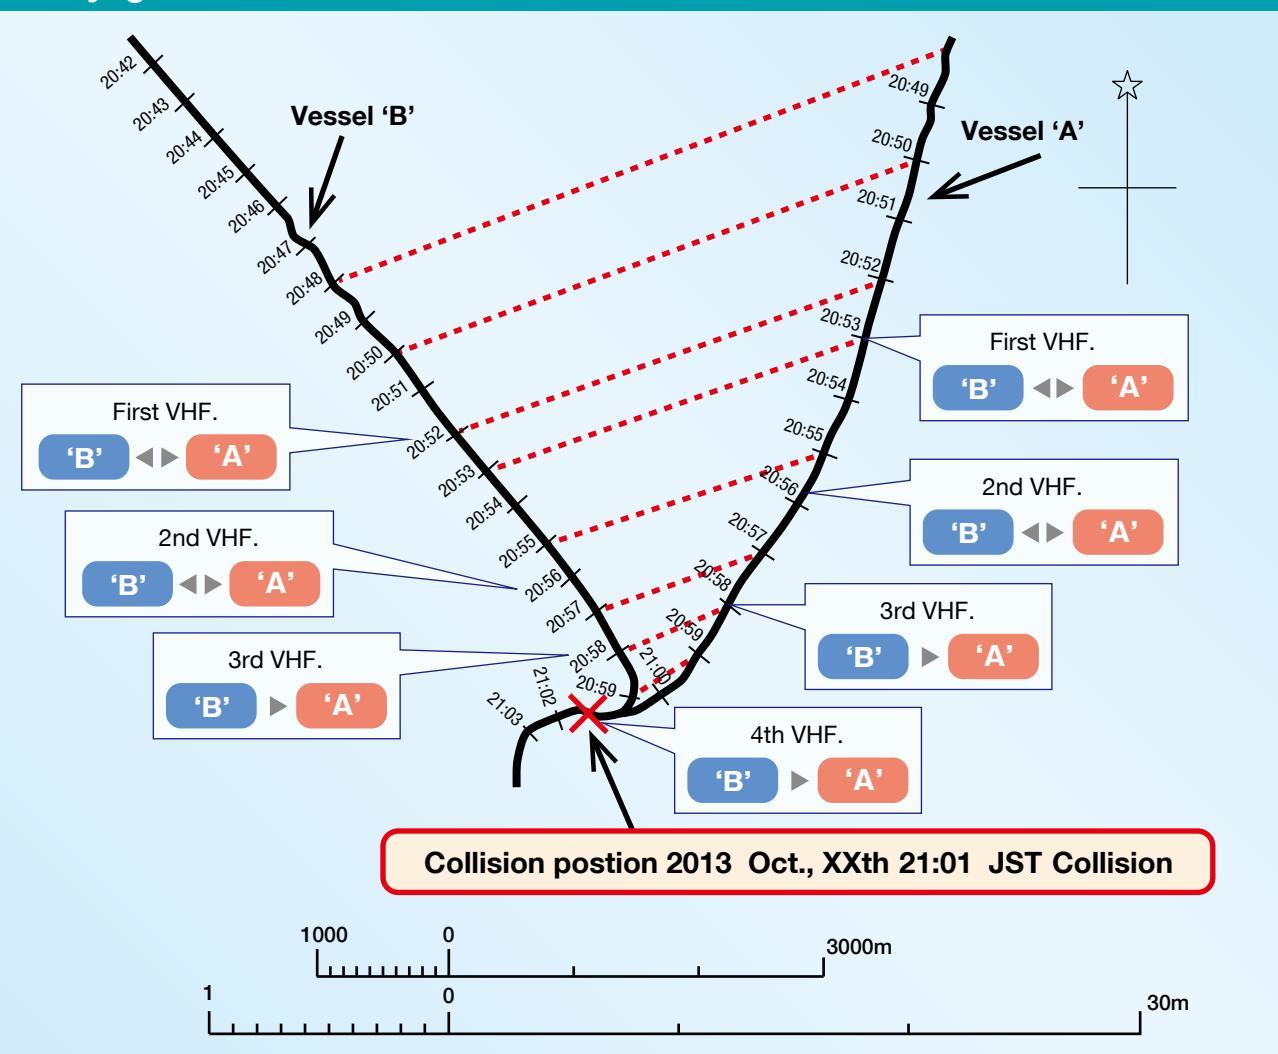
Fig. 18 Details of Voyage Route

As a result, both vessels kept closing head-on to each other. Although it steered immediately to avoid collision immediately before the collision, the starboard side bow of Vessel A collided with the port side astern of Vessel B. Both vessels sustained damage to the hull, however, there were personal injuries. Please see Figs. 17, 18 and 19 and Table 20 for collision details and the actions that were taken by both Vessels.

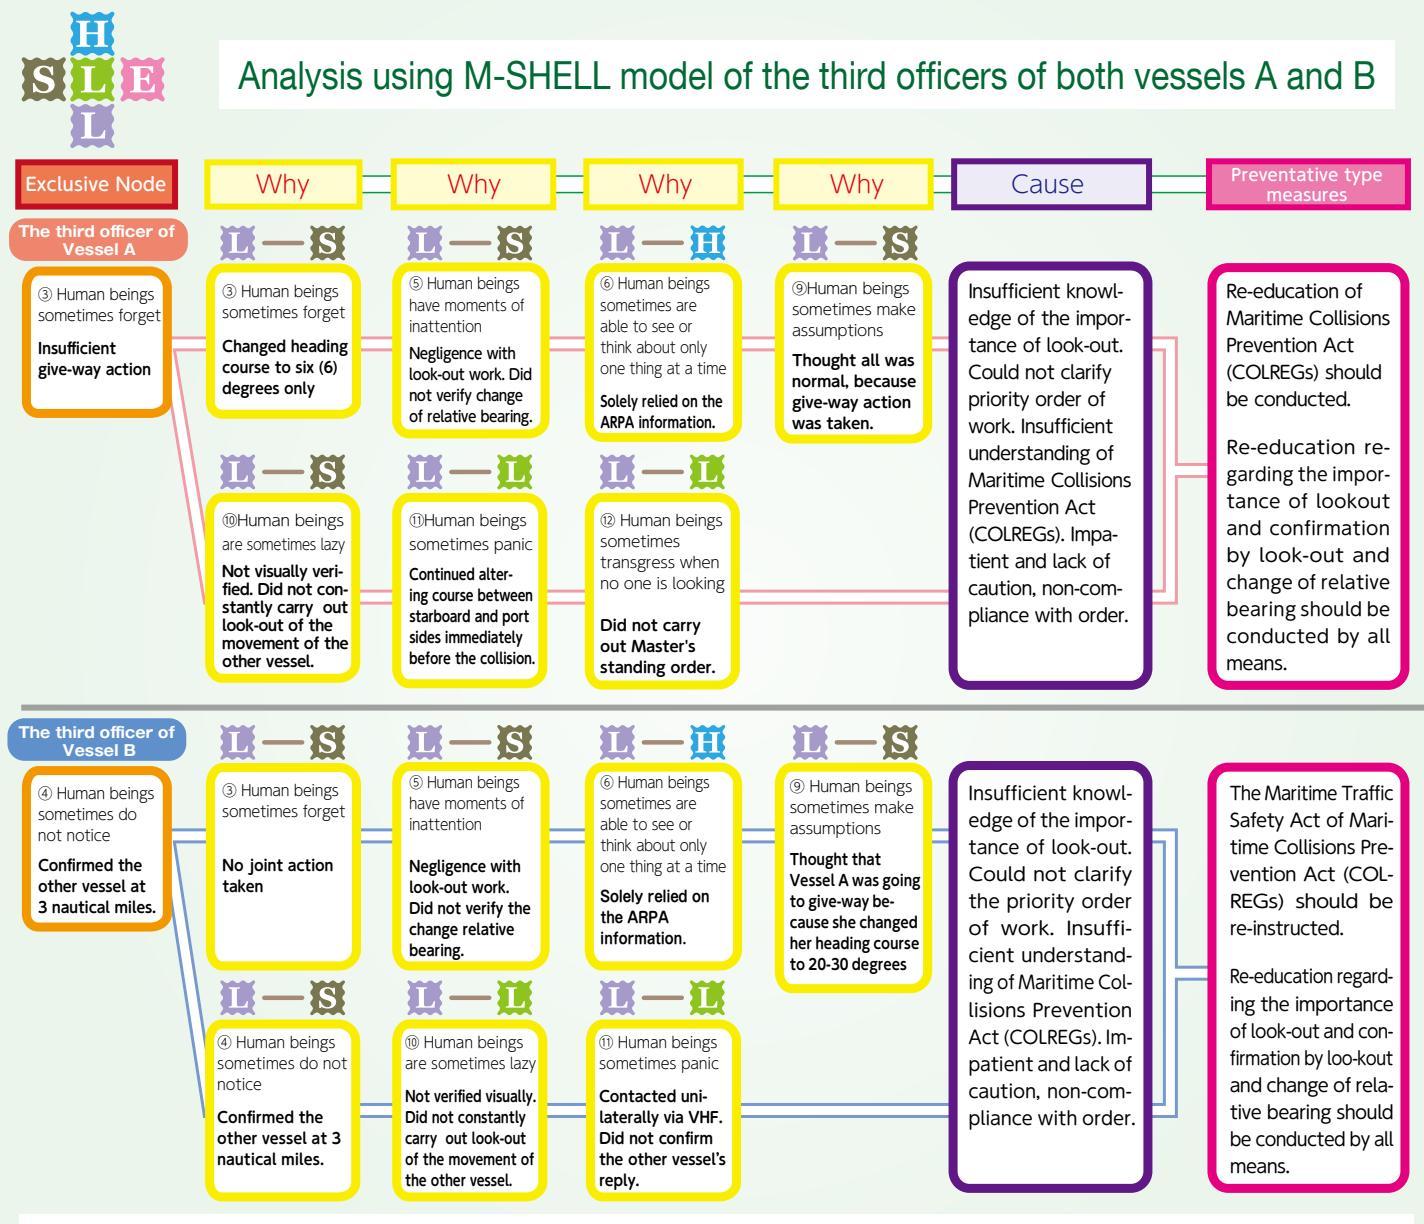
Fig. 24 Why-why? Model

For the third officer of Vessel A, seven (7) out of the twelve (12) Human Characteristics items are applicable, whereas, eight (8) of the Human Characteristics are applicable to the third officer of Vessel B. An analysis using the M-SHELL model as to why such behaviour was taken in relation to these characteristics is shown in Fig. 24.

To begin with, we consider the root cause to be 'Exclusive Node'. In spite of insufficient avoidance action (third officer communicated that Vessel A would pass the astern of Vessel B), however in reality, Vessel A altered course to starboard 6 degrees only (in general, Vessel A should alter her heading course to starboard 60 degrees). Meanwhile, vessel B did not notice vessel A until she approached at a distance of 3.0 nautical miles.

On analysing as to why the third officer of Vessel A caused the accident, firstly we can say that there was a lack ability in recognizing the importance of look-out. Further, this was not only down to the fact that work was not prioritised appropriately, but that there was also an insufficient understanding of the Maritime Collisions Prevention Act (COLREGs). In addition, it is clear that there were other causes, such as impatience, a lack of caution and non compliance with the Master's standing order.

On the other hand, when analysing the third officer of Vessel B similarly, we can conclude that the accident causes are the same for the third officer of Vessel A. We understand that the cause was not only down to the fact that there was a lack ability in recognizing the importance of look-out, but in addition, work was not prioritised appropriately. Moreover there was insufficient understanding regarding the Maritime Collisions Prevention Act (COLREGs). It is also clear that there were other causes, such as impatience, a lack of caution and non compliance with the Master's standing order.

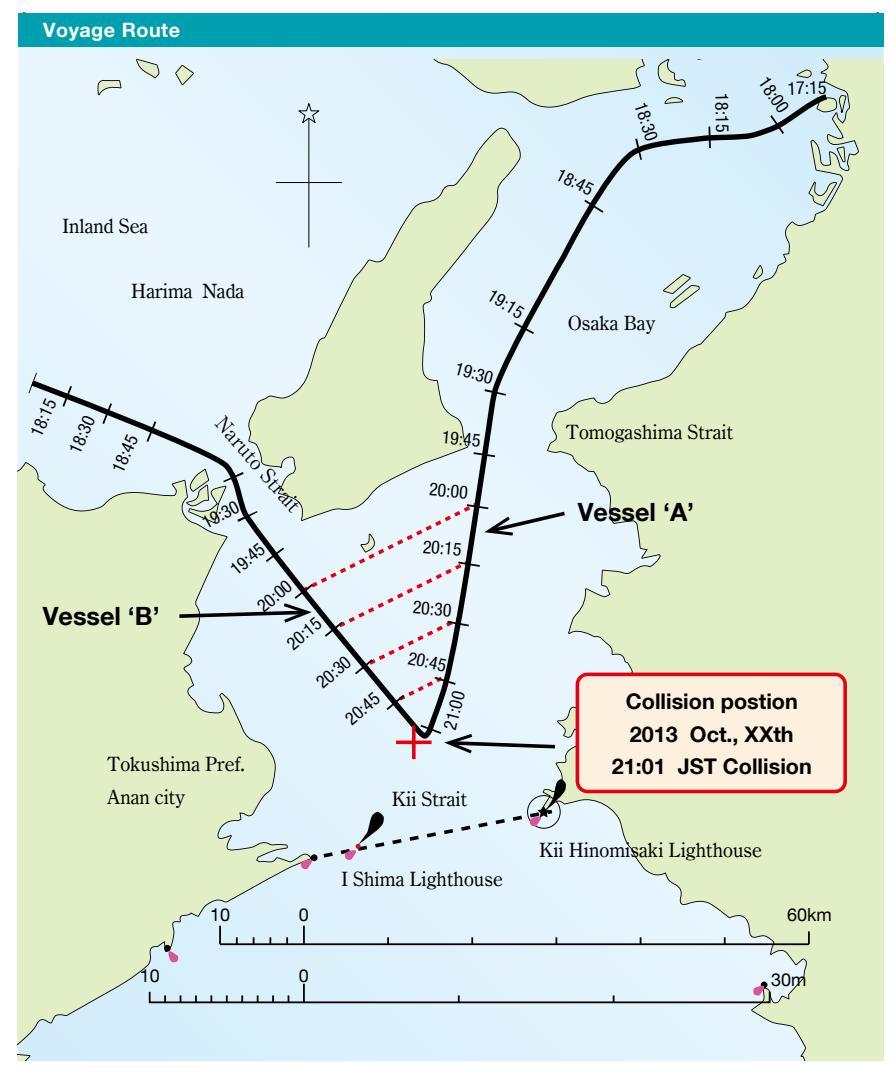
Fig.26 Voyage Route (same as Fig17)

As can be seen in Fig. 26, the traffic system of the Kii Suido (Strait) is a sea area which easily causes a crossing situation because it has a narrow angle for approaching 'vessels between the Naruto Strait and Hinomisaki' and 'those navigating north to south between the Tomogashima Strait and the Kii Hinomisaki coast of I-shima Island'. Also, there are a large number of fishing vessels operating, along with a high volume of marine traffic.

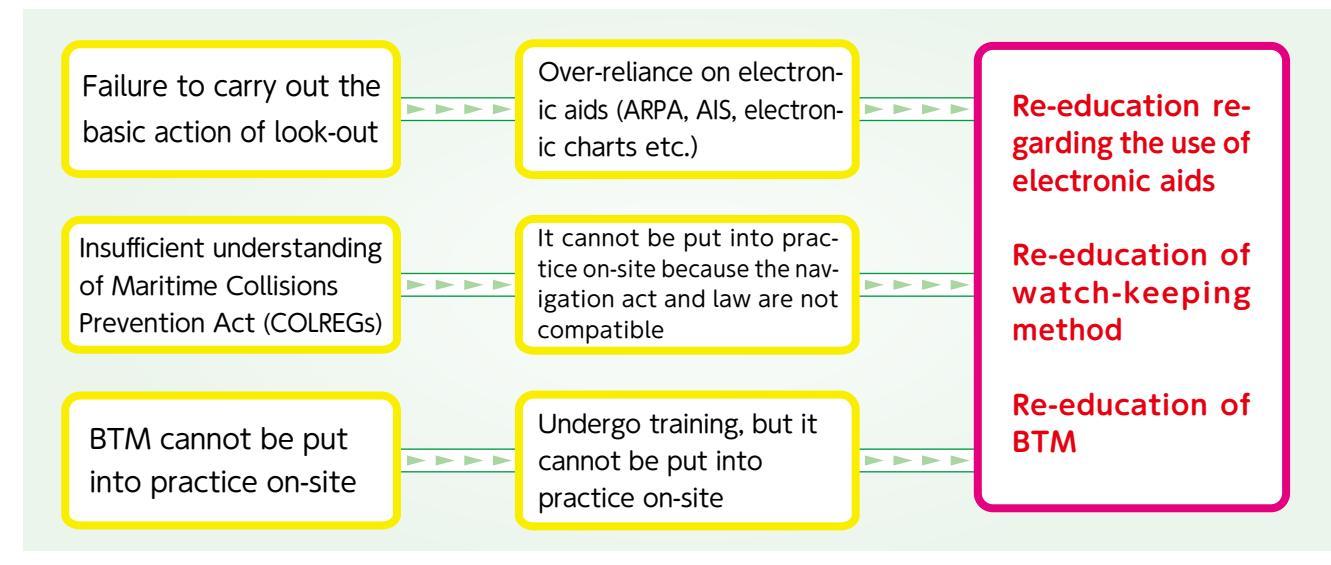
Fig. 27 Preventive Measures for the Third Officers of Vessels A and B

There were similarities in the specific behaviours of the Human Characteristics involved that led to the accident. If these specific behaviours can be eliminated, preventive measures can be formulated. These are summarized as illustrated in Fig. 27 below:

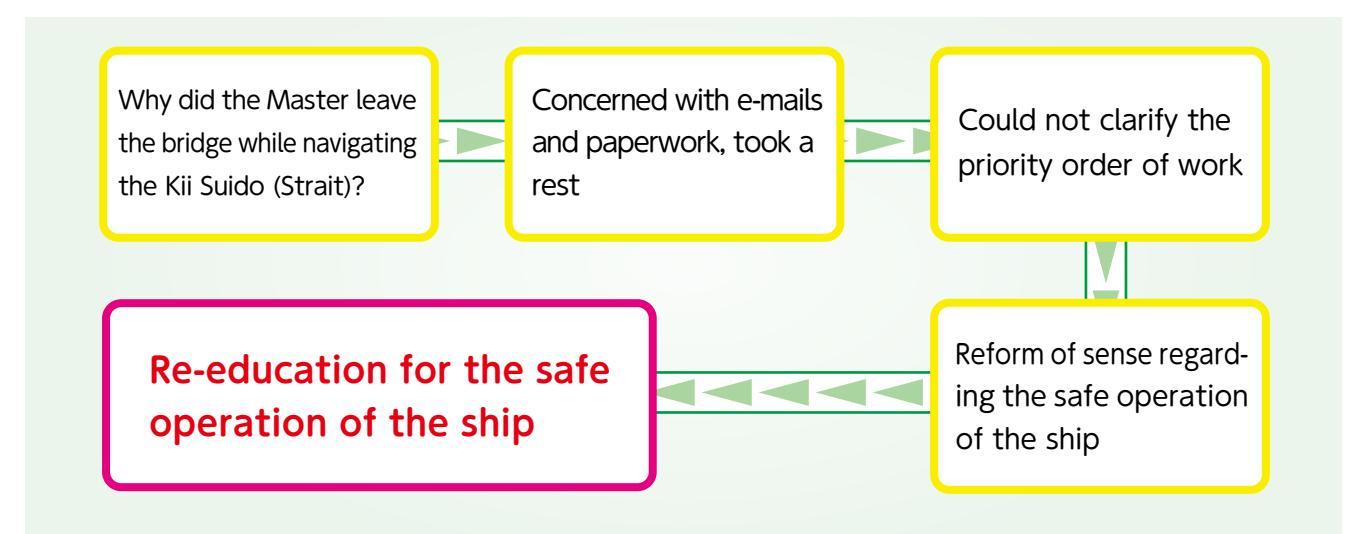
Fig. 28 Preventive Measures for the Masters of Vessels A and B

Despite the fact that the Kii Strait is congested with a narrow channel, the fact that the Masters were not on their respective bridges is one of the reasons for the collision. This is summarized as illustrated in Fig. 28 below.

In addition, it is also a fact that the Master of Vessel B did not give priority to manoeuvring the ship through the narrow channel over taking a break. Therefore, the root cause for the accident can be taken as a lack of awareness regarding the safe operation of the ships.

In the case of both Masters, there were no problems regarding the level of their technical skills or their ability to operate in these waters. Both Masters presumably would have felt enough regret regarding their actions, but they clearly both need retraining in maintaining priorities concerning the safe operation of a ship.

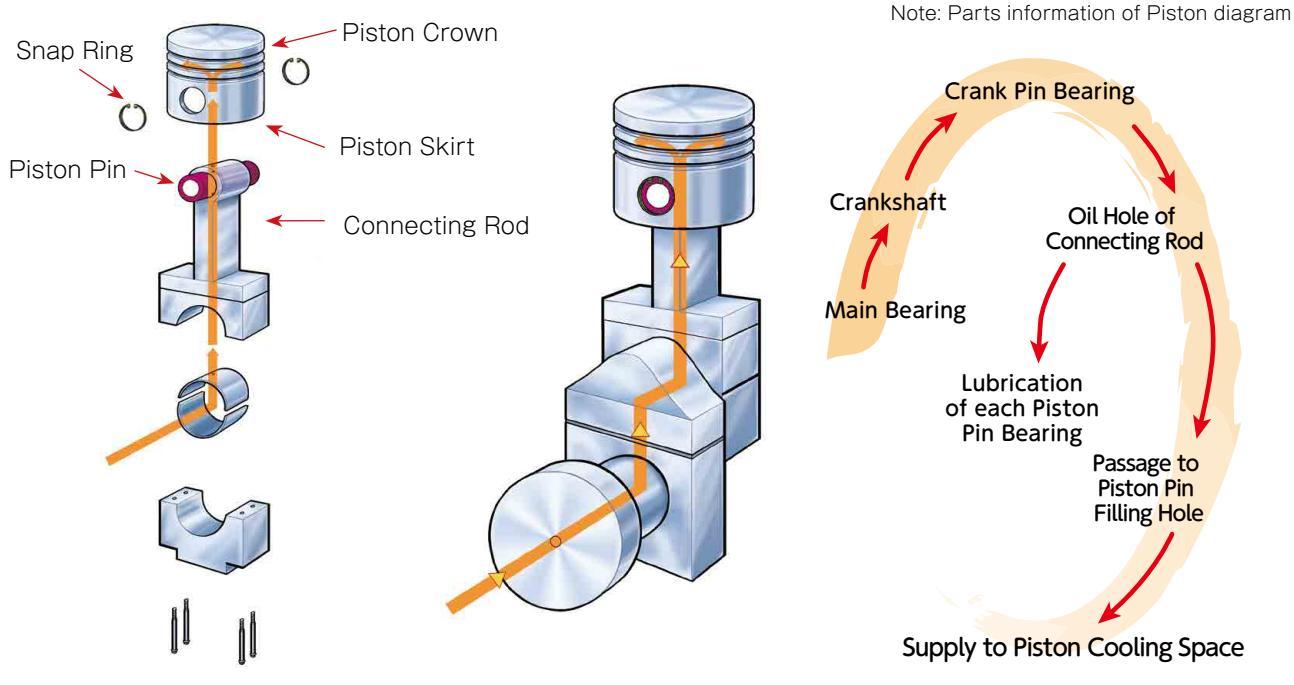
Fig. 32 Piston diagram and Cooling oil supply route

The piston structure consists of two parts: an upper part and a lower part. The upper part has a special alloy piston crown and the lower has a cast iron piston skirt. The piston is of the assembly-type. The upper and lower parts are connected by tightening bolts. The yellow line in Fig.32 shows the route of the cooling and lubricating oil that is supplied from the main bearing.

As can be seen in Figs. 32, 33-1 and 33-2, the piston pin is prevented from coming adrift from the bearing by metal C-shaped retaining rings (hereinafter, snap rings) affixed in these gutter areas. In addition, there is a hole that allows for LO (as cooling oil) to flow to the piston pin. This cooling oil is supplied from the oil hole in the connecting rod up to the piston.

- Although the manufacturer carried out a repair in October 2010, the snap ring of the piston pin boss was not fully inserted into the snap ring gutter during the assembly process. Due to this, the ring broke and dropped down during operation.

- Thereby, the route for supplying LO was blocked because the piston pin moved to the axial direction retarding the supply of LO. As a result, the piston was deprived of coolant, which caused it to seize and subsequently sustain broken damage to the piston skirt.

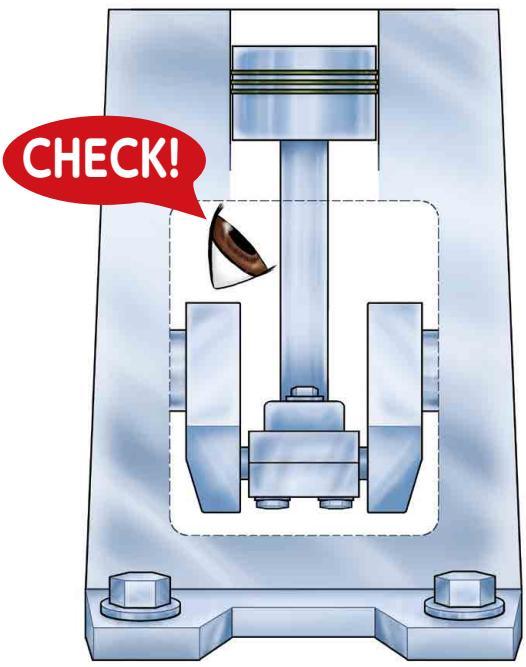
Fig. 42 Appearance of Crankcase

A crankcase is, as shown in Fig. 42, a box shape room which houses the crankshaft. As there is a door attached, it is possible to inspect the inside. However, this door is too small and it is not possible to observe the internal structure without using a hand mirror or adjusting the position of the crankshaft (See Fig. 42). There are three errors that occurred in the chain, when analysing as to why the abnormality was not detected at the time of inspecting the crankcase.

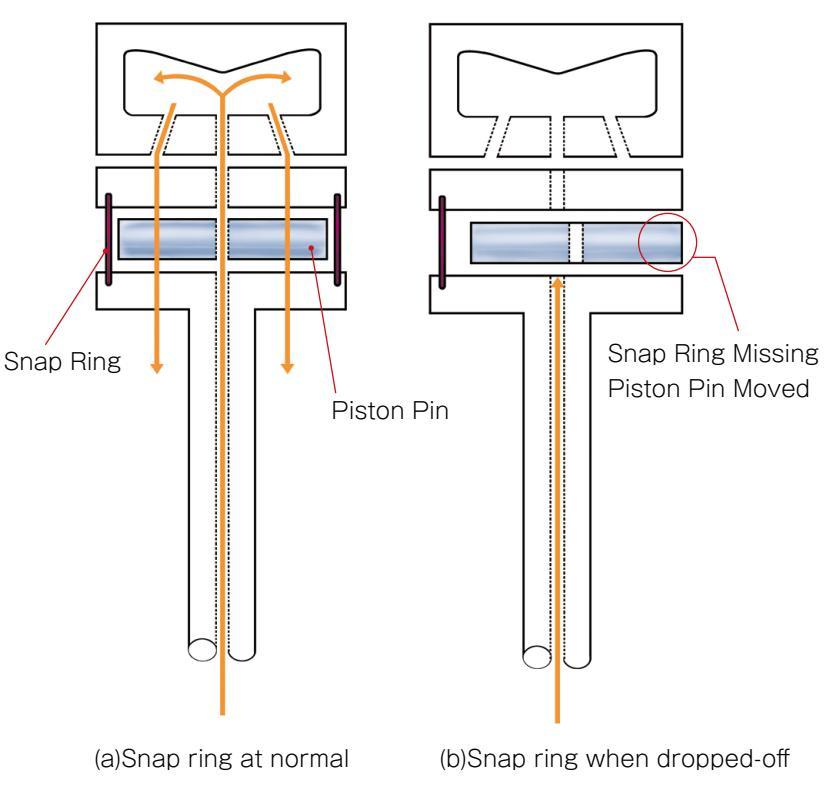
Fig. 43 Prevention of LO Flow which Aids Piston Pin Movement

The main reason for burnout was a lack of LO, but it was in fact caused by the dropping-off of a snap ring. A description of the mechanism that controls LO and how this causes the oil to not flow smoothly, as a result of a snap ring dropping off, is as follows. (See Fig. 43)

- (a) As described earlier, the piston pin (full floating type) is inserted into the piston pin boss. The snap ring is inserted into the gutter of both ends of the boss.
- (b) Therefore, if the ring gets separated, the pin will move toward the axial direction. Thus, the passage of LO gets blocked by the shifting of the positions between the oil hole of the connecting rod and the filling hole of the piston pin.
- (c) As a result, the filling oil to the upper part of the piston pin boss and piston cooling space will be stopped.
