JAPAN P&I CLUB

Vol.40 September 2017

# P&I Loss Prevention Bulletin

## CASE STUDY

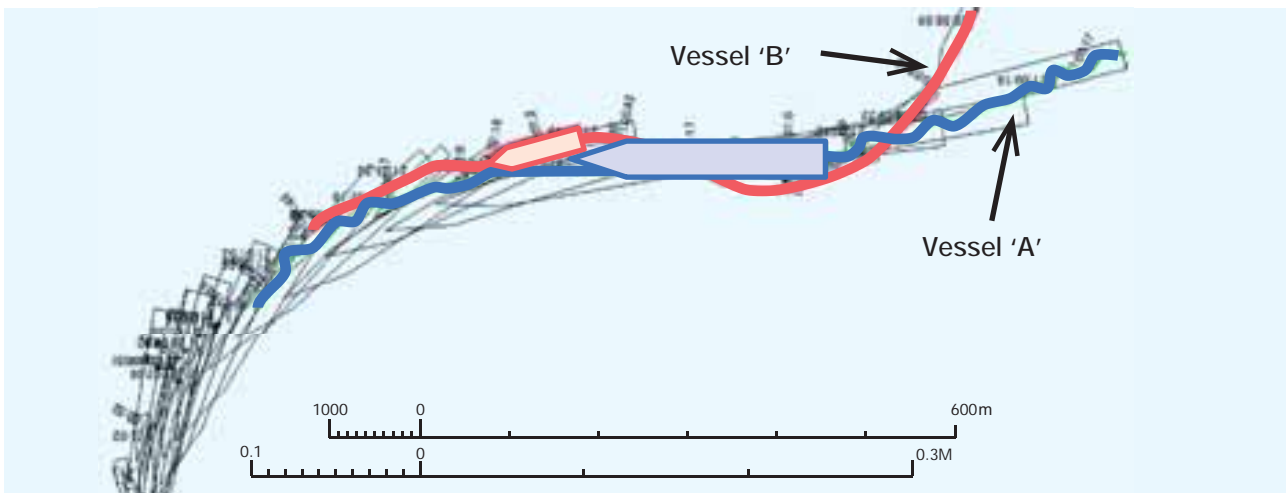
Fig. 19 Details of Voyage Route

As a result, both vessels kept closing head-on to each other. Although it steered immediately to avoid collision immediately before the collision, the starboard side bow of Vessel A collided with the port side astern of Vessel B. Both vessels sustained damage to the hull, however, there were personal injuries. Please see Figs. 17, 18 and 19 and Table 20 for collision details and the actions that were taken by both Vessels.
