§ 3 Traffic Systems of the Kii Suido (Strait) and Tokyo Bay

§ 4

§ 4-1 Feature of Trouble and Damages (Attachment See ' 4 Cycle Diesel Engine of vessel ')

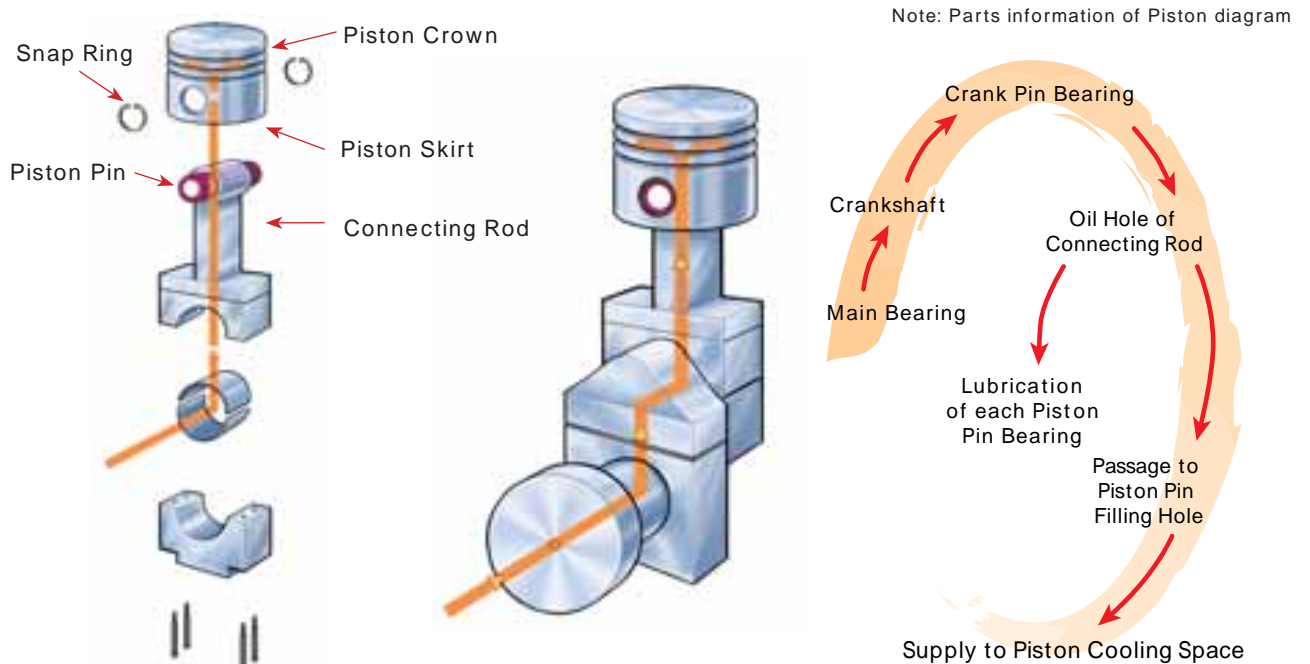
Fig. 32 Piston diagram and Cooling oil supply route

The piston structure consists of two parts: an upper part and a lower part. The upper part has a special alloy piston crown and the lower has a cast iron piston skirt. The piston is of the assembly-type. The upper and lower parts are connected by tightening bolts. The yellow line in Fig.32 shows the route of the cooling and lubricating oil that is supplied from the main bearing.

As can be seen in Figs. 32, 33-1 and 33-2, the piston pin is prevented from coming adrift from the bearing by metal C-shaped retaining rings (hereinafter, snap rings) affixed in these gutter areas. In addition, there is a hole that allows for LO (as cooling oil) to flow to the piston pin. This cooling oil is supplied from the oil hole in the connecting rod up to the piston.
