JAPAN P&I CLUB Vol.43 July 2018 P&I Loss Prevention Bulletin

Dragging Anchor

Case Studies and Preventive Measures -

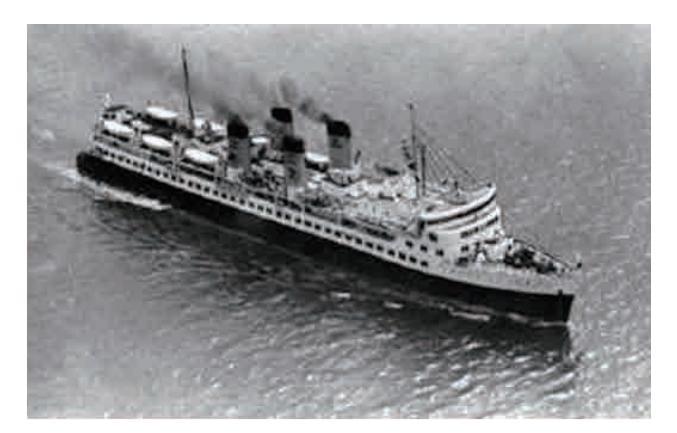
Photograph 36 "Bygone days of Touya Maru"

Regarding the Aomori - Hakodate ferry, Touya Maru, the total number of persons on board was 1,314, (crew members: 111, passengers and so on: 1,203) with 12 freight cars loaded. While Typhoon No. 15 was approaching, Touya Maru

departed Hakodate Pier from within the Port of Hakodate bound for the Port of Aomori. She was to take refuge at the Hakodate Bay because outside the Port of Hakodate had already been seeing very stormy weather (at sea), however, she dragged anchor due to a gale and high waves. Touya Maru therefore grounded in the shallows of Nanaehama in Hakodate Bay. She then capsized and sank which caused a total number of 1,155 deceased or missing persons including passengers etc.

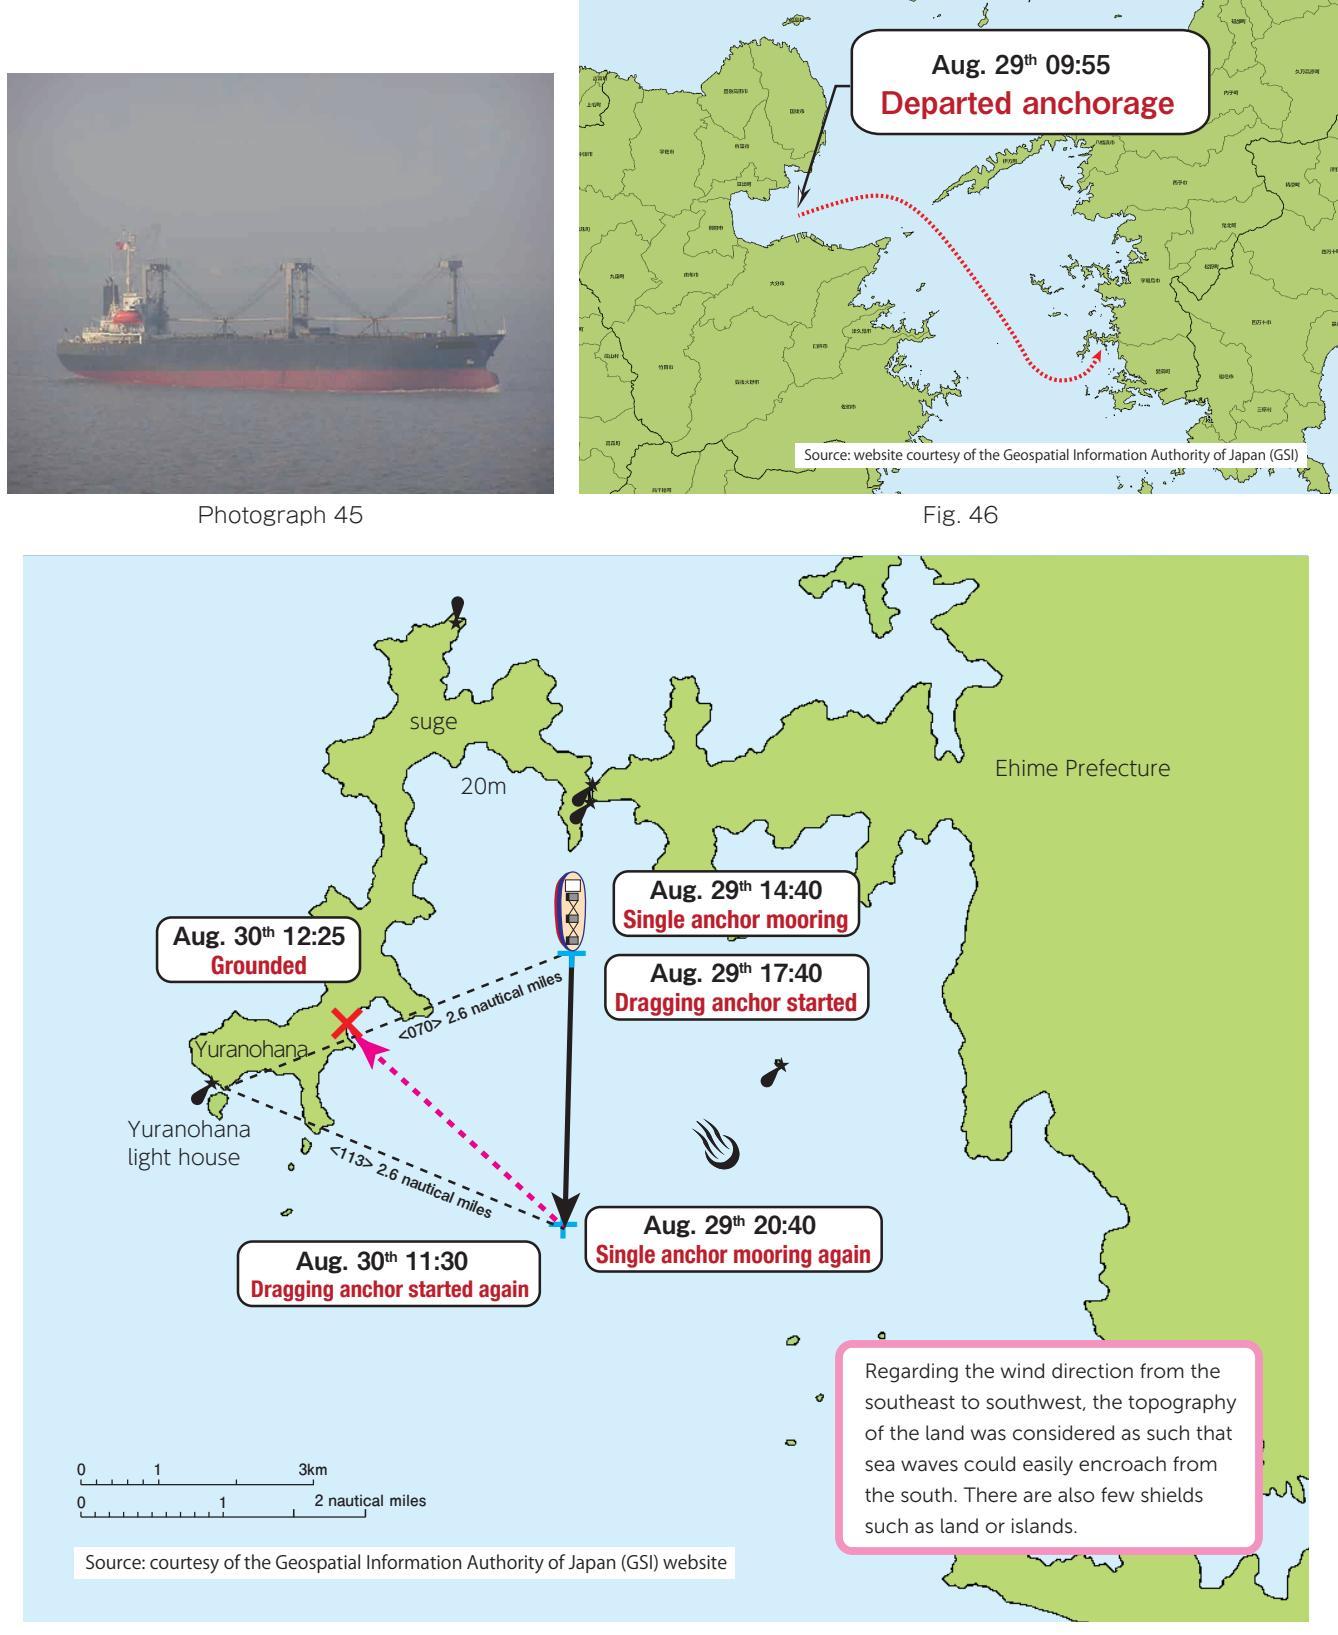
Fig. 47

deceased and three missing). The remaining 16 crew members including the Master were rescued by the helicopters of the Japan Coast Guard and the Self-Defense Force. Photograph 45, Figs. 46 and 47 show the path of Vessel B and its anchor being dragged.

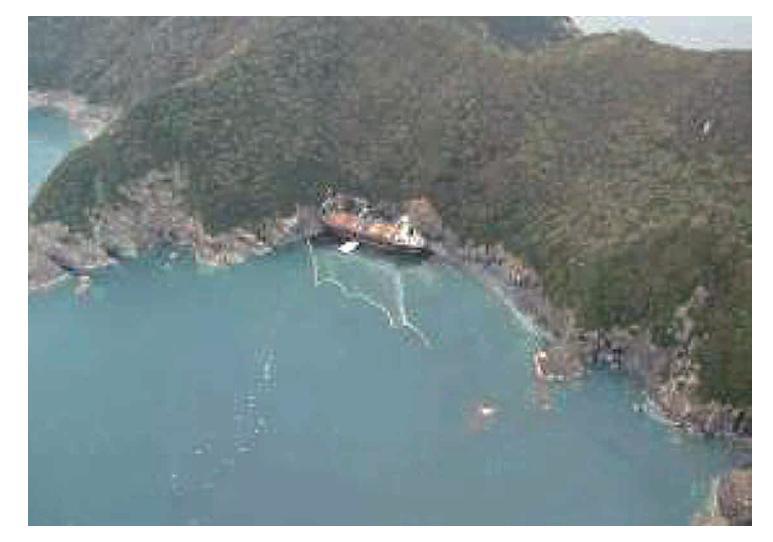
Photograph 51

The 16 crew members were rescued by the helicopters of the Japan Coast Guard and the Self-Defense Force. Among the four who fell into the sea, one was confirmed as deceased and three as missing.

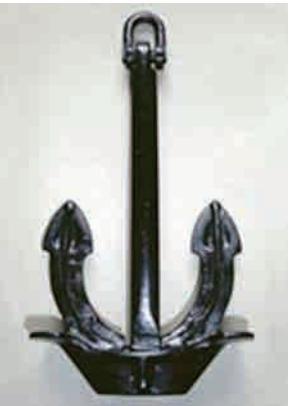
Photograph 52 JIS type anchor

Anchor:	JIS type Weight 3,300kgs
Anchor cable:	1 shackle was at 27.5m \times 9 shackles per side 248m

When tentatively calculating the minimum required length for an anchor chain, in 92m of water, an anchor chain with 513m (19 shackles) of length is required (at times of rough seas: $4 \times d + 145m$). Sheltering from stormy weather in a location which

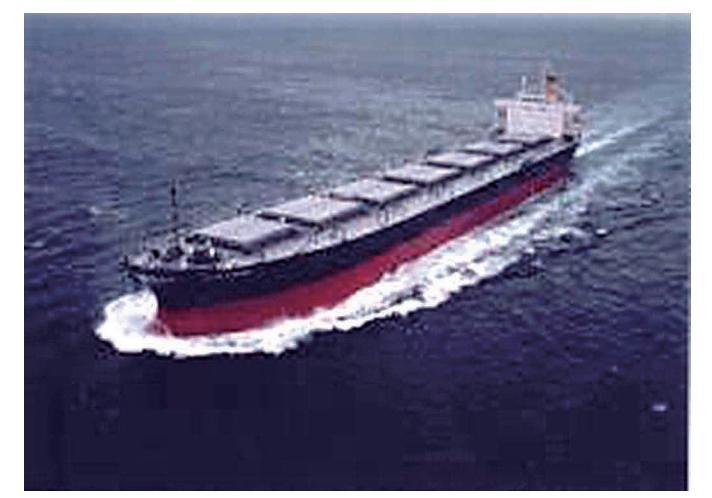
Photograph 53

Regarding dry bulk, Vessel C, the total number of crew members on board was 23 (four Indian nationals and 19 Filipino nationals) and 57, 474 tons of corn was loaded at the Port of New Orleans in North America. She entered into the Port of Shibushi, Kagoshima Prefecture, on the 23rd of July, 2002 in order to unload. At the Port, among the people disembarking were: 9 crew members (a chief officer [Indian national] and 8 others [Filipino nationals]) that disembarked and a total number of 5 crew members (the successor, a chief officer [(Indian national)] and 4 other crew members) relieved them and boarded. The crew arrangement at the time when the accident occurred was 4 Indian nationals

Regarding the damage, cargo holds, between No. 5 and No. 6, near the centre of the hull there was breakage and No. 2 Fuel Oil Tank under No. 5 cargo hold was damaged. Immediately, at the same time as he activated the distress signal by operating the EPIRB, the Master reported the distress to the Japan Coast Guard via international VHF radio communications.

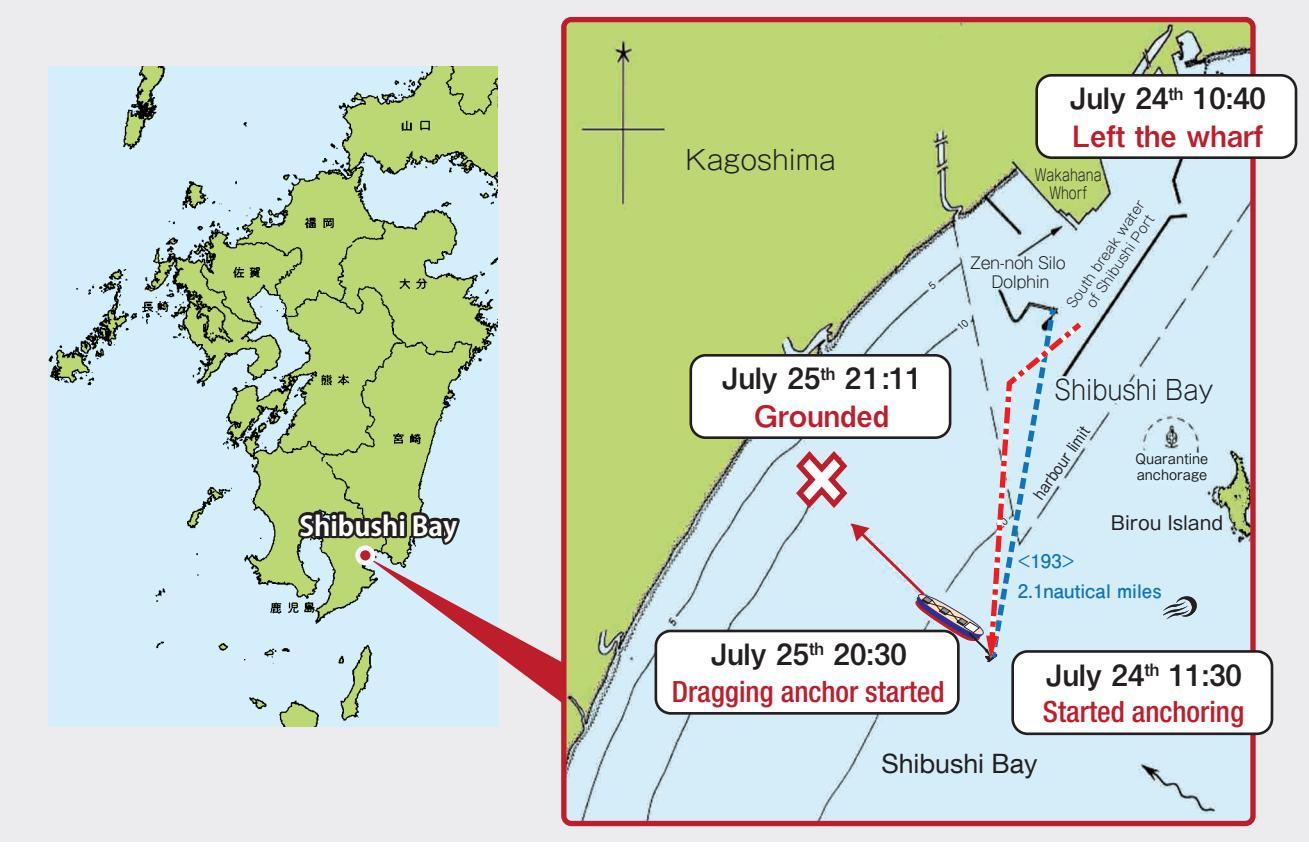
Fig. 54

The Master was thinking that he had not experience with entering Kagoshima Bay, it would take 11 hours as a roundtrip and there was a risk of being close to the centre of the typhoon according to the forecast of the typhoon's path, then. He also judged that the force would decay judging by the information from NAVTEX. Because there was ample spare time until the typhoon approached, the Master decided to choose the anchorage according to the movement of the typhoon from the following three choices as his original plan: ① head for Kagoshima Bay, ② stay anchored at Shibushi Bay without navigating a direct course to Kagoshima Bay or ③ seek shelter offshore. As a result, at 11.30, the vessel dropped her starboard anchor at 6 shackles <056> 2.0 nautical miles off of Birou Island and 2.1 nautical miles off Shibushi south breakwater, light house <193>, where the sea bottom was sand with a water depth of around 25 metres.

Afterwards, partly because a similar size of ship, Vessel M started anchoring at Shibushi Bay, Vessel C also continued single anchor mooring with 6 shackles of anchor cable. However, contrary to expectation, the force of the typhoon did not decrease and Shibushi Bay gradually entered the storm area and the right semicircle of the typhoon. Due to
