§ 3 Dragging Anchor Cases

(From the Maritime Casualty Analysis Report [Vol. 6]: Typhoons and marine accidents issued by the Marine Accident Inquiry Agency [MAIA] in 2006)

3 - 1 The Aomori - Hakodate ferry “ Touya Maru ” accident

3 2 Cargo Vessel B Dragging anchor and grounding accident

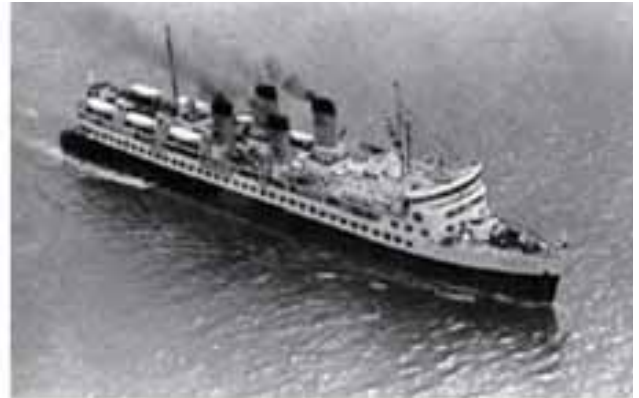
Photograph 36
"Bygone days of Touya Maru"

Regarding the Aomori - Hakodate ferry, Touya Maru, the total number of persons on board was 1,314, (crew members: 111, passengers and so on: 1,203) with 12 freight cars loaded. While Typhoon No. 15 was approaching, Touya Maru

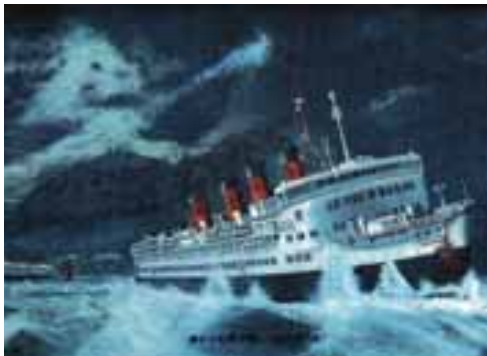
21 : 40	Further heeled to the port side.
21 : 50	Main engine on the port side became inoperable, and the bilge could not be discharged. Ship's heel started shifting from port side to starboard side.
22 : 05	Main engine on the starboard side became inoperable and the vessel became trim by the stern due to flooding.
22 : 15	Passengers were instructed to wear life vests.
22 : 26	<p>Grounded in the shallow off Nanaehama, with a 45 degree inclination to the starboard side.</p>

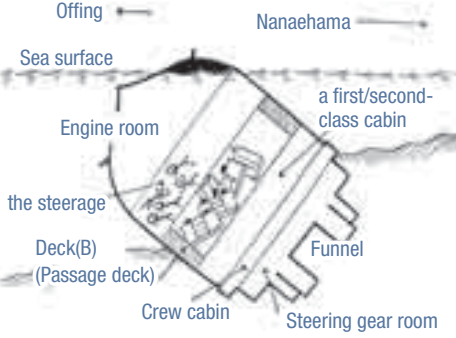
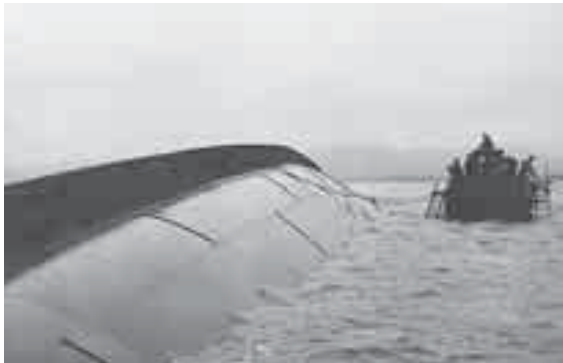
22 : 42	Blackout on board with a deluge of water flowing in.
22 : 45	<p>Sinking after rolling over to the starboard side.</p>

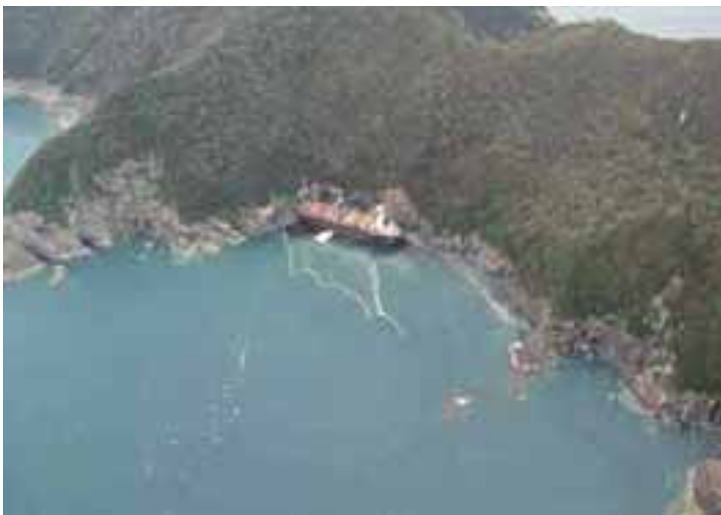
Photograph 51

17 : 40	Dragging anchor started. Tried weighing the anchor, but it was not possible to heave up it. Gave up weighing the anchor and started shifting to the south while using the engine under dragging the anchor.
20 : 40	Started anchoring at 8 shackles of the anchor cable at the point <113>, 2.6 nautical miles from Yuramisaki Lighthouse. Using the engine, countermeasures were taken to prevent anchor dragging against the wind.
<div style="background-color: #8B4513; color: white; border-radius: 10px; padding: 2px 5px; display: inline-block;">August 30th</div> 11 : 30	Wind force reached 12 due to the increase of southeast wind, and dragging anchor started in a leeward direction.
11 : 57	Distress alarm was activated via Emergency Position Indicating Radio Beacon (EPIRB) and Digital Selective Calling (DSC). Instructed the crew to wear life vests and muster at the bridge.
12 : 25	Grounded at the point of <066> 1,750m from Yuranohana Cape Lighthouse. At approximately 13:00, four panicked crew members left the bridge. When they climbed down the stern deck they were carried away with the waves and fell into the sea.

The 16 crew members were rescued by the helicopters of the Japan Coast Guard and the Self-Defense Force. Among the four who fell into the sea, one was confirmed as deceased and three as missing.

There were facts related to the process leading to the accident such as not obtaining the information about anchoring from the agency and only obtaining weather information by means of NAVEX. Also, not being able to use the anchor on the starboard side due to windlass failure was one of the causes of the accident.

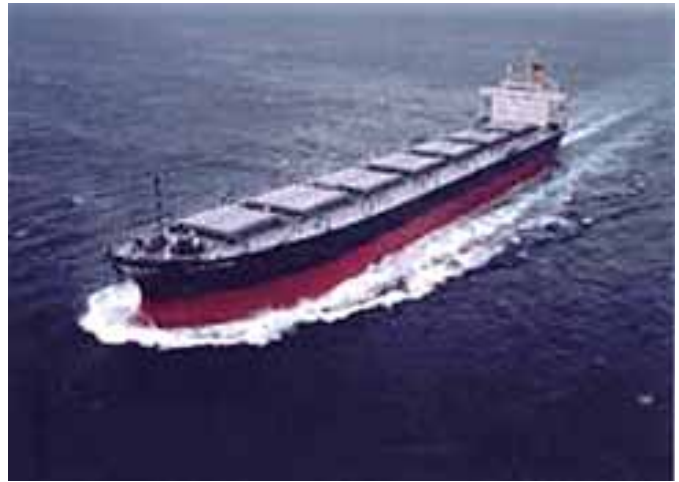
Photograph 53

Regarding dry bulk, Vessel C, the total number of crew members on board was 23 (four Indian nationals and 19 Filipino nationals) and 57, 474 tons of corn was loaded at the Port of New Orleans in North America. She entered into the Port of Shibushi, Kagoshima Prefecture, on the 23rd of July, 2002 in order to unload. At the Port, among the people disembarking were: 9 crew members (a chief officer [Indian national] and 8 others [Filipino nationals]) that disembarked and a total number of 5 crew members (the successor, a chief officer [(Indian national)] and 4 other crew members) relieved them and boarded. The crew arrangement at the time when the accident occurred was 4 Indian nationals made up of the Master, the chief officer, the chief engineer and the 1st engineer and 15 other Filipino nationals. (The number of crew members decreased by 4)
