§3 Case Study = Collision Accident =

Japan Transport Safety Board Report MA2019-6-02

The collision accident of the outgoing large size container which occurred off the port of Kobe on XX May, 2018 is to be analysed.

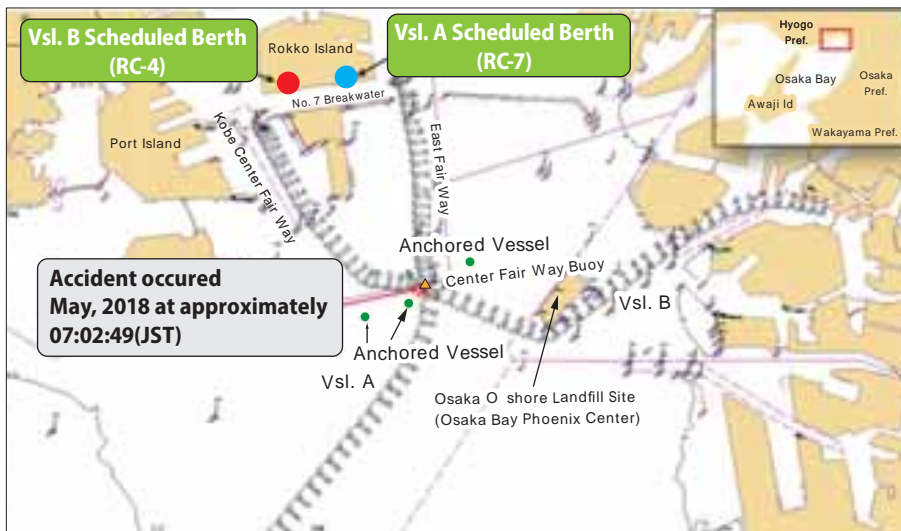
Fig. 22

Point of Occurrence

Near Kobe Rokko Island East Fairway Central FW Buoy

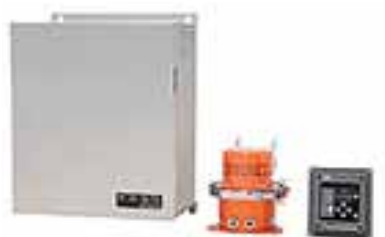
Photograph 29

Vessel A switched off its VDR immediately after the accident in order to preserve the data, however the vessel set off on its next voyage before the data could be extracted (Kobe to Nagoya). The VDR was again switched on and the previous data overwritten and deleted.
