5 - 2 Summary and Damage Sustained to a Vessel (Cargo ship E)

5 - 3 Summary of Oshima Bridge (Figure 40) and the Damage Sustained (Photograph 41)

§6 4M4(5)E Analysis of Bridge Collision = Accident =

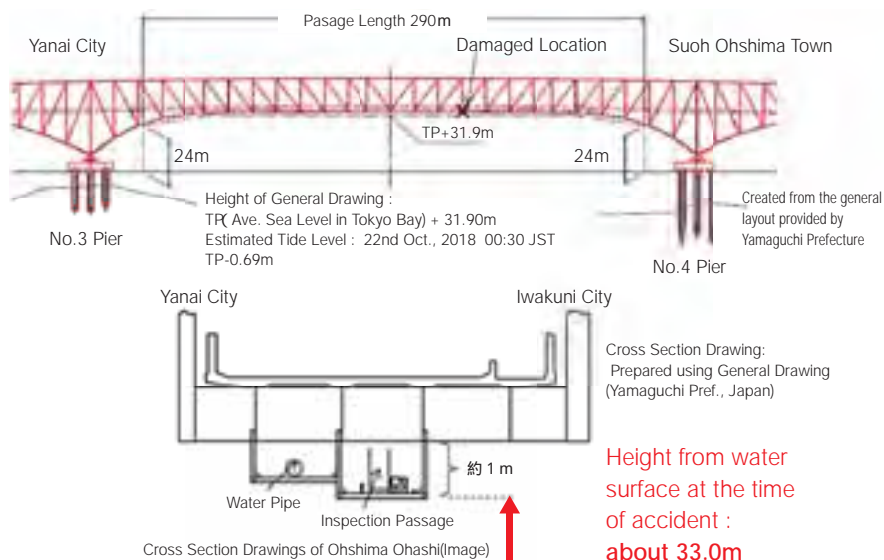
Fig. 40

Bridge sustained cracks and depressions in the bridge girders, and an inspection corridor which was situated under the girders dropped down damaging a water mains pipe, power and communications cables etc.
