§5 Case Study Bridge Collision Accident

Reference : Japan Transport Safety Board Report (MA2019-10-2)

Let's analyse the Ōshima Bridge Damage in Yamaguchi Prefecture that occurred on October 22, 2018.

5-1 Accident Summary

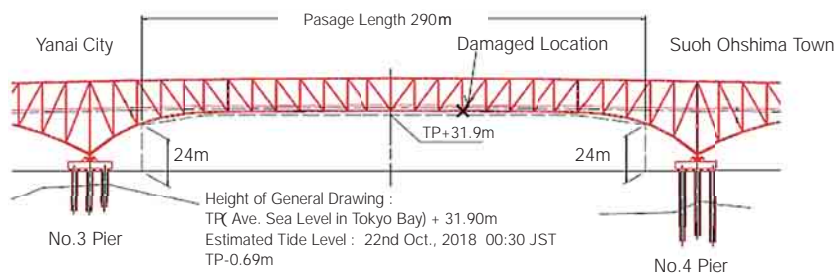
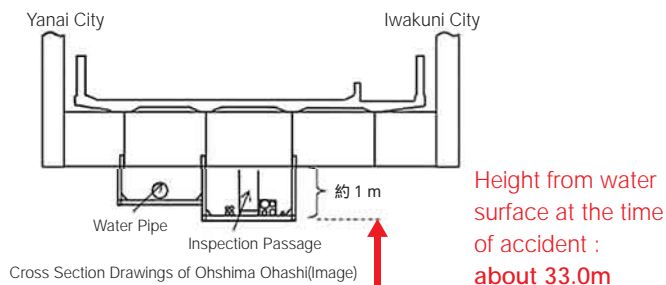
Fig. 26

shima Bridge Damage

Bridge sustained cracks and depressions in the bridge girders, and an inspection corridor which was situated under the girders dropped down damaging a water mains pipe, power and communications cables etc.
