## § 5 Case Study

### Analysis of an Accident

Vessel A Quay collision accident Accident timeline

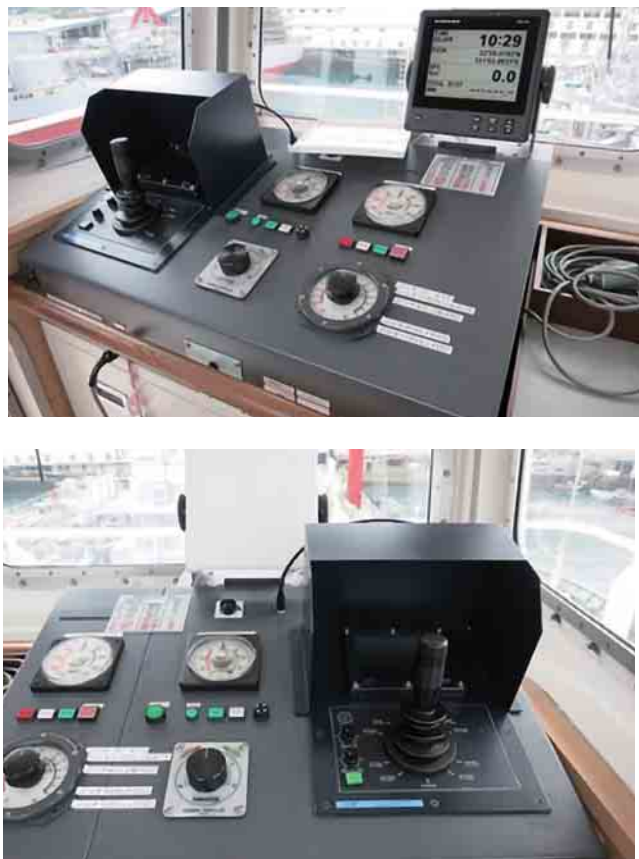
Fig. 41 Remote operation unit

It is considered that the Master of the vessel, during docking work, **continued to manoeuvre without realising that the rudder switch on the control stand was not switching to remote rudder** and that the joystick device could not control the speed to fetch headway which caused the collision with the quay.

He did not realise that the rudder switch was stuck in the non-follow-up position (not switching to remote control) and moved to the port side of the bridge in front of the control stand (Unsafe behaviour).
