# §4 Case Study of Oil Spillage Accidents

## 4-1 Oceangoing Vessel Case

Ship type: General cargo ship  
approx. 19,000 G/T

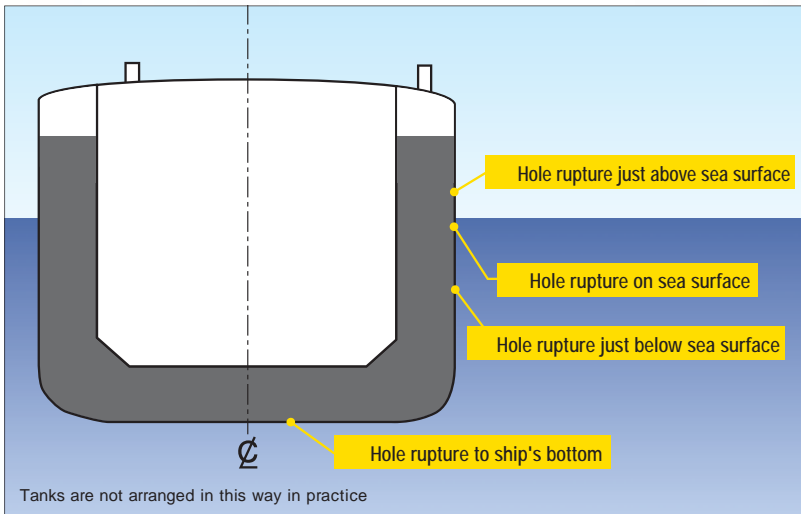
**Q** In the case of a collision accident etc., as shown in Figure 14, and in the event of a hole rupture in any one part from to , predict how much oil will be spilled. This is assuming no change in hull angle inclination, trim or draft, and no effects from currents or waves. It is also assumed that no fuel oil tank is actually connected to the double bottom and tanks in the port and starboard sides.

Figure 14: Oil Spillage Differs According to Hole Rupture Location

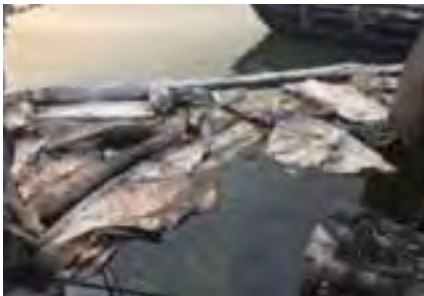
Photograph 13:  
Recovery via Oil Adsorbent

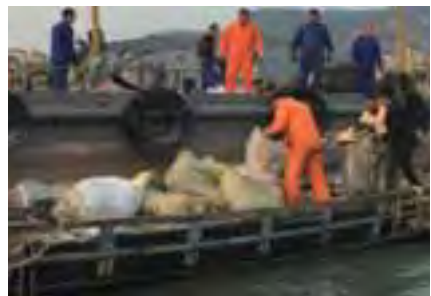
Photograph 14:  
Recovery Work Using Oil Adsorbent

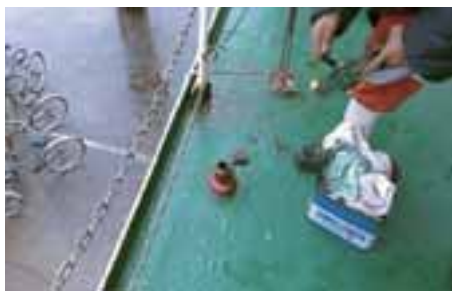
- (4) Had crew on duty checked the venting of all fuel tanks for air escape? Human beings sometimes forget, Human beings sometimes do not notice, and Human beings are sometimes lazy will apply.

Photograph 20: Tank Sounding

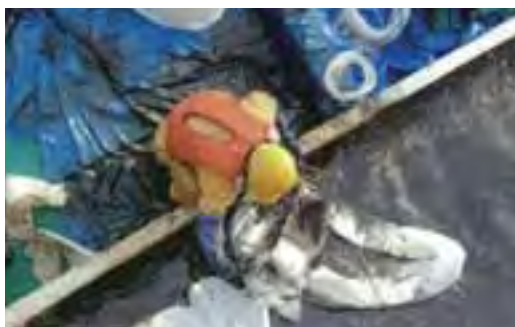
Photograph 24: Recovery Work Using Oil Adsorbent

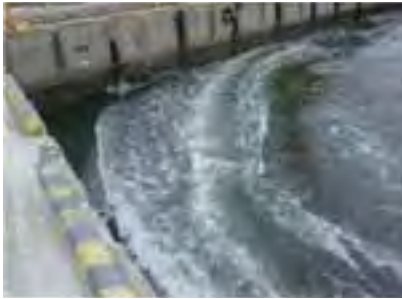
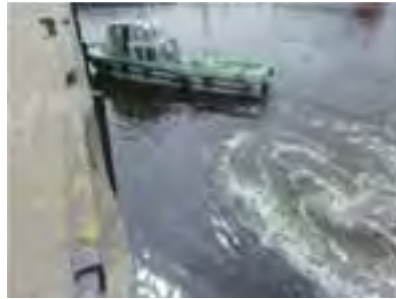
Most of the spilled oil was recovered by the evening of the day of the accident, but some was spread by the current. Later, the oil reached a seawall and the inside of a quay apron within a radius of approx. 3 km. It took 16 days to spread the oil and clean up the damaged seawall, resulting in a loss of almost the same amount as that of the first day's recovery service fee. Fortunately, fishing facilities were not damaged.

Photograph 25: Agitation Process

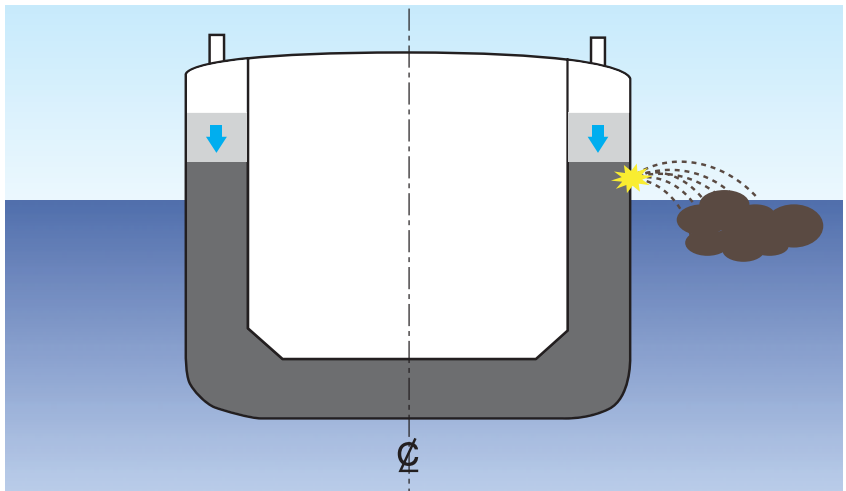
The oil loaded above the lower edge of the hole rupture (grey area) spills momentarily.

Thereafter, a small amount of oil may be spilled due to the ship's pitching and rolling, but this will not be a continuous spill. However, it is ideal to carry out shift and gas release of as much of the cargo oil as possible in the tanks where a hole rupture has occurred, in case of spills or repairs due to the ship's pitching and rolling or changing conditions. If other cargo tanks are fully loaded or ship-to-ship cargo transfer is not possible, as an emergency measure, shift it to other tanks in so far as oil will not breach the tank.

Figure 19: Hole Rupture Just above Sea Surface

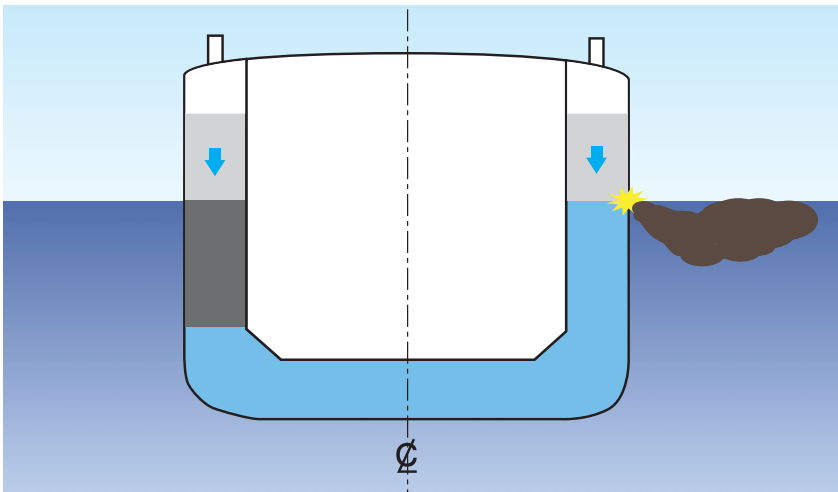
Then, due to the relationship between the specific gravity of water and oil (displacement), seawater infiltrates from the hole rupture and gradually accumulates at the bottom of the tank, and the oil is pushed out because of the inflow that it continues to flow out in turn and is replaced by seawater up to the hole rupture.

In the event of grounding, the water level will be lowered by the change in tidal current or, if Deballasting is carried out to reduce the draft, the oil level will be raised above the water level by that amount. It is important to understand that this will lead to a continuous oil spill.

Figure 20: Hole Rupture on Sea Surface

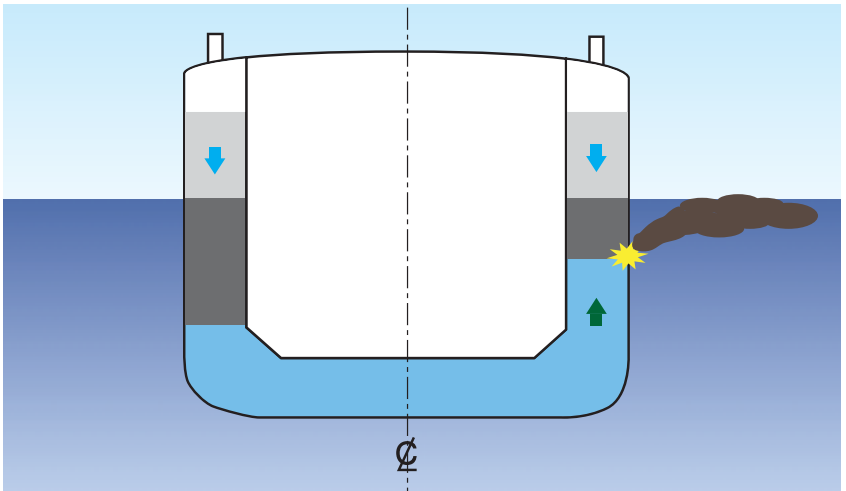
Then, similar to ②, due to the relationship between the specific gravity of water and oil (displacement), seawater infiltrates from the hole rupture and gradually accumulates at the bottom of the tank, and the oil is pushed out because of the inflow that it continues to flow out in turn and is replaced by seawater up to the hole rupture.

In the event of grounding, the water level will be lowered by the change in tidal current or, if Deballasting is carried out to reduce the draft, the oil level will be raised above the water level by that amount. It is important to understand that this will lead to a continuous oil spill.

Figure 21: Hole Rupture Just below Sea Surface

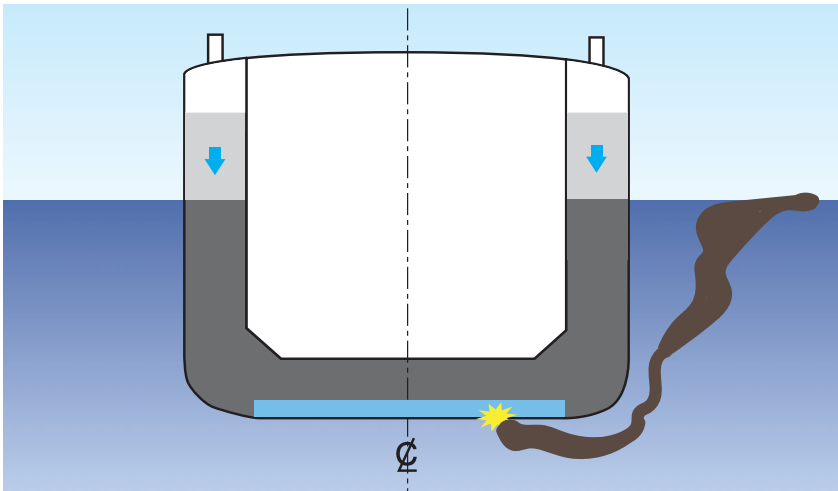
Similar to ①, the oil above the surface of the water spills momentarily. Then, the spill will stop when the pressure of the oil at the bottom of the tank is equal to the pressure at the bottom of the ship. Not only because the specific gravity of oil is smaller than that of seawater, but because the pressure from the surface of the water to the bottom of the ship is lower than the water pressure at the bottom of the ship, the seawater floods into the tank through the hole rupture.

( For example, if the draft is 10m and the specific gravity of theseawater is 1.025, the water pressure is  $1.025\text{kg/cm}^2$ . On the other hand, because the specific gravity of C-type fuel oil is about 0.998, and the pressure at the bottom of the ship is  $0.998\text{ kg/cm}^2$ , seawater will enter through the hole rupture, until this pressure difference is eliminated. ) Similar to ③, if the oil level rises above the surface of the water due to draft or discharging quantity adjustments, the hole rupture in the ship's bottom will cause a mixture of seawater and oil to spill. Care should be taken to avoid this.

Figure 22: Hole Rupture to Ship's Bottom

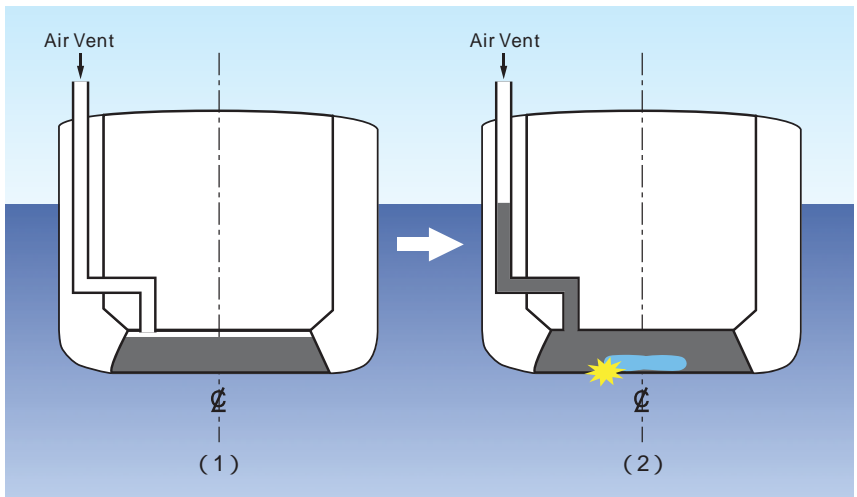
Each company has its own ISM code, SMS manual (Safety Management System) and internal regulations which determine the maximum amount of fuel that can be accepted in a fuel oil tank, but generally in most cases, it is between 85% and 90% of the tank capacity. This means that no more up to the air ventilation can be filled with fuel. Figure: 23(1))

In the event of a hole rupture in a double bottom fuel tank, due to groundings etc., the water pressure in the bottom of the tank will push the fuel oil up to the level of the vent line, which will in turn be flooded by seawater. Figure: 71(2)) However, the fuel in the tank is unlikely to spill.

Figure 23: Hole Rupture to Ship's Bottom of a Common Double-Bottom Fuel Oil Tank

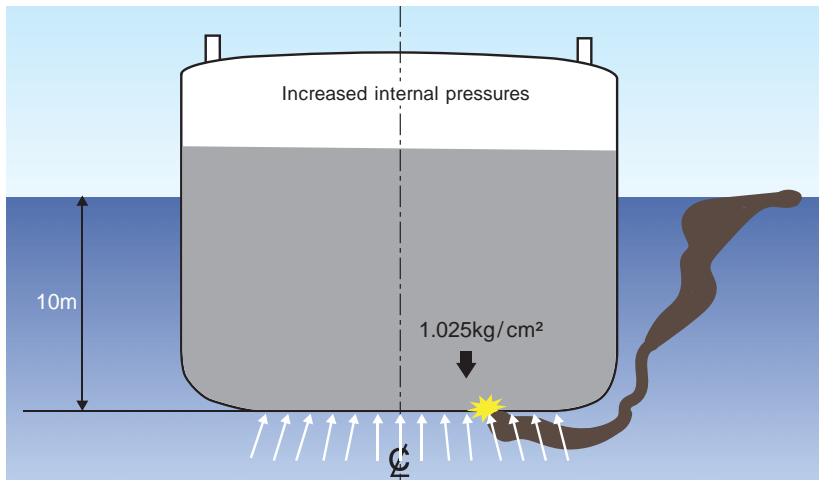
Currently, there are no tankers with a single hull, only those with double hulls. However, suppose that a hole rupture is made in the bottom of the ship, in the case of a tanker with a single hull as shown in Figure 72, and internal pressure is applied. With a draught of 10m, the water pressure at the bottom of the ship is  $1.025 \text{ kg/cm}^2$ . In the event of a hole rupture here, depending on the specific gravity of the oil, the cargo oil will be pushed out until the pressure on the bottom of the ship is equal to the water pressure.

Figure 24: Hole Rupture to Ship's Bottom of a Single Hull Tanker

Except in the ① event of a hole rupture just above sea surface, the residual oil in the tank shall be shifted in order to prevent a continuous oil spill. However, even if a transfer pump is used for fuel oil, or a cargo pump for tankers, the suction is located close to the bottom of the tank. If the hole rupture is large, only flooded seawater is sucked in, which makes it difficult to shift the oil. This will be time-consuming, but requires a flexible response to the situation, such as using a portable pump to suck up the oil from near the surface and shift it.
