## 2 Medium/high speed 4-stroke diesel engine problems

## Detection of and countermeasures for issues arising from oil with poor ignition and combustibility

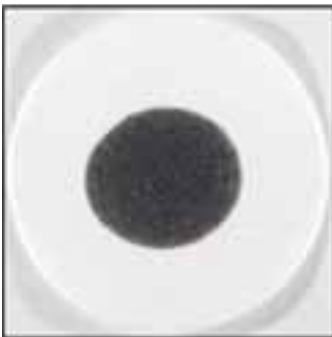
Left :Evaluation 1 Good compatibility

Photograph 5-35 Example of test result (compatibility of FO)

Particles that cannot smoothly pass through the test paper are deposited in a circular shape (inner ring), making it easy to judge by their appearance. As shown in Photograph 5-35, when a more distinctive spot can be seen in the center of the filter paper, this implies that the fuel is unstable. If we think of the filter paper as a strainer, it can be seen that the strainer would immediately become clogged if the oil did not spread evenly and appears thick around the center.

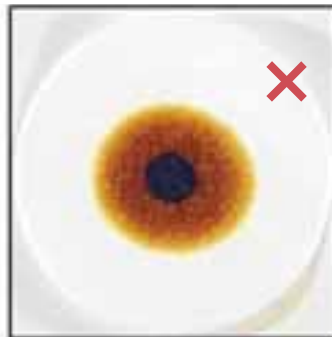
Right ; Evaluation 5 Very Poor compatibility
