# JAPAN P&I NEWS

## **Proper Maintenance and Rigging of Pilot Transfer Arrangements**

Attachment: Tokyo MOU Safety Bulletin 2025

## Proper Maintenance and Rigging of Pilot Transfer Arrangements

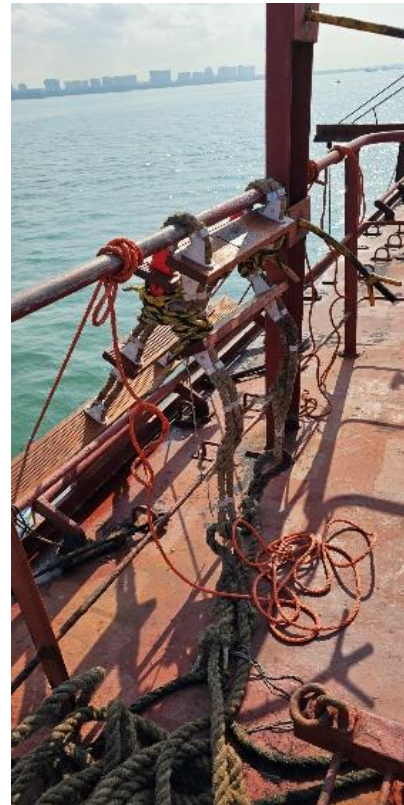
Figure 3. The pilot ladder secured to railings which is non-compliant, amongst others.

1. **Conduct Physical Checks**  
Verify the current method of securing pilot ladders to ensure there are no rigging errors or lapses in safety.
2. **Perform Regular Maintenance and Training**  
Carry out routine maintenance of pilot ladders and conduct regular crew training on proper rigging procedures.

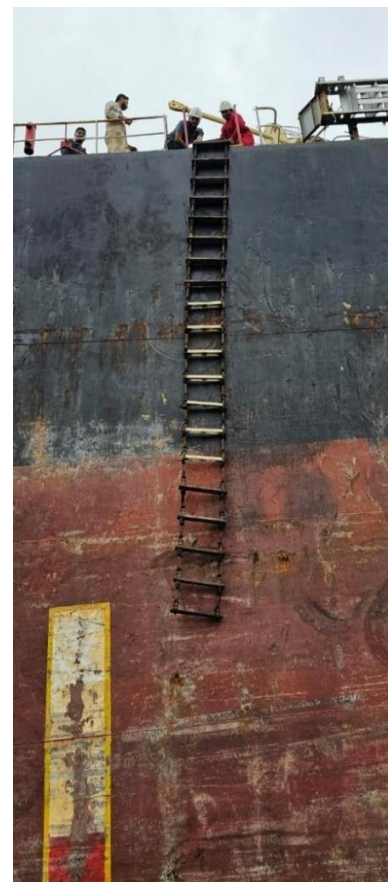
Figure 4. Incorrect ladder used, no spreaders, and combination arrangement not provided for safe embarkation to the vessel despite freeboard of vessel more than 9 m.

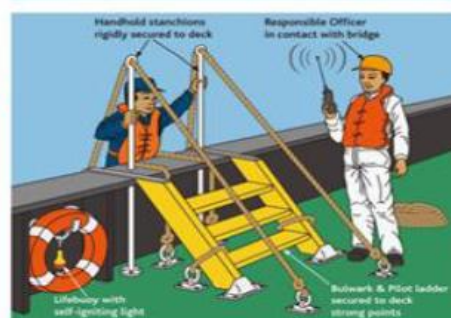
## Annex II (a): REQUIRED BOARDING ARRANGEMENTS FOR PILOTS (INTERNATIONAL MARITIME PILOT'S ASSOCIATION)

# REQUIRED BOARDING ARRANGEMENTS FOR PILOT

In accordance with SOLAS Regulation V/23 & IMO Resolution A.1045(27)

Required Pilot Transfer Arrangement Poster (IMPA) – **Annex II (a)**. Pictorial representation of the required boarding arrangements for pilot in accordance with SOLAS Regulation V/23 & IMO Res. A. 1045(27) – **Annex III**.
