# JAPAN P&I NEWS

## ココアバターのフレートコンテナ輸送に関する CINS ガイドライン

# CINS Guidelines for the Carriage of Cocoa Butter in Freight Containers

A Publication of CINS, the Cargo Incident Notification System

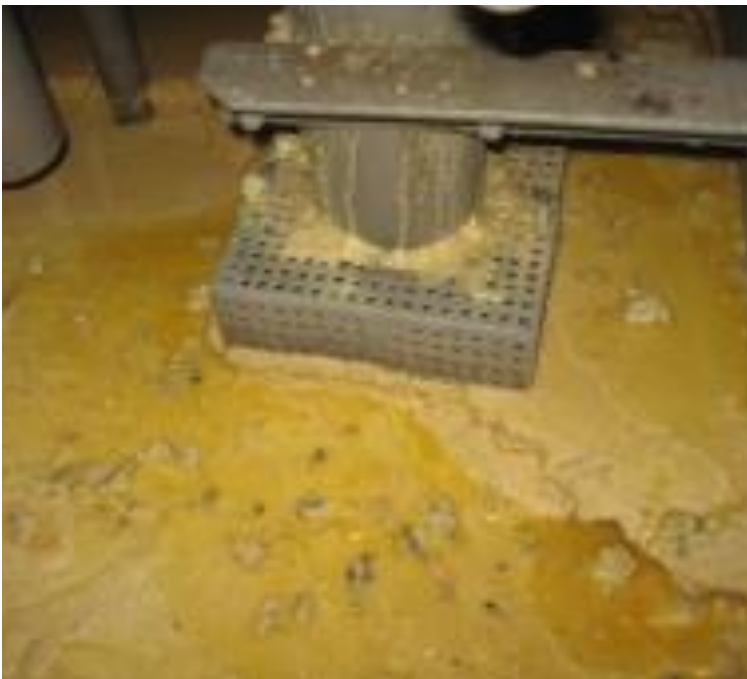
Upon heating, cocoa butter expands and may cause it to burst the packaging and seep out, staining adjacent cartons (see **Appendix II**) and possibly leaking outside of the container or causing damage to the container structure. There have been incidences of cocoa butter melting on board ships, resulting in the clogging of ships' bilges. The figure below left shows a ship's cargo hold bilge well clogged by melted cocoa butter stowed under deck.

*A ship's cargo hold bilge significantly clogged by melted cocoa butter*

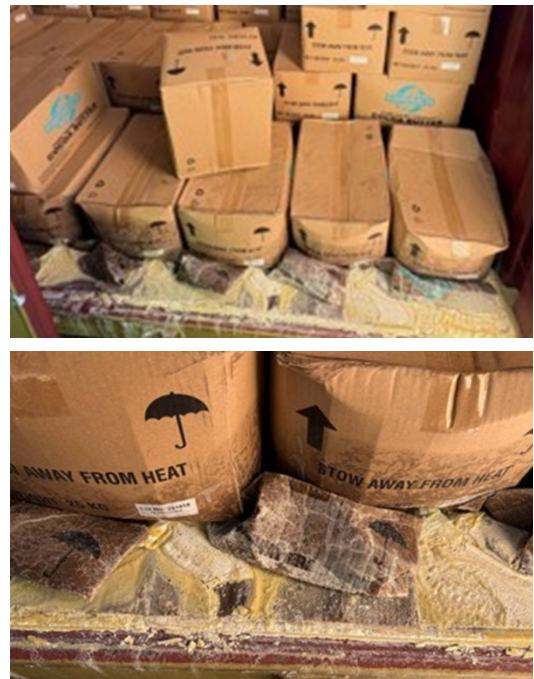
*Leaking packages*

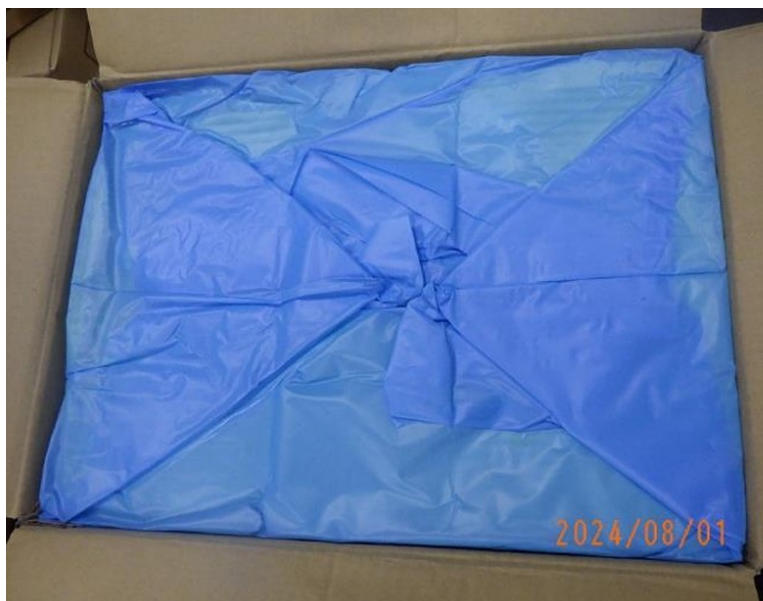
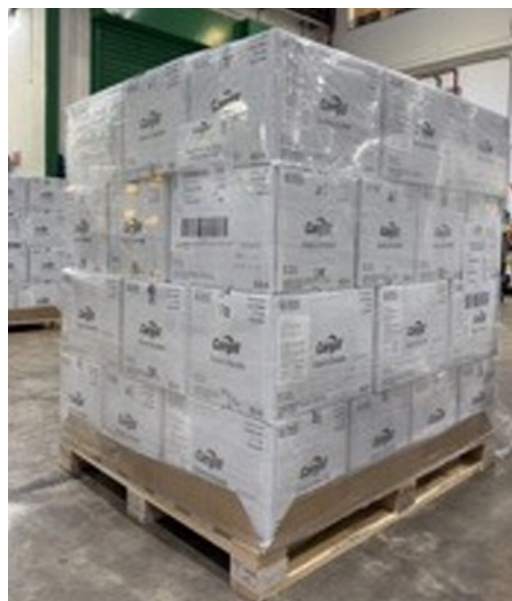
### Illustrations 3.1: Typical inner and outer packaging

Cocoa butter shall be packaged in sealed plastic bags and placed within robust cardboard cartons. When transported in dry containers, it is imperative that the cartons are engineered to withstand the total stacked weight, including scenarios in which the cocoa butter may soften due to elevated temperatures. A standard packing method involves placing 25 kg blocks in sealed bags within cartons measuring 40 × 30 × 25 cm. In a 20-foot standard container, up to 800 cartons may be stowed, typically in 8 tiers, resulting in a gross container weight of approximately 22 tons. Stack heights must not exceed the load-bearing capacity of the bottom-most cartons.

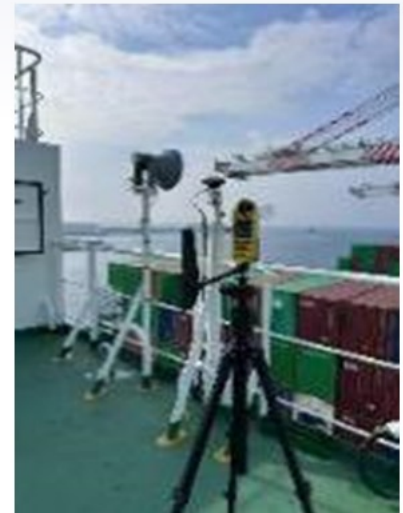
### 5. Thermal Imaging Observation

A thermal image taken at the marine terminal shows that the surface temperature of dry freight containers may exceed the melting point of cocoa butter (37 °C), reaching up to 46.1 °C. The photograph was taken on January 15, 2026, at Taipei Port. At the time of observation, the average daytime ambient temperature was 22.8 °C, and the average wind speed was 7.1 kt.

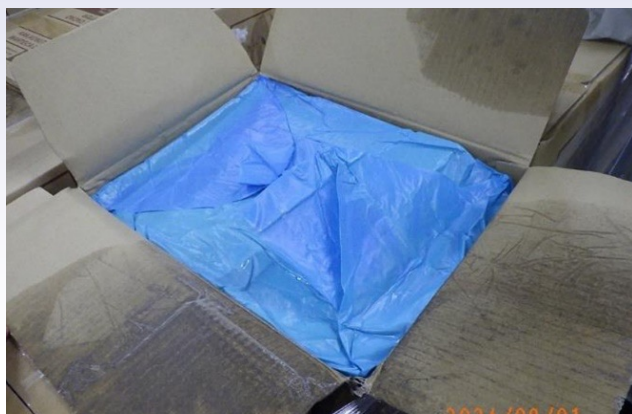
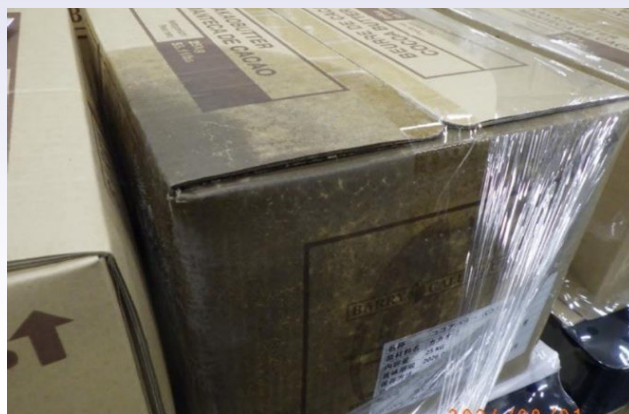
1. A typical cargo damage case: The following illustrations show the cocoa butter shipments damaged by high ambient temperature during transportation.

It was a 32-day voyage, starting from gate-in at the port of origin, via a transshipment port, to the port of discharge. The ambient temperature during the shipments' stay at the terminals was generally warmer than during the period on the ships.

Sea conditions on both legs of the voyage were relatively calm, indicating that the ship's motions were unlikely to be the primary cause of the carton damage. During the 32-day journey, containers spent 12 days—approximately 37% of the time—stowed under deck and away from any heat sources on both legs, an environment considered free from radiant heat, with container internal temperatures estimated to remain within the 31–35 °C range.

For the remaining 20 days, or 63% of the journey, containers were at three marine terminals. In these locations, internal container temperatures could exceed 50 °C (and potentially reach 70 °C or higher) for about 10 hours per day if exposed to direct sunlight or exceed 35 °C (up to 40 °C or higher) due to radiant heat when positioned in shaded areas protected from direct sunlight.

Referring to the temperature dataset in Appendix I, this cocoa butter melting was very likely to have occurred during the period spent at the three (3) terminals. As stated in section 4.1 Terminal Operations, it is advised that both shippers and carriers take feasible prevention actions to avoid long terminal dwell time to minimize the risk of cargo damage.
